# Historic Landmark Property

## City Hall and Lincoln School

### Condition Assessment

# Wise Homestead

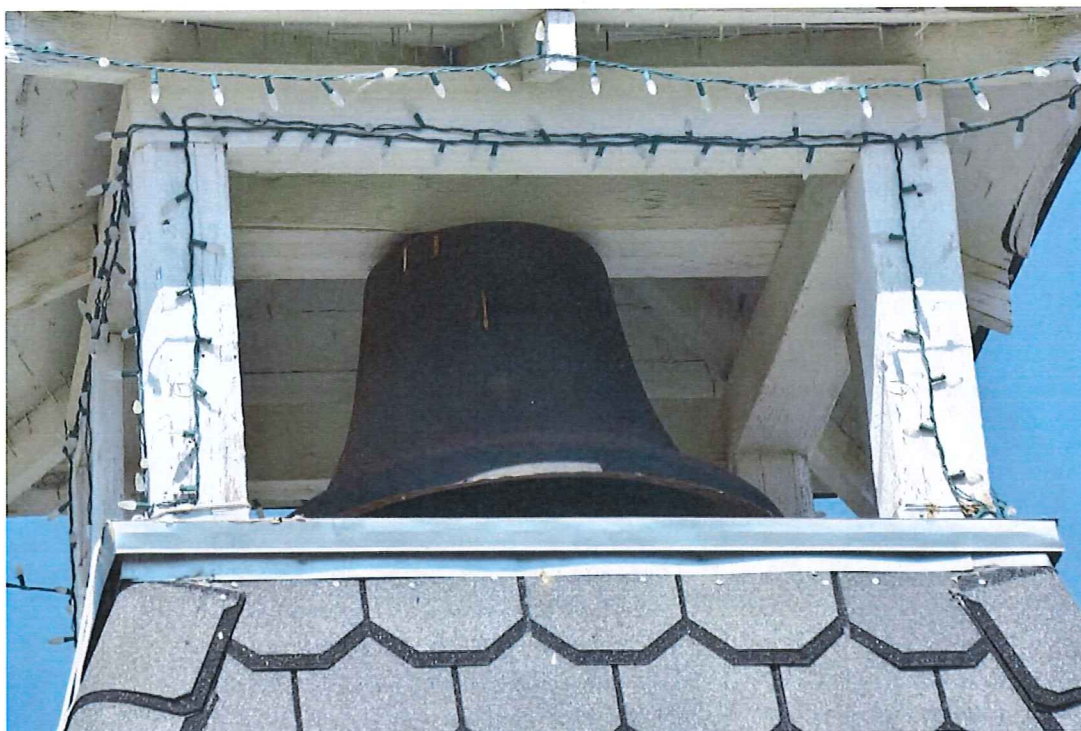
*City Hall: Bell Tower Detail*

1. The paint on the exposed portions of the roof rafter tails appears worn away where they are the most exposed to the weather on the south ends.
2. The paint on the exposed wood framing of the bell tower appears to be weathering where it is exposed to the weather.
3. In one location, on the lower portion of the east wall, it appears the stucco is disengaging from the brick substrate.

1. Plan to paint exterior trim and bell tower wood framing prior to paint peeling and bare wood becoming exposed to the weather. Weathered wood does not hold paint well and typically requires special treatment such as sanding and priming, otherwise new paint will fail to adhere.

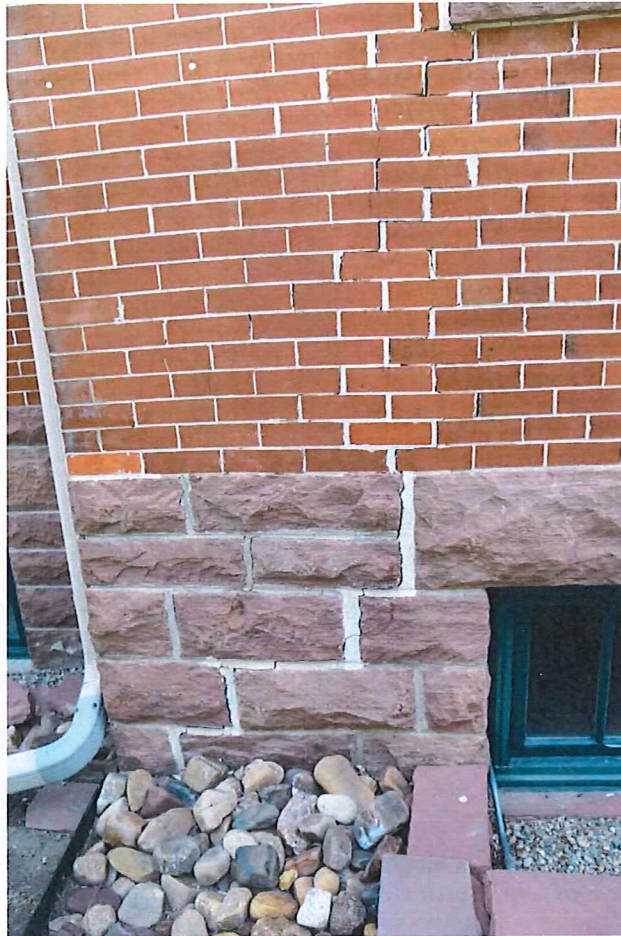
1. Many of the wood window sills are severely weathered where exposed to the elements.
2. In some locations, displaced window weather stripping was observed.
3. A downspout on the southeast corner has been cast aside and is located nearby.
4. There appears to be numerous instances of poorly executed masonry pointing performed in the past. Using Portland Cement type mortar appears to have created premature mortar failure at many of the past masonry repairs. Historic lime base mortars can last centuries and actually heal in some circumstances.

*Lincoln School: Detail of Corner Settlement and Repair*

2. It appears that window weather stripping needs either repair or replacement.
3. Reinstall dislocated downspout extension. It is critical that roof drainage be carried as far from the base of the historic masonry walls as possible. It is obvious this has been an on-going problem and has caused masonry settlement at nearly every downspout location.
4. A mortar test needs to be performed so that when maintenance is required the correct mortar (color, consistency, application) starts being used. In some situations, where the contemporary repairs have failed, the joints may need to be raked out and the proper mortar installed. Follow the link below to the National Park Service Preservation Brief #2 for information on repointing historic masonry.

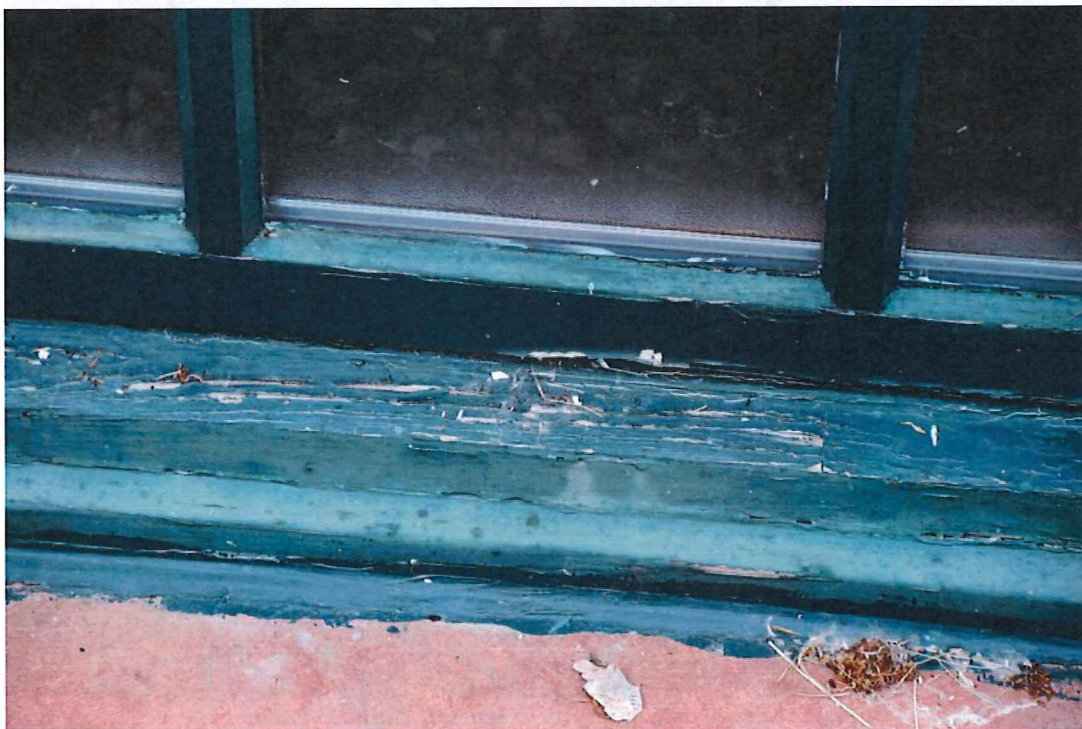
*Lincoln School: Detail of Deteriorating Window Sill*

1. It appears exterior priming and painting of wood window sash and sills is due. Weathered wood does not hold paint well and typically requires special treatment such as sanding and priming, otherwise new paint will fail to adhere. The following link is to Preservation Brief #9 for information on the repair of historic wood windows.

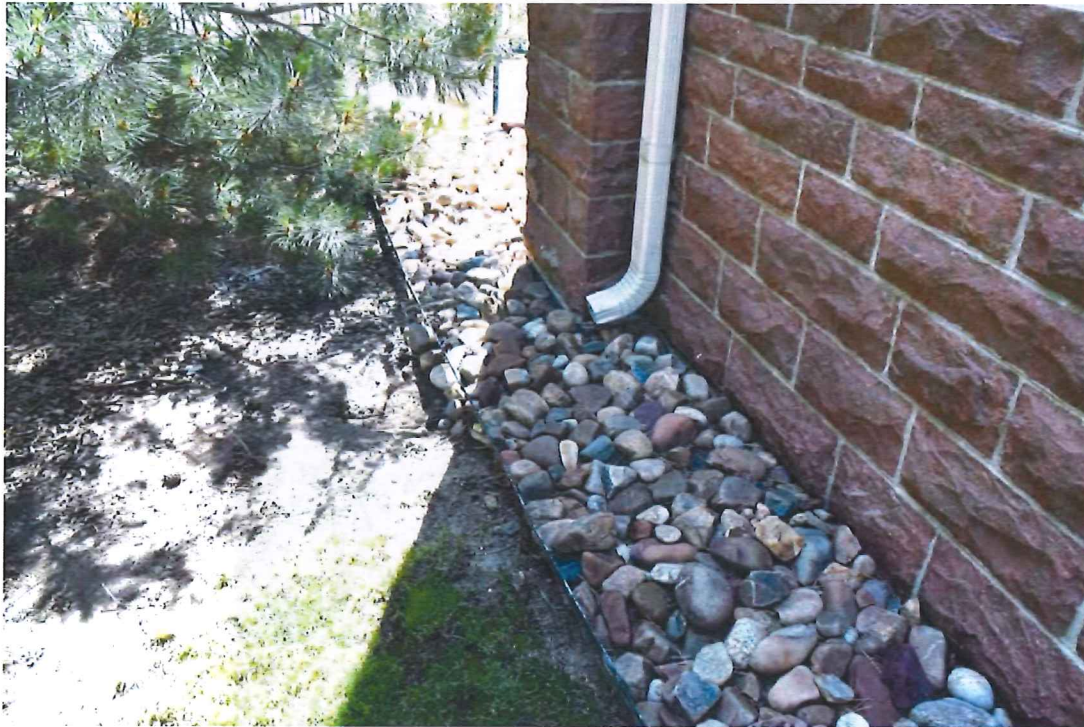
*Lincoln School: Northeast Corner Missing Downspout Extension*

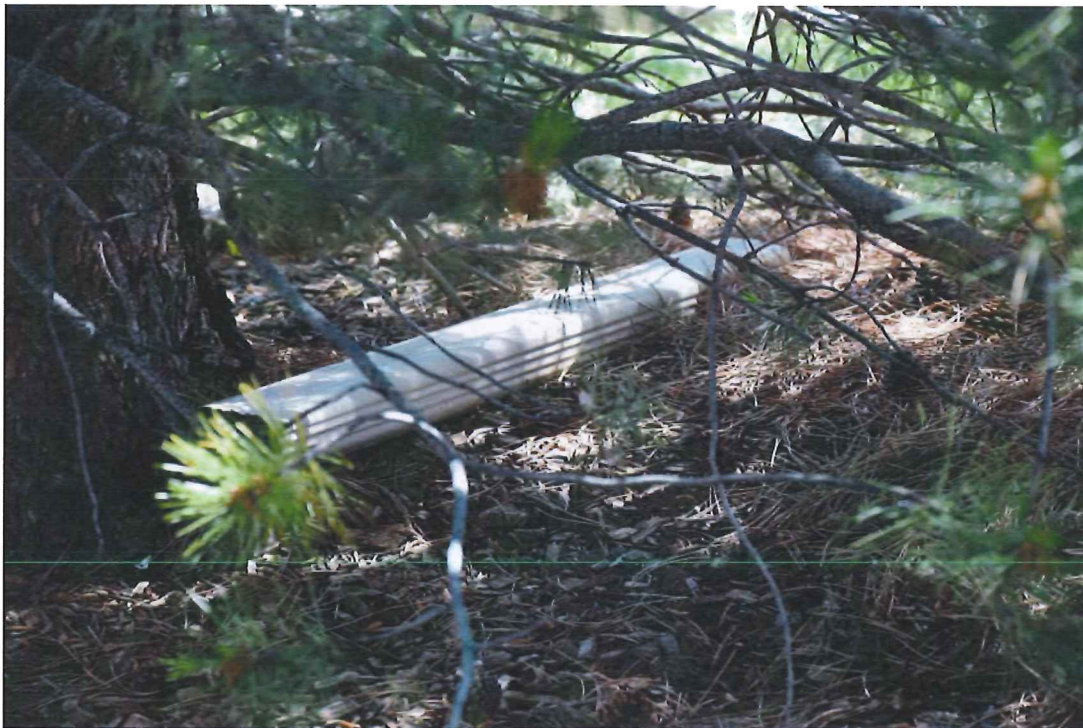
*Lincoln School: Downspout Extension Under Nearby Tree*

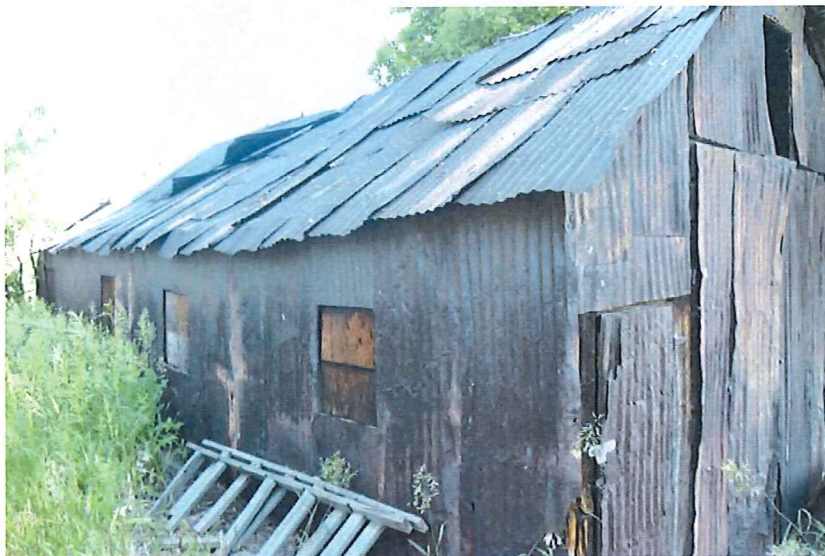
*Site 2: Blacksmith Shop: Southwest corner*

The Blacksmith Shop appears to be in **“Poor Condition”** and near imminent collapse. The entire perimeter of the structure is overgrown by vegetation and layers of past seasonal detritus. The entire building is threatened by potential falling limbs from a nearby tree of considerable size. Access is adversely affected by an adjacent road with considerable fast moving traffic. There appears to be no contemporary foundation. Due to dense vegetation, much of the structure is inaccessible. The walls and roof undulate (indicating possible structural inadequacy or failure) and there appears to be considerable roof leakage (warped, severely deteriorated and warped corrugated panels). There are little to no visible maintenance efforts.

Emergency Stabilization and Mothballing is highly recommended:

1. Removal or trimming of all threatening vegetation for at least six to eight feet from the base of all exterior walls.
2. Remove vegetative detritus from the base of the walls and insure the site drains away from the building.

3. After removal of vegetation, further assess the condition of the structure.
4. Document historic materials and dimensions so that no historic details get lost during emergency stabilization efforts.

5. Structurally assess (structural engineer) and stabilize (with temporary supports) the building making sure it's safe to work on and that no historic details will get lost during further stabilization efforts.

6. Mothball the structure ASAP by creating a dry and ventilated interior.
  - a. Create a ventilated weather-tight envelope by repairing roofs and walls (replacement in kind for roof and walls and install weatherproof window vents).

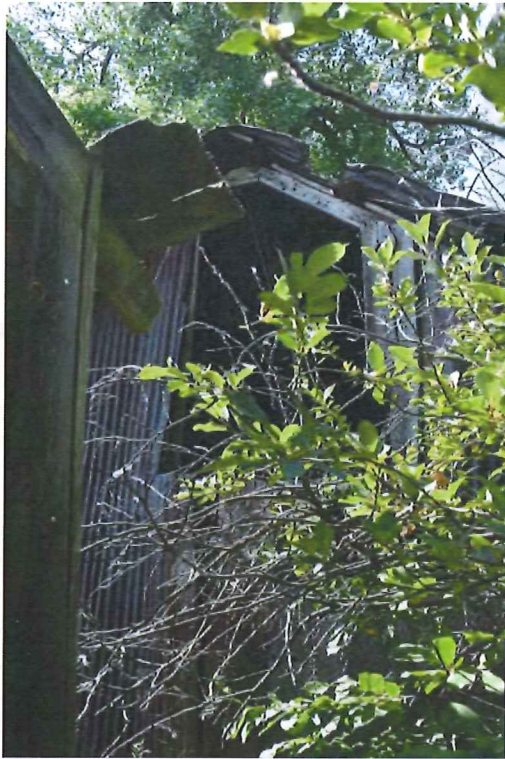
*Site 3: Mill: Wall Detail*

Similar to the Blacksmith Shop, the Mill appears to be in **“Poor Condition”** but at a higher degree of degradation as portions have already collapsed. The entire perimeter of the structure is also overgrown by vegetation and layers of past seasonal detritus. Due to dense vegetation, most of the structure is inaccessible and vegetation is visible growing inside the building. Since complete portions of the Mill have already collapsed, the exposure to weather is further compromising structural elements and accelerating deterioration and collapse. Most of the interior (historic mill features/artifacts exposed) is open to the weather. Access is adversely affected by an adjacent road with considerable fast moving traffic. There are little to no visible maintenance efforts.

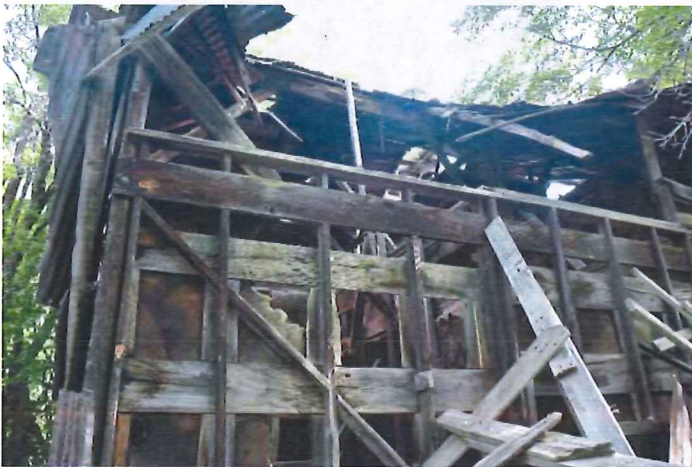
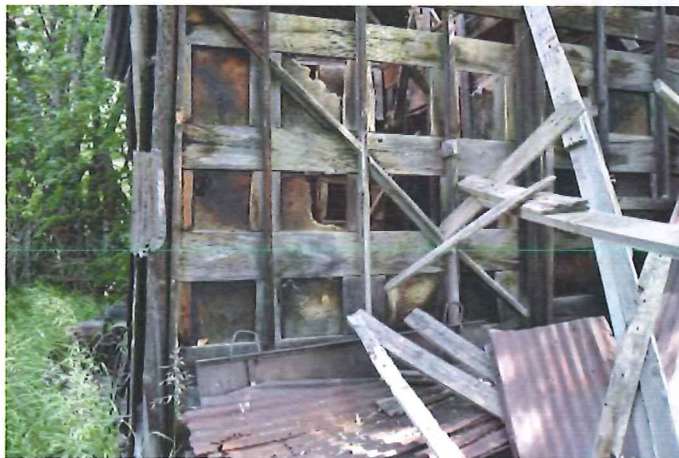
*Site 3: Mill: Collapsed Wall*

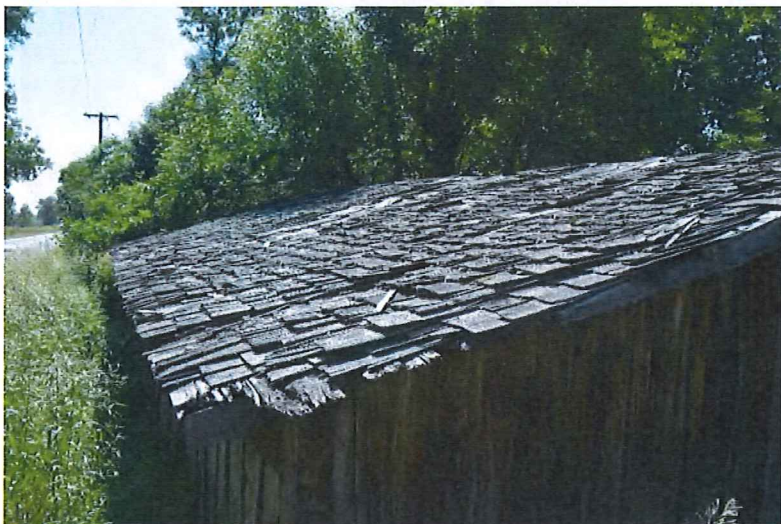
*Site 4: Chicken Coop: Looking East*

The Chicken Coop is in similar condition to the Granary. Overall it appears to be between **“Fair and Poor Condition.”** Large portions of the corrugated metal roof are missing, warped, bent, deteriorated and there is likely abundant roof leakage, but again, the walls and roof remain relatively plumb (as previously stated: a testament to first-growth lumber that weathers exceptionally well). Similar to others, the entire perimeter of the structure has limited access due to overgrown scrub vegetation, trees, and layers of past seasonal detritus. Walls of this structure appear to have been treated with linseed oil that can blacken the wood and accelerate the growth

of mildew. Access is adversely affected by an adjacent road with considerable fast moving traffic. There are little to no visible recent maintenance efforts.

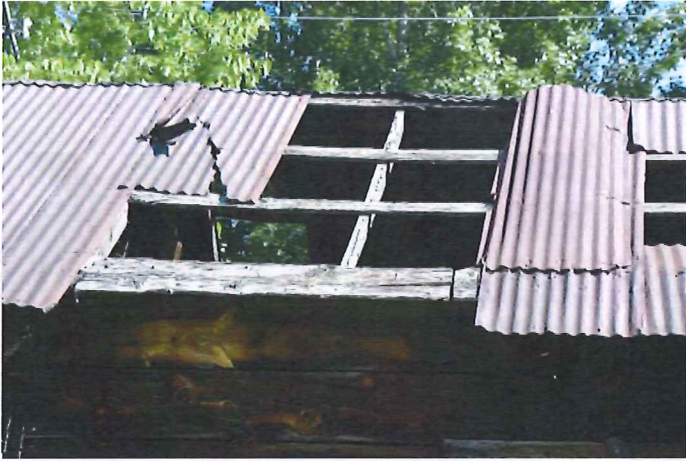
*Site 5: Granary: Roof Detail*

The Granary is a very weathered board and batten wood shed that appears to still retain its original wood shingle roof (though some portions of the roof are missing). Overall the structure appears to be between **“Fair and Poor Condition.”** There are likely extensive roof leaks, but the walls and roof remain relatively plumb (a testament to first-growth lumber that weathers exceptionally well). Similar to others, the entire perimeter of the structure has limited access and is overgrown by scrub vegetation, trees, and layers of past seasonal detritus. Walls of this structure appear to have been treated with linseed oil that can blacken the wood and accelerate the growth of mildew. Access is adversely affected by an adjacent road with considerable fast moving traffic. There are little to no visible recent maintenance efforts.
