**SUBSIDENCE INVESTIGATION
BRIDGEWATER
WELD COUNTY ROADS 8 and 5
ERIE, COLORADO**

**COMMUNITY DEVELOPMENT GROUP
2500 Arapahoe Avenue, Suite 220
Boulder, Colorado 80302**

Project No. CT15,114-130

October 14, 2010

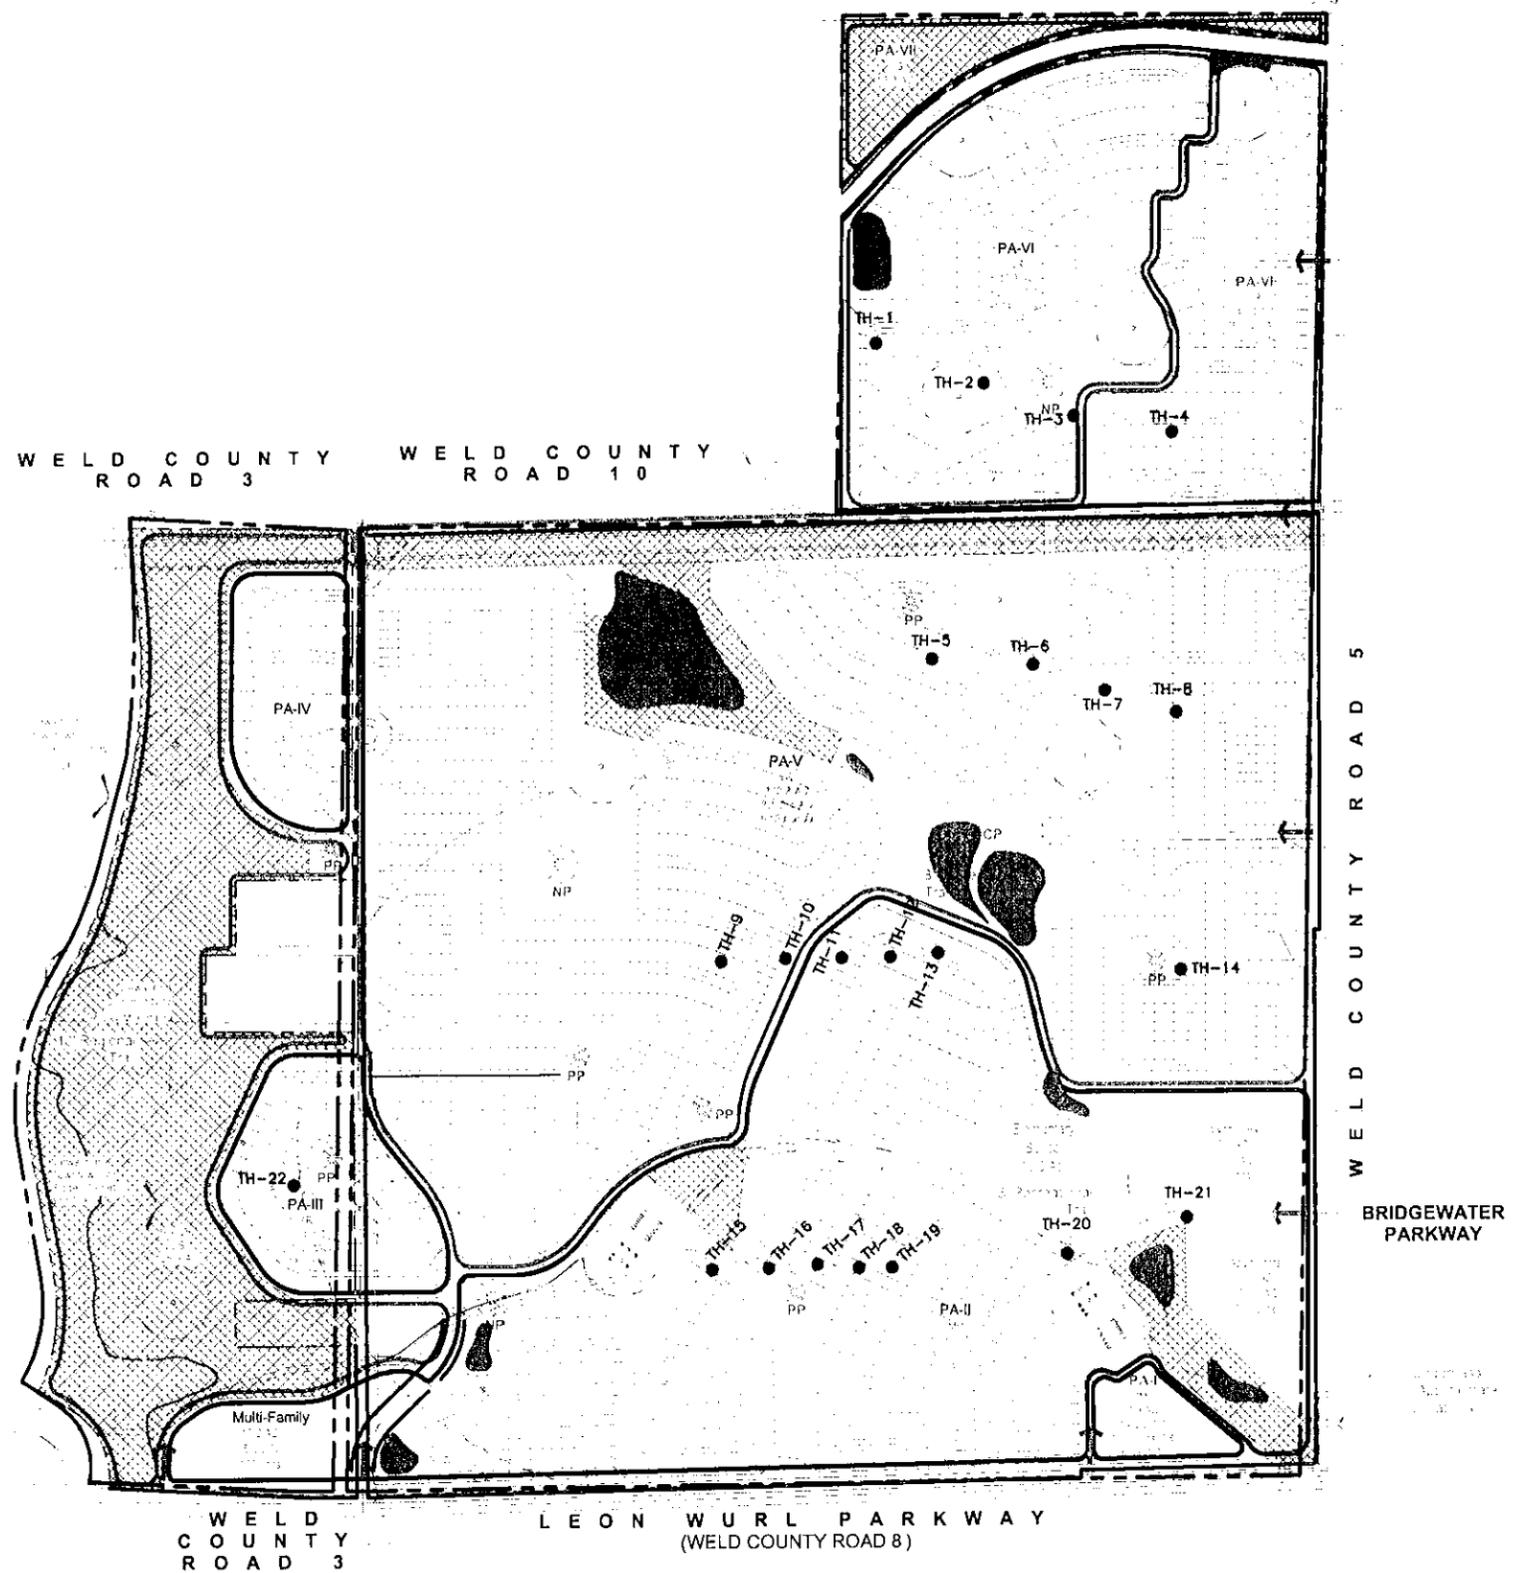
Fig. 1

Twenty-one exploratory borings were drilled in the area of the Clayton and Boulder Valley (new) mines and one boring near the Boulder Valley (old) mine using rotary drilling techniques. Drilling was conducted by Precision Sampling of Colorado Springs, Colorado. The location of exploratory borings is shown on Figs. 1 and 2. Boring logs are shown on Figs. 4 through 6 and a summary of conditions found is presented in Table 1.

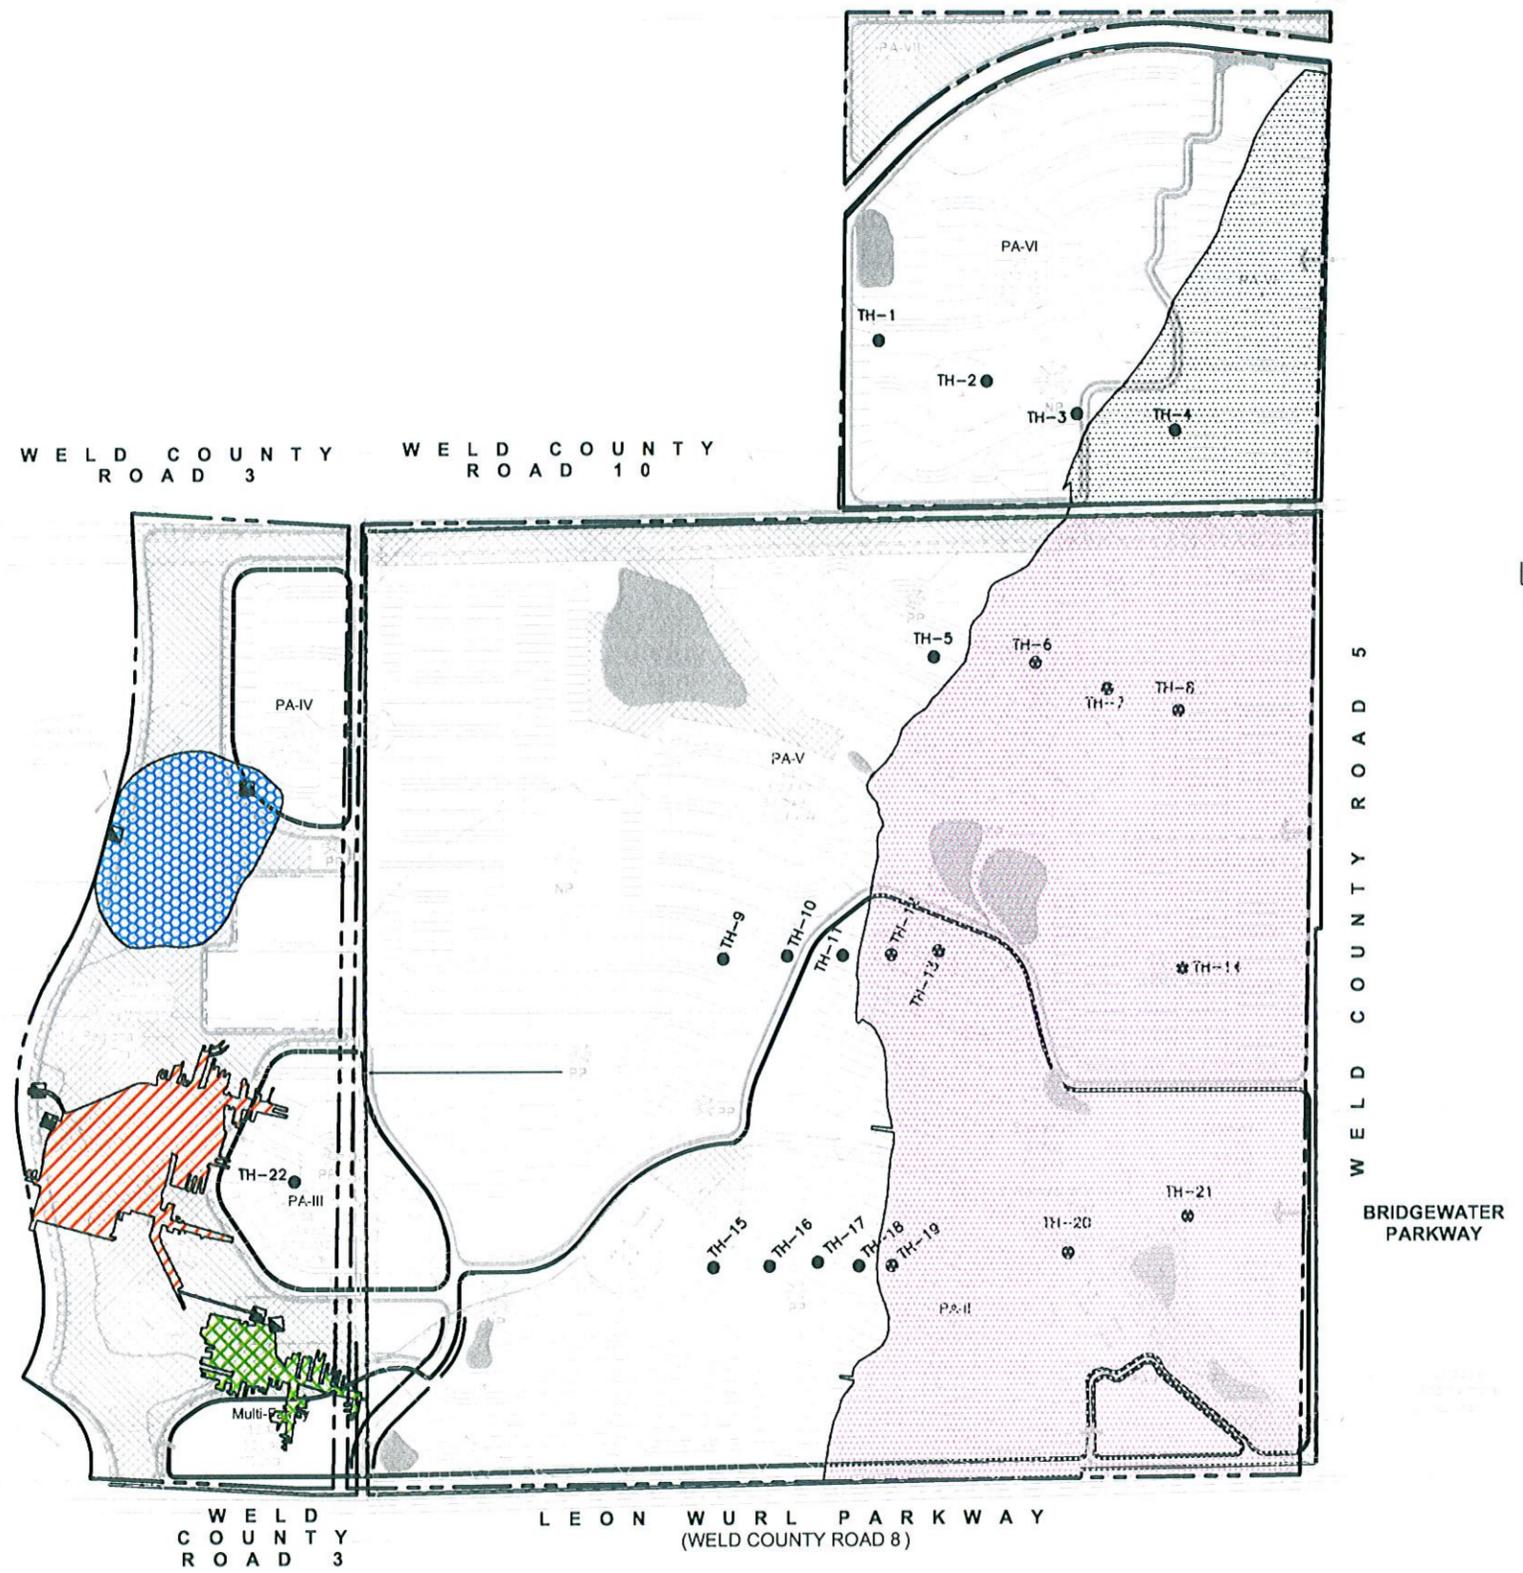
Approximate
Mine
Locations

The Northwestern Mine operated between 1892 and 1907 with a reported production of 54,193 tons of extracted coal. Coal was mined through a main shaft located on the northeast portion of the mine. An air shaft was located approximately 125 feet west of the main shaft (Fig. 2). The coal seam ranged between 5 to 8 feet thick.

The Boulder Valley (old) Mine is northwest of the Northwest Mine. The mine operated from 1883 to 1885, and again from 1890 to 1895. The reported coal production was 35,813 tons during the first operating period. No records could be found documenting production during the second five year operating period. Coal was mined through a main shaft located on the western edge of the mine. An air shaft was located approximately 180 feet southeast of the main shaft (Fig. 2). The coal seam ranged between 5 to 7 feet thick.

Two shafts are mapped to the north of the Boulder Valley (old) Mine (Fig. 2). There are no mine maps or production records filed with the Colorado Division of Mines for this mine. Collapse features at the surface were previously documented, and the estimated depth to the mine was 40 to 50 feet.

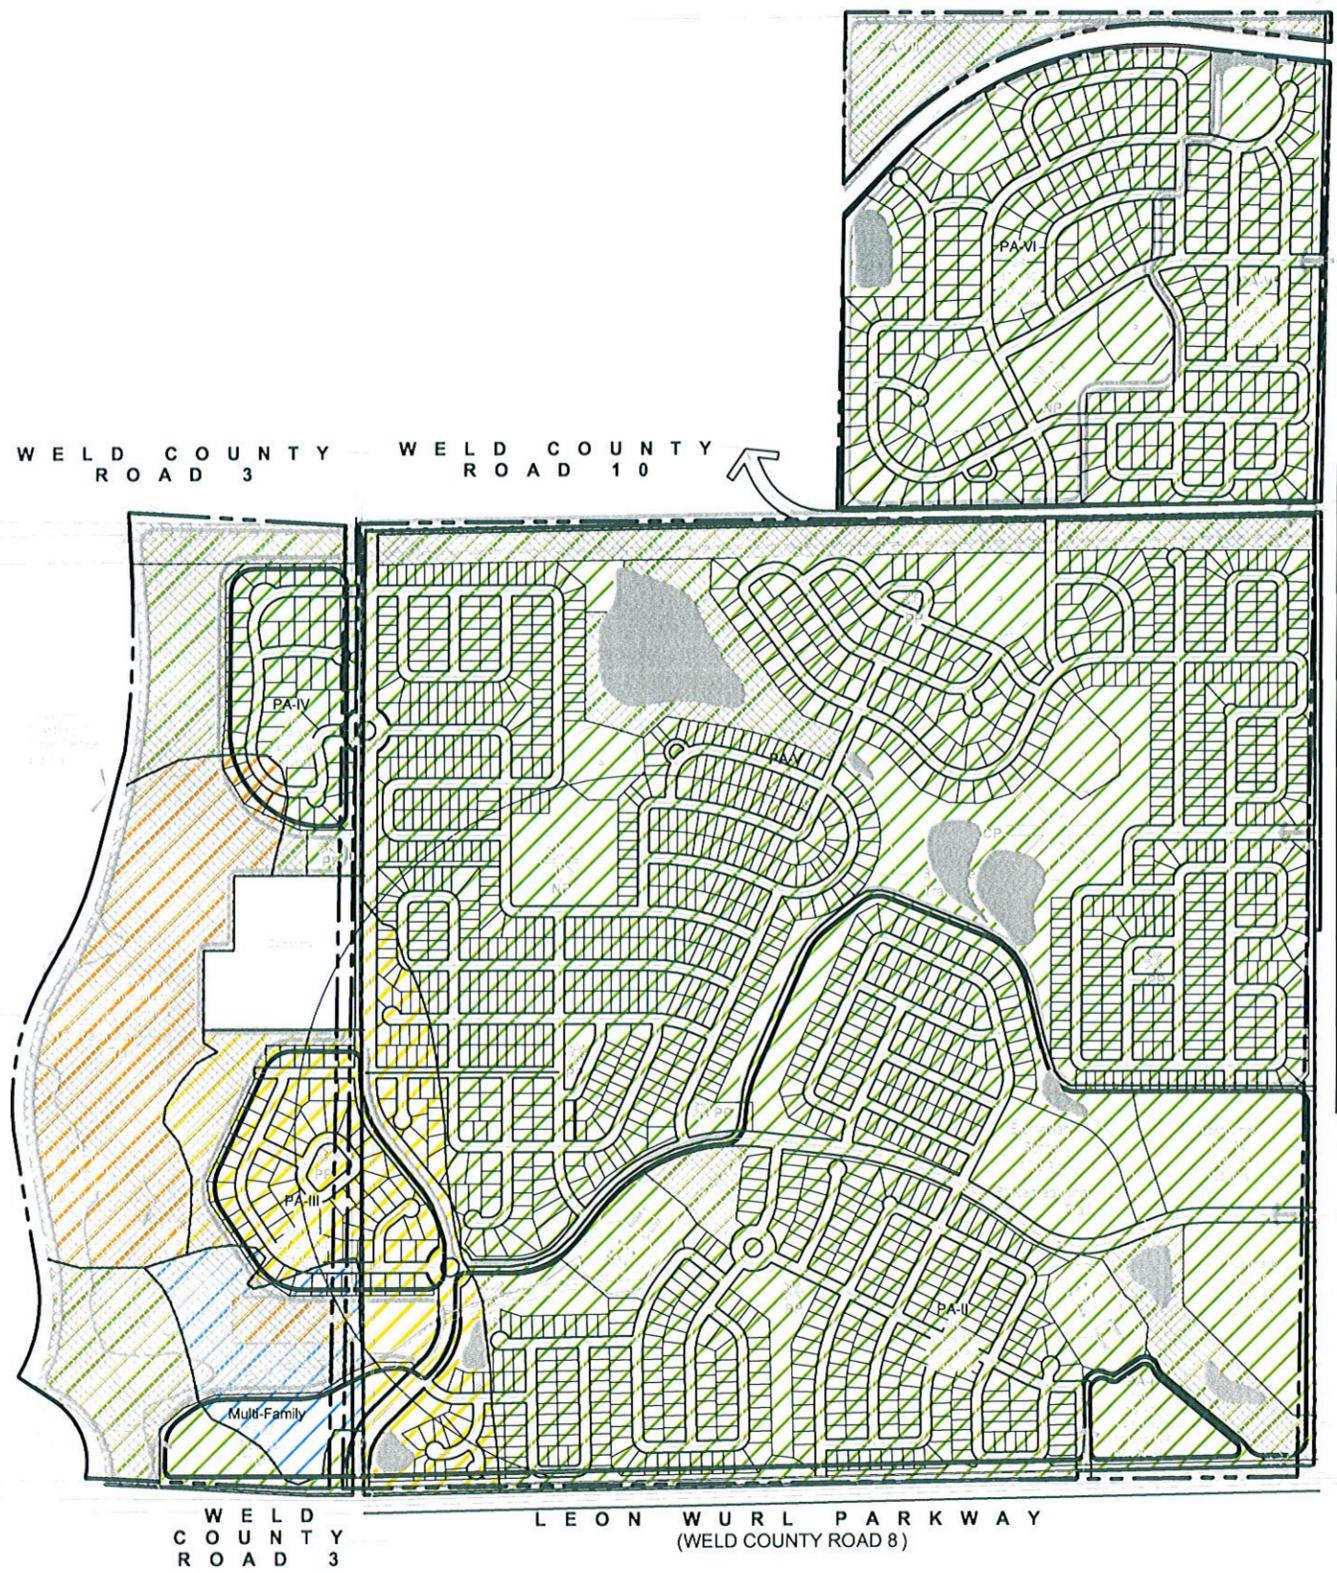
Mine conditions beneath the Clayton and Boulder Valley (new) mines and near the Boulder Valley (old) were explored by drilling twenty-two borings to depths up to 300 feet. The floor of the likely mined coal seam was found at depths ranging from 102 to 250 feet. We reviewed an investigation of the areas underlain by the Northwestern, Boulder Valley (old) and Unknown mines completed by Western Environmental and Ecology, Inc. (WEE)¹. Our analysis and review indicate the risk of future subsidence propagating to the surface is low for areas where the thickness of bedrock above the mined coal seam is greater than 90 feet. The majority of the property is categorized as low subsidence potential. Some areas of shallow mining and areas around the six mapped shafts are categorized as severe subsidence potential.

Our investigation and analysis indicates there is risk of caving subsidence reaching the surface in areas where the bedrock above the coal seam is less than 90 feet thick. Undermined areas with a bedrock thickness in excess of 90 feet are judged to have a low risk of caving subsidence. This is a conservative choice based upon the two methods used. A map showing estimated areas of low and severe subsidence potential is presented on Fig. 3.

Due to the depth to mining and the thickness of bedrock above the mine levels, the subsidence risk for the majority of Bridgewater is judged low. We believe residential or commercial construction is feasible in areas rated as low risk. No extraordinary restrictions or special building requirements are necessary. Typical building code requirements for foundation walls to be reinforced to simply span a minimum of 15 feet should apply.

We believe residential or commercial construction is feasible in these areas provided buildings have a maximum foundation length of either 60 feet or 80 feet, depending on the depth and condition of the mines (see Fig. 3). In addition to the maximum foundation length, a strain isolation trench should be constructed around the perimeter of the foundation.

We do not recommend buildings, roads or major utilities be constructed over areas mapped as severe risk. Shaft areas should be avoided (100 foot radius) or mitigated as discussed below.

To mitigate the mine areas rated severe would require extensive void filling with grout. The procedure is relatively expensive. Avoidance of the severe risk area is considered the primary alternative.

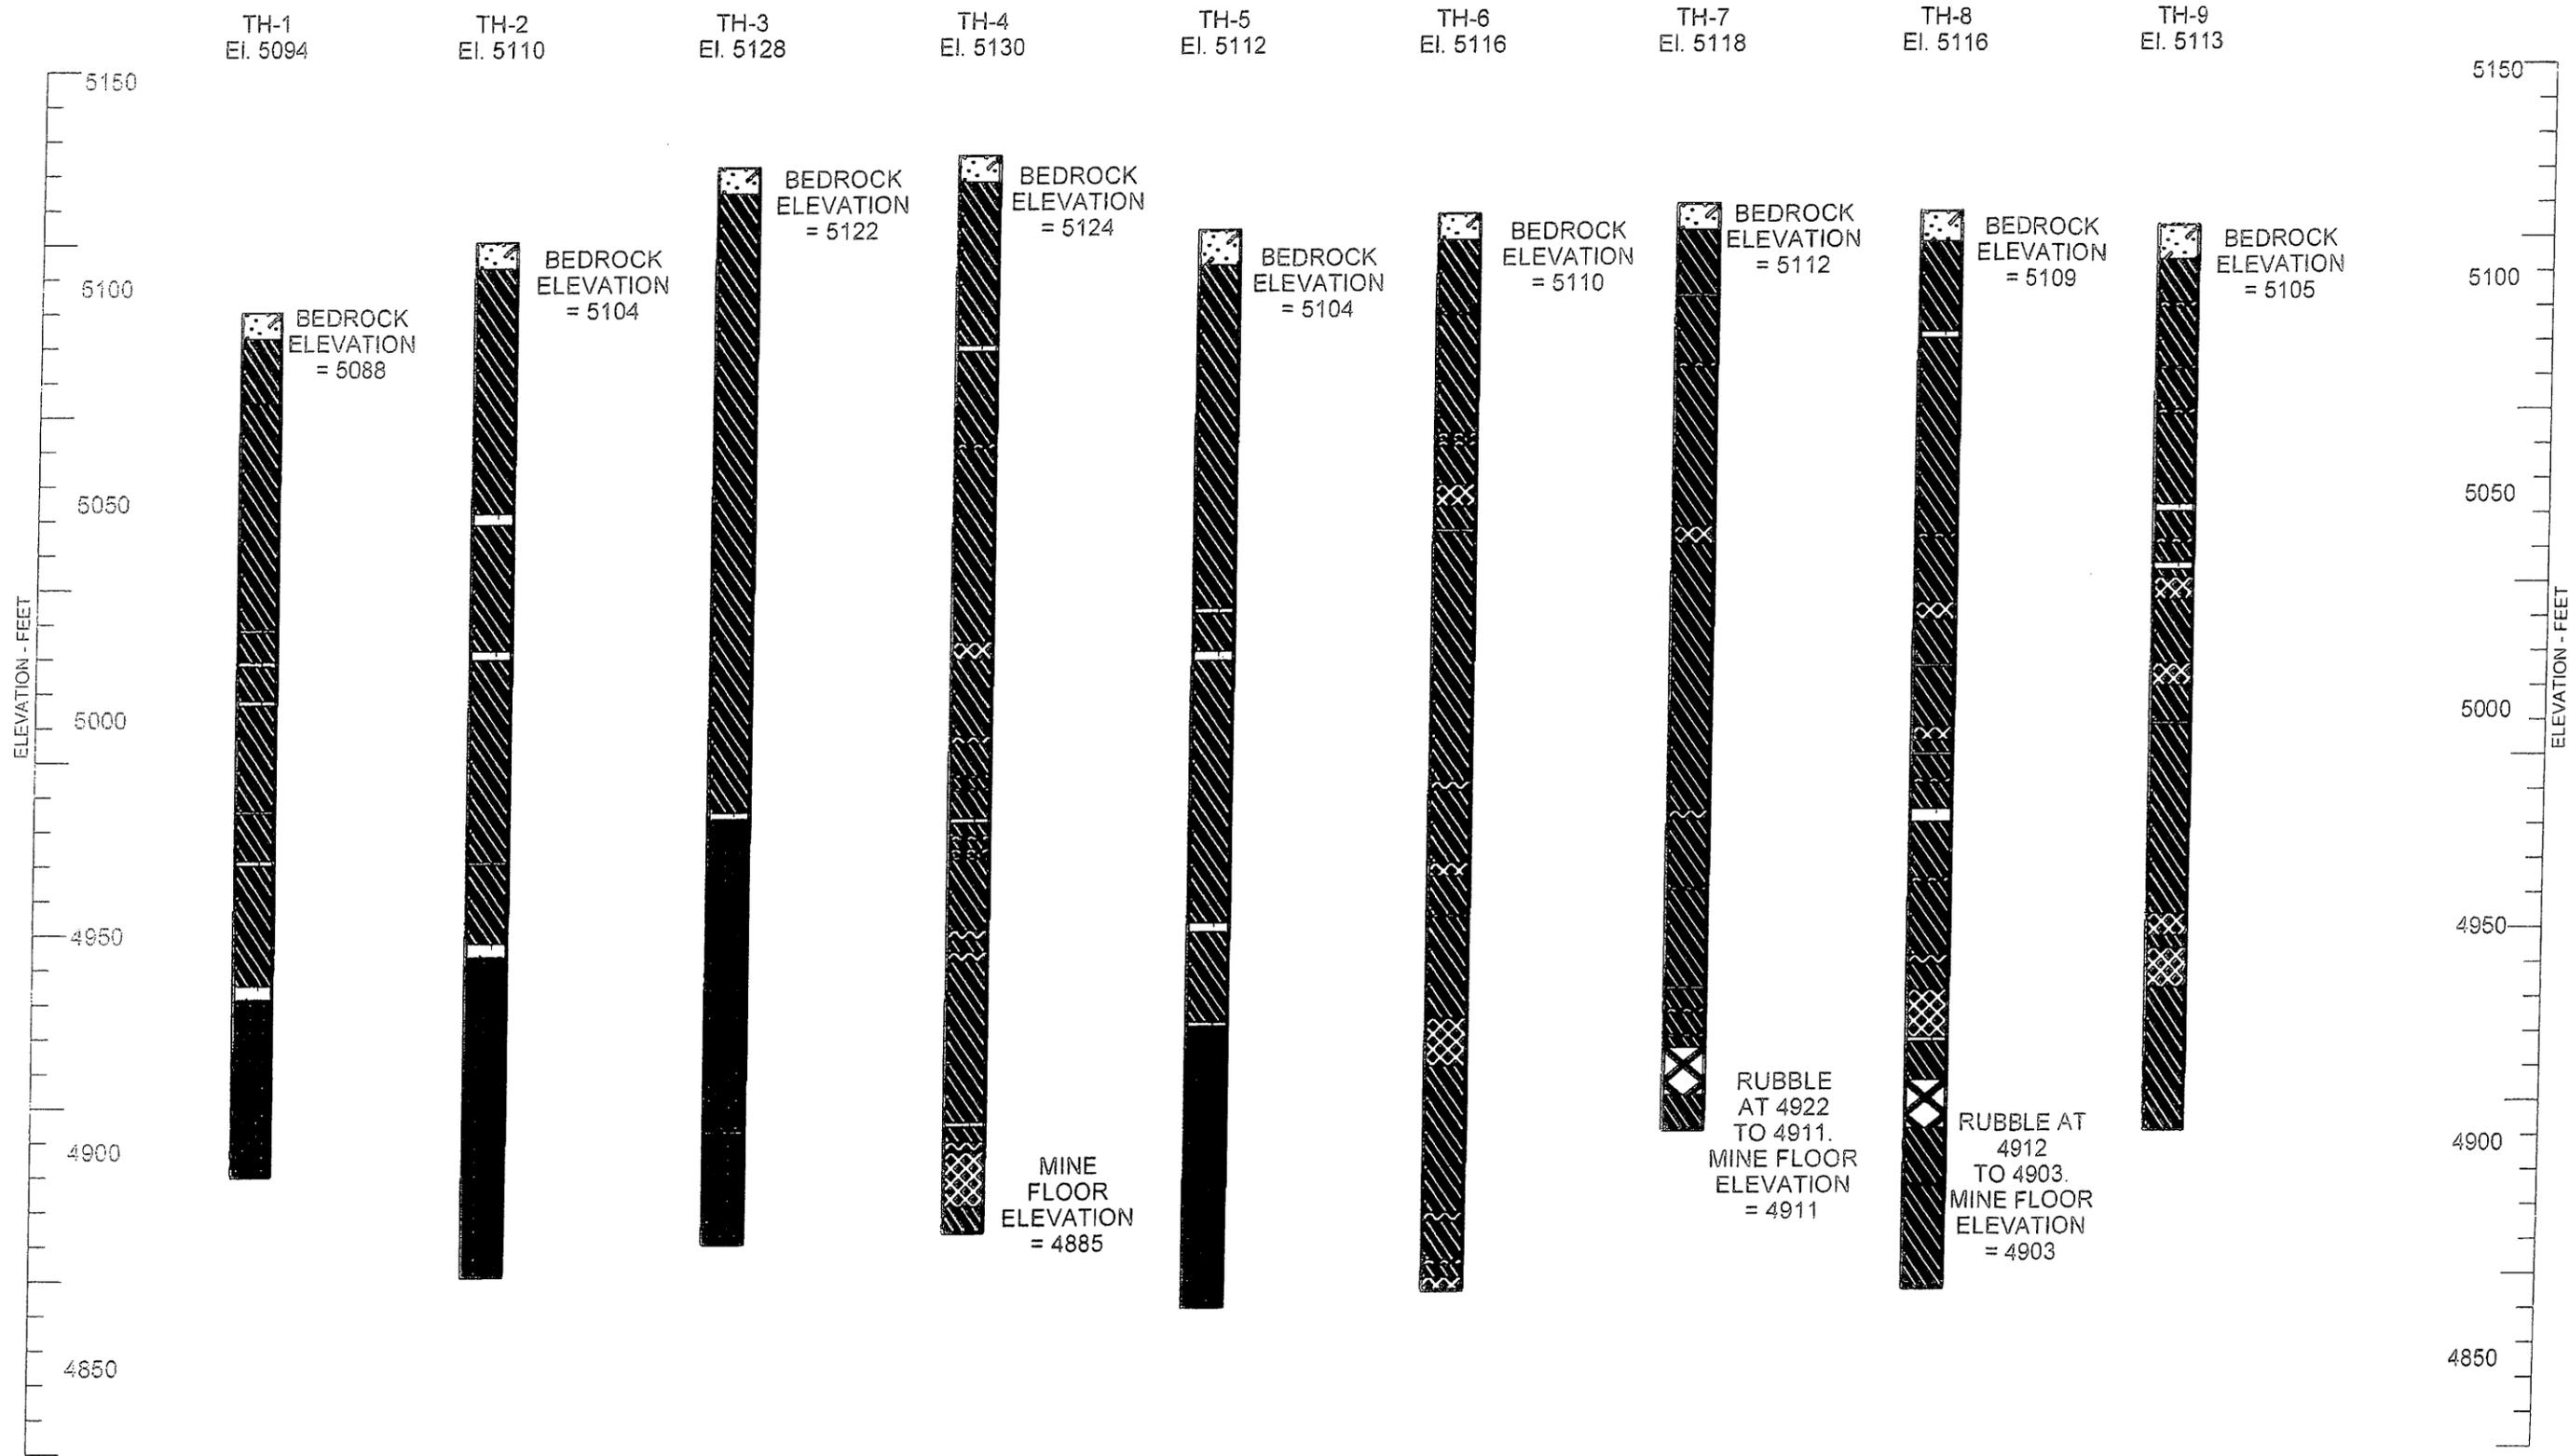
FIG. 4

The thickness of bedrock above the mined seam ranged from 90 to 231 feet. The 90 foot thickness was in boring TH-22, which is in the shallower area near the Boulder Valley (old) and Northwest Mines. The bedrock thickness above the Boulder Valley (new) and Clayton Mines ranged from 139 to 231 feet. Six of our twenty-two borings encountered mine workings. No open void was encountered in those six borings indicating roof contact was made by the bulked rubble.
