Historic Landmark Property

City Hall and Lincoln School

Condition Assessment

Historic Landmark Property Name: City Hall (a.k.a. Erie Town Hall) and Lincoln School

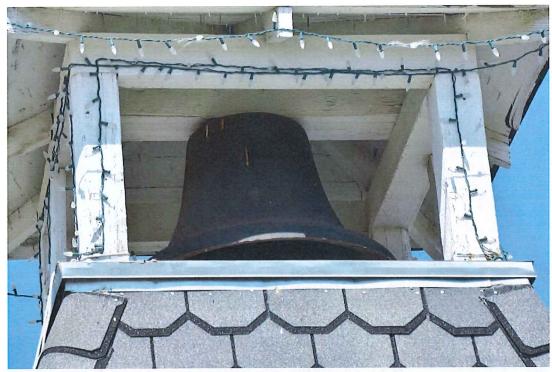
City Hall: Bell Tower Detail

- 1. The paint on the exposed portions of the roof rafter tails appears worn away where they are the most exposed to the weather on the south ends.
- 2. The paint on the exposed wood framing of the bell tower appears to be weathering where it is exposed to the weather.
- 3. In one location, on the lower portion of the east wall, it appears the stucco is disengaging from the brick substrate.

Plan to paint exterior trim and bell tower wood framing prior to paint peeling and bare wood becoming exposed to the weather. Weathered wood does not hold paint well and typically requires special treatment such as sanding and priming, otherwise new paint will fail to adhere.

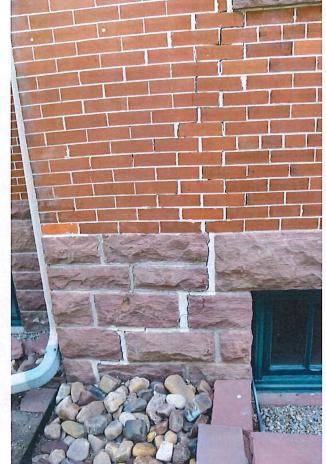
Lincoln School: Detail of Corner Settlement and Repair

- 1. Many of the wood window sills are severely weathered where exposed to the elements.
- 2. In some locations, displaced window weather stripping was observed.
- 3. A downspout on the southeast corner has been cast aside and is located nearby.
- 4. There appears to be numerous instances of poorly executed masonry pointing performed in the past. Using Portland Cement type mortar appears to have created premature mortar failure at many of the past masonry repairs. Historic lime base mortars can last centuries and actually heal in some circumstances.

- 3. Reinstall dislocated downspout extension. It is critical that roof drainage be carried as far from the base of the historic masonry walls as possible. It is obvious this has been an ongoing problem and has caused masonry settlement at nearly every downspout location.

- 4. A mortar test needs to be performed so that when maintenance is required the correct mortar (color, consistency, application) starts being used. In some situations, where the contemporary repairs have failed, the joints may need to be raked out and the proper mortar installed. Follow the link below to the National Park Service Preservation Brief #2 for information on repointing historic masonry.

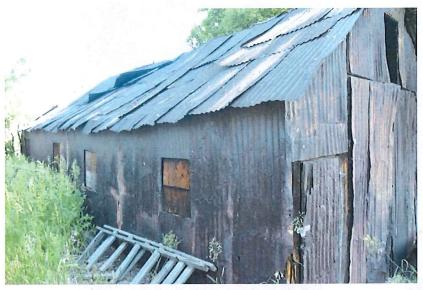
Site 2: Blacksmith Shop: Southwest corner

The Blacksmith Shop appears to be in "Poor Condition" and near imminent collapse. The entire perimeter of the structure is overgrown by vegetation and layers of past seasonal detritus. The entire building is threatened by potential falling limbs from a nearby tree of considerable size. Access is adversely affected by an adjacent road with considerable fast moving traffic. There appears to be no contemporary foundation. Due to dense vegetation, much of the structure is inaccessible. The walls and roof undulate (indicating possible structural inadequacy or failure) and there appears to be considerable roof leakage (warped, severely deteriorated and warped corrugated panels). There are little to no visible maintenance efforts.

Site 2, Blacksmith Shop; Site 3 The Mill, Site 4, Chicken Coop; Site 5, The Granary Emergency Stabilization and Mothballing is highly recommended:

- 1. Removal or trimming of all threatening vegetation for at least six to eight feet from the base of all exterior walls.
- 2. Remove vegetative detritus from the base of the walls and insure the site drains away from the building.

- 5. Structurally assess (structural engineer) and stabilize (with temporary supports) the building making sure it's safe to work on and that no historic details will get lost during further stabilization efforts.

- 6. Mothball the structure ASAP by creating a dry and ventilated interior.
 - a. Create a ventilated weather-tight envelope by repairing roofs and walls (replacement in kind for roof and walls and install weatherproof window vents).

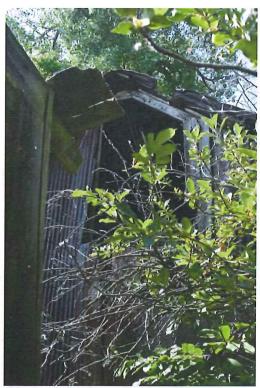
Site 3: Mill: Wall Detail

Similar to the Blacksmith Shop, the Mill appears to be in "Poor Condition" but at a higher degree of degradation as portions have already collapsed. The entire perimeter of the structure is also overgrown by vegetation and layers of past seasonal detritus. Due to dense vegetation, most of the structure is inaccessible and vegetation is visible growing inside the building. Since complete portions of the Mill have already collapsed, the exposure to weather is further compromising structural elements and accelerating deterioration and collapse. Most of the interior (historic mill features/artifacts exposed) is open to the weather. Access is adversely affected by an adjacent road with considerable fast moving traffic. There are little to no visible maintenance efforts.

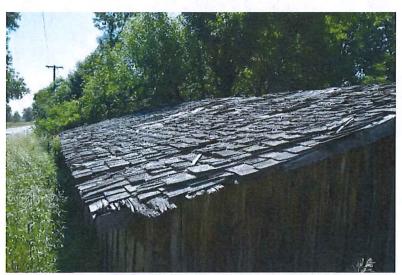
Site 4: Chicken Coop: Looking East

The Chicken Coop is in similar condition to the Granary. Overall it appears to be between "Fair and Poor Condition." Large portions of the corrugated metal roof are missing, warped, bent, deteriorated and there is likely abundant roof leakage, but again, the walls and roof remain relatively plumb (as previously stated: a testament to first-growth lumber that weathers exceptionally well). Similar to others, the entire perimeter of the structure has limited access due to overgrown scrub vegetation, trees, and layers of past seasonal detritus. Walls of this structure appear to have been treated with linseed oil that can blacken the wood and accelerate the growth

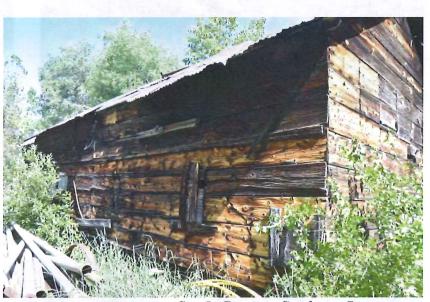
Site 5: Granary: Southeast Corner

The Granary is a very weathered board and batten wood shed that appears to still retain its original wood shingle roof (though some portions of the roof are missing). Overall the structure appears to be between "Fair and Poor Condition." There are likely extensive roof leaks, but the walls and roof remain relatively plumb (a testament to first-growth lumber that weathers exceptionally well). Similar to others, the entire perimeter of the structure has limited access and is overgrown by scrub vegetation, trees, and layers of past seasonal detritus. Walls of this structure appear to have been treated with linseed oil that can blacken the wood and accelerate the growth of mildew. Access is adversely affected by an adjacent road with considerable fast moving traffic. There are little to no visible recent maintenance efforts.
