### **Brief Narrative**

### **Detailed Scope**

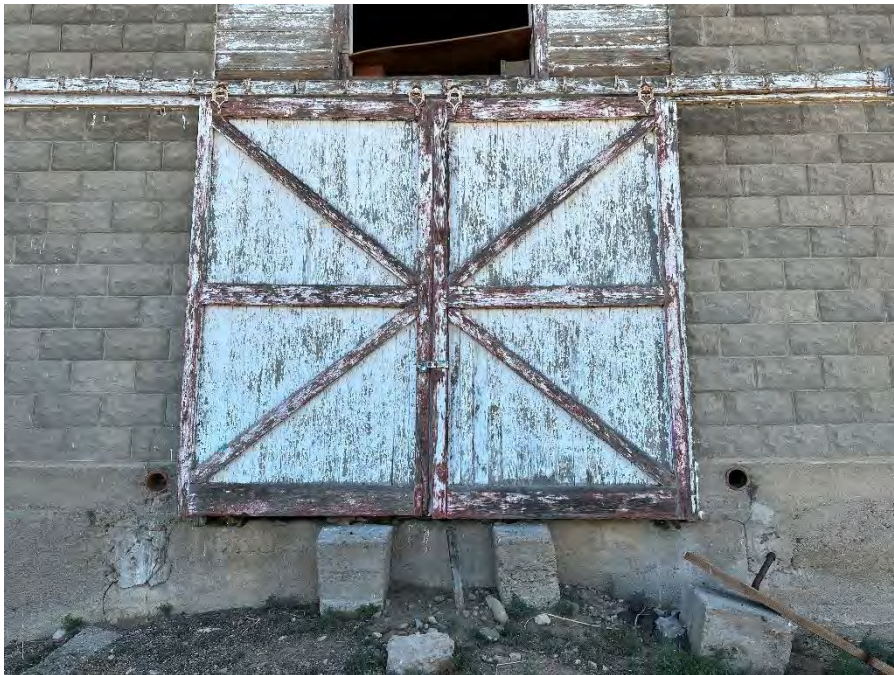
*Figure 4: Detail view of exterior condition of west elevation sliding doors.*

The original exterior windows and doors remain in place but are in poor condition. Deterioration includes paint failure, wood rot, broken glazing, deteriorated glazing putty, and missing or damaged components. To preserve the barn's exterior character, 24 existing windows will be carefully restored. Four existing exterior swinging doors and two sets of large sliding barn doors will also be rehabilitated. Restoration work will include replacing missing or deteriorated wood, epoxy repair of minor wood damage, glazing replacement, hardware repair or replacement, and priming and painting of wood surfaces. New entry systems will be installed just inside the sliding doors on the east and west first-floor elevations to allow modern, functional entrances while retaining the barn's historic appearance. These improvements will ensure ADA-compliant access while maintaining the barn's original openings.

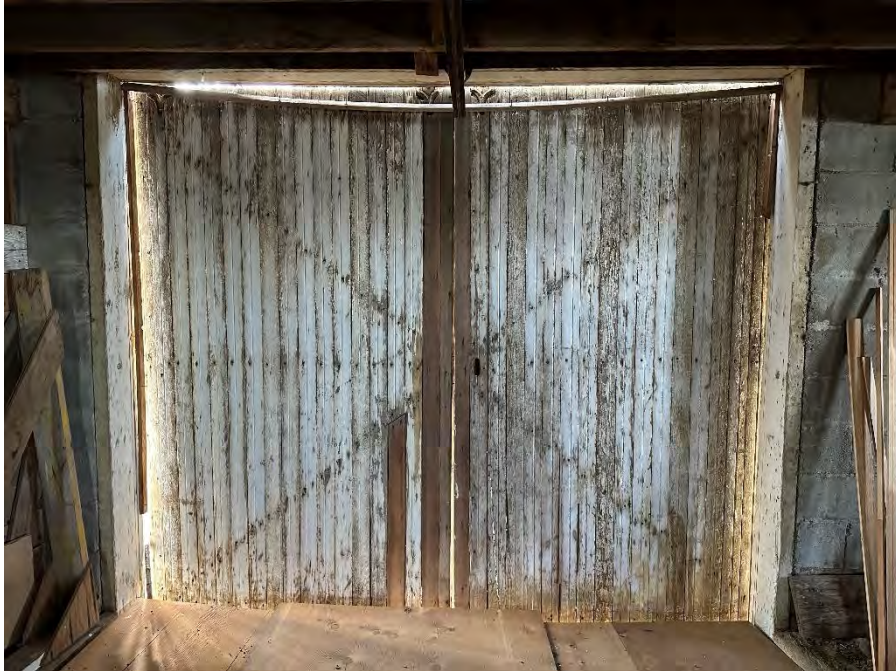
*Figure 5: Interior conditions typical at east and west sliding doors (shown from the interior).*

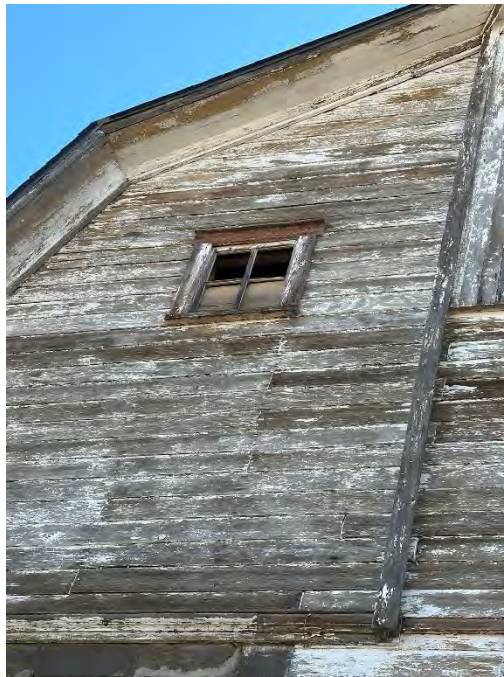
*Figure 6: Siding, trim, and window conditions at the west gable end.*

The north and south gables will be rehabilitated to improve energy efficiency while preserving their historic appearance. Existing horizontal siding will remain in place, and new Zip panels will be added to provide insulation and structural stability. Zip panels are a high-performance sheathing product that integrates insulation, moisture protection, and air sealing. Historic-looking siding will be installed over the panels to reflect the original design. Where feasible, original exterior woodwork in the center of each gable will be preserved and rehabilitated. For the east and west gable ends, bypassing doors are proposed for the enlarged openings. The upper panel could be the historic hayloft door, with a lower panel that slides vertically beneath it. The added trim needed to accommodate insulation and siding will allow space to create a dual-track system for the bypass doors. These changes will preserve original materials while adding natural light to the second-floor event space, enhancing the barn's functionality for events.

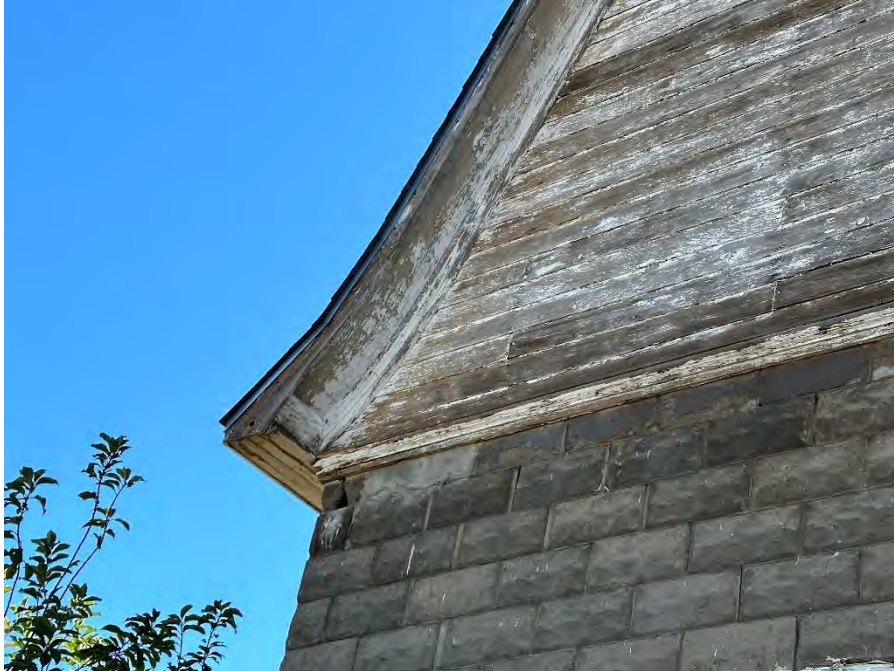
*Figure 7: Masonry, trim, and eave conditions at the west gable end.*

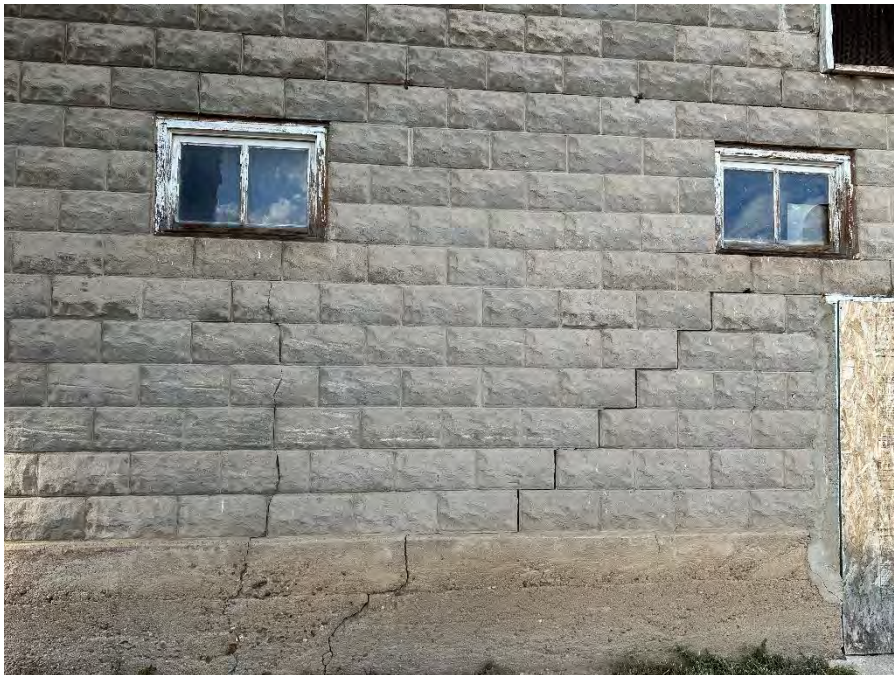
*Figure 8: Detail view of exterior window and masonry conditions. Note deterioration of original wood windows and cracks visible in the concrete block masonry.*

The original concrete block walls and poured concrete foundation walls are intact but require rehabilitation. To preserve the barn's structural integrity, cracks in the poured concrete foundation will be sealed using epoxy. Damaged masonry blocks will be repaired or replaced to match the original materials. Where needed, patches will be installed to blend seamlessly with the historic fabric. Where diagonal cracks are present in the masonry walls, they will be stitched using Heli-ties or a similar system to ensure long-term stability. The walls will be cleaned with an approved restoration cleaner using the gentlest means possible, and approximately 25% of the block will be repointed using mortar matching the original. Rehabilitation of the exterior concrete and block will prioritize maintaining the historic appearance.

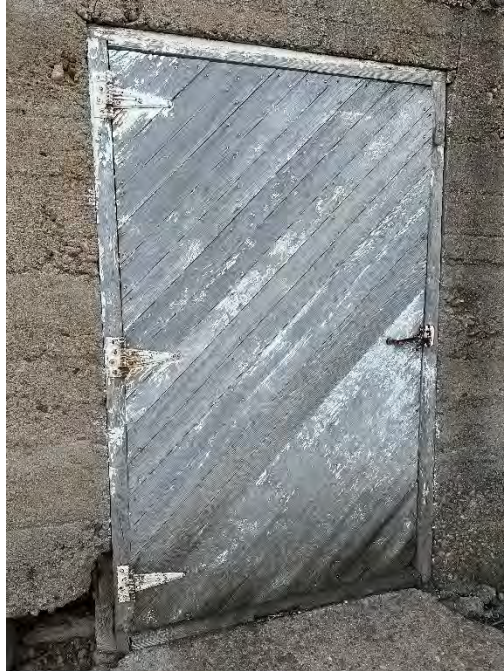
*Figure 9: Detail view of exterior conditions at north-facing basement level door.*

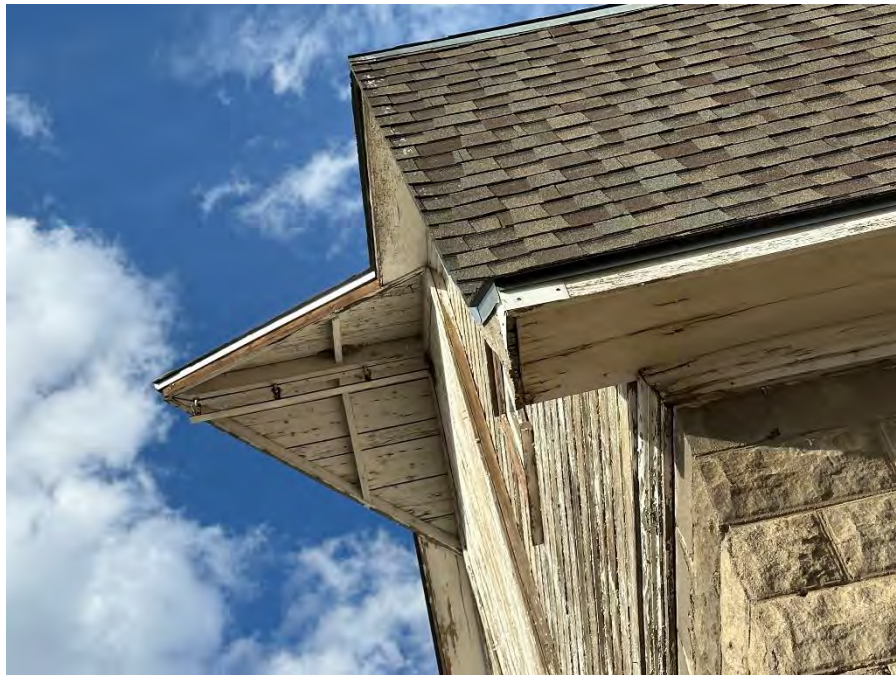
*Figure 10: Detail view of roof and eave conditions.*

A new cedar shingle roof will be installed, including necessary underlayments, flashings, cedar breather, and ridge vent, enhancing the barn's durability while maintaining its historic look. Insulation will be added within the new exterior roofing assembly to preserve the interior character of the barn. The cupola will be reconstructed to match its original design based on historic photographs. The fascia will be rehabilitated to accommodate the insulation, and the soffit and fascia will be restored to their original profiles. Roof insulation will taper to minimize visual changes to the roof eaves and trim. Sheet metal gutters and downspouts will be installed to prevent moisture damage.

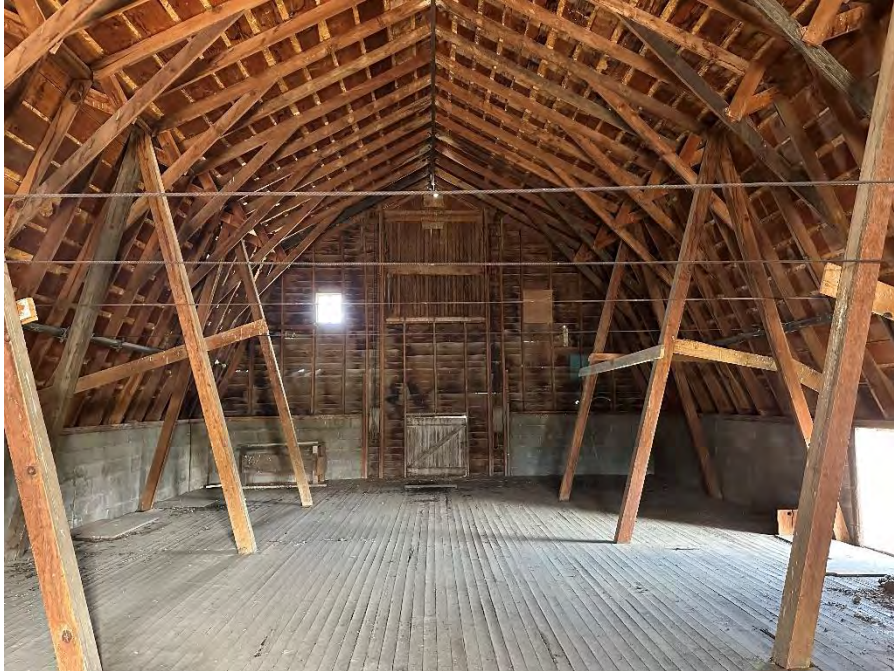
*Figure 11: Overall view of second floor hayloft space. Note that exterior insulation is proposed at the roof and gable ends to maintain the historic character and appearance of this unique space (interior work not in scope).*

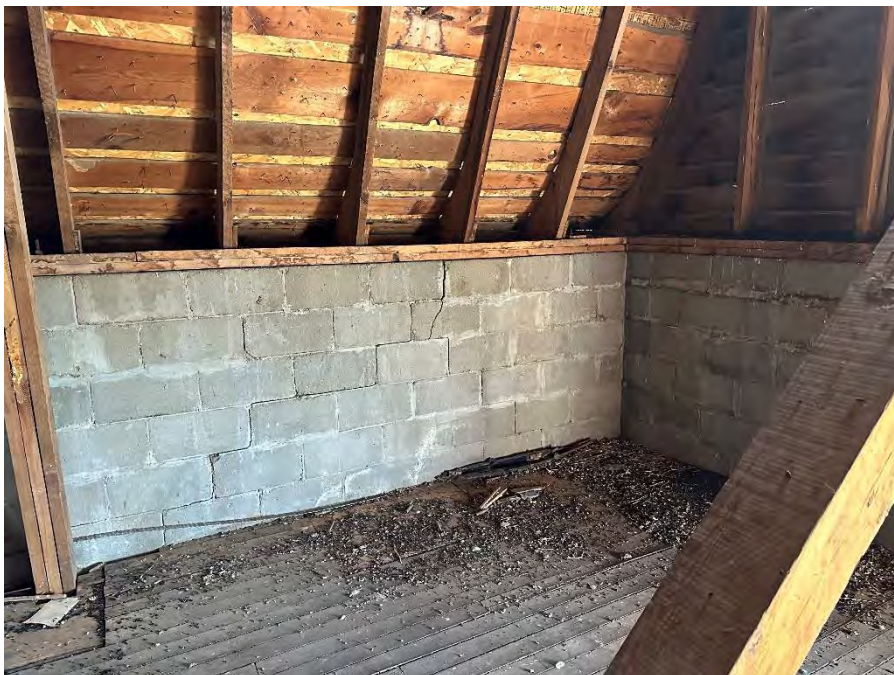
*Figure 12: Cracks visible at concrete block on the second floor of the building. Note that some of the cracks visible on the exterior telegraph through to the interior (interior not in scope).*

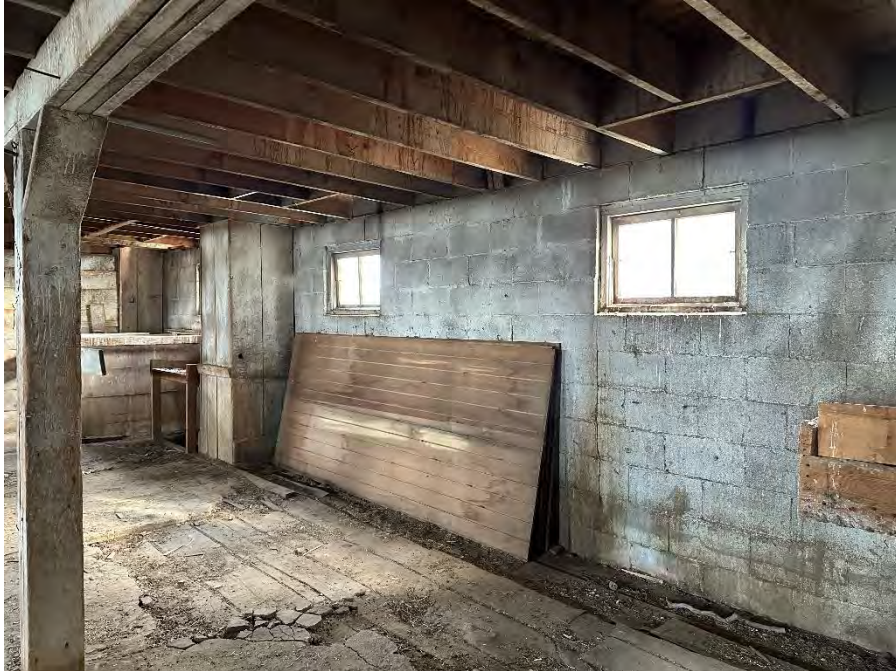
*Figure 13: Typical conditions at the first floor level interior of the barn (not in scope).*

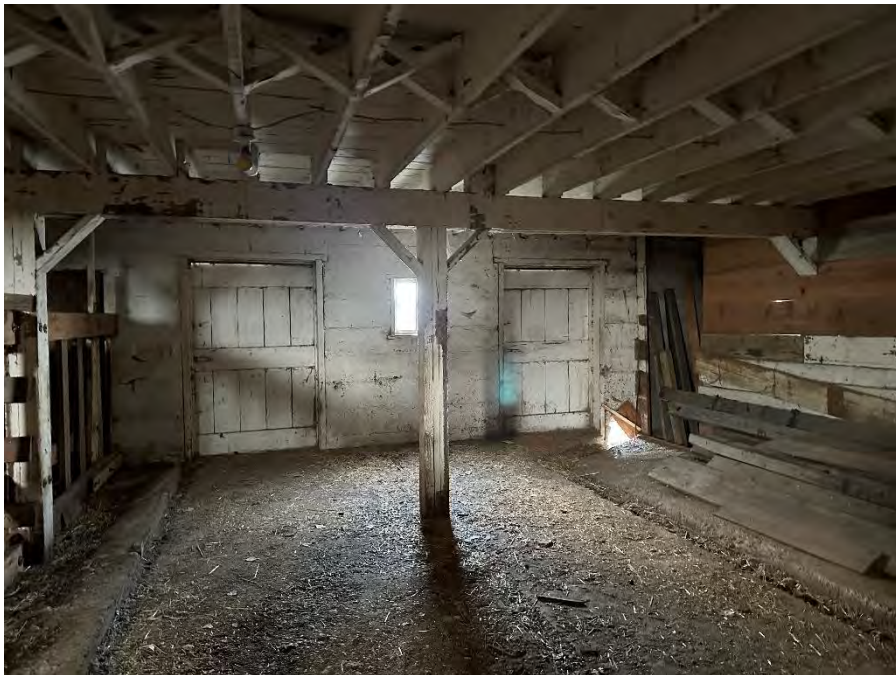
*Figure 14: Typical conditions at the basement level of the barn (not in scope).*
