# **REDTAIL RANCH**

## **WATER & WASTEWATER UTILITY REPORT**

### **(PRELIMINARY PLAT)**

**March 9, 2023**

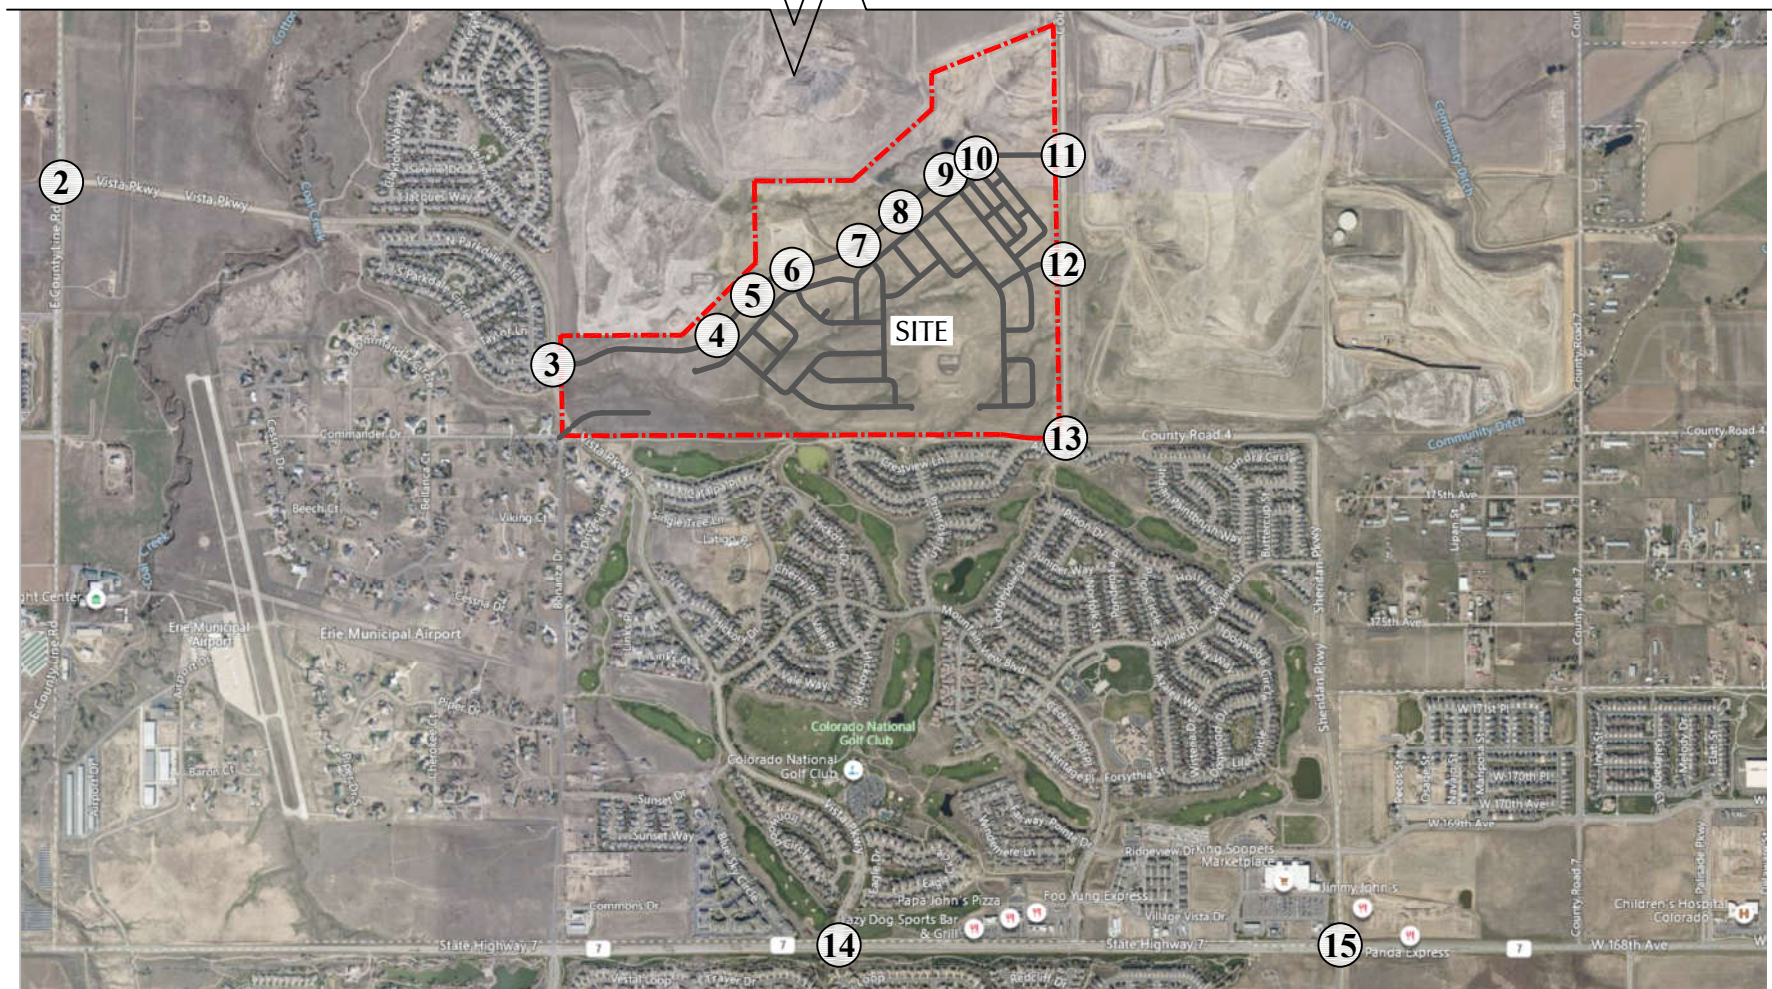
Figure 4b

**Year 2027 Background Lane Geometry and Traffic Control**  
Redtail Ranch Update (LSC #211310)
