Technical Memorandum

File and Literature Review

I-25 Erie Gateway South PD District

Weld County, Colorado

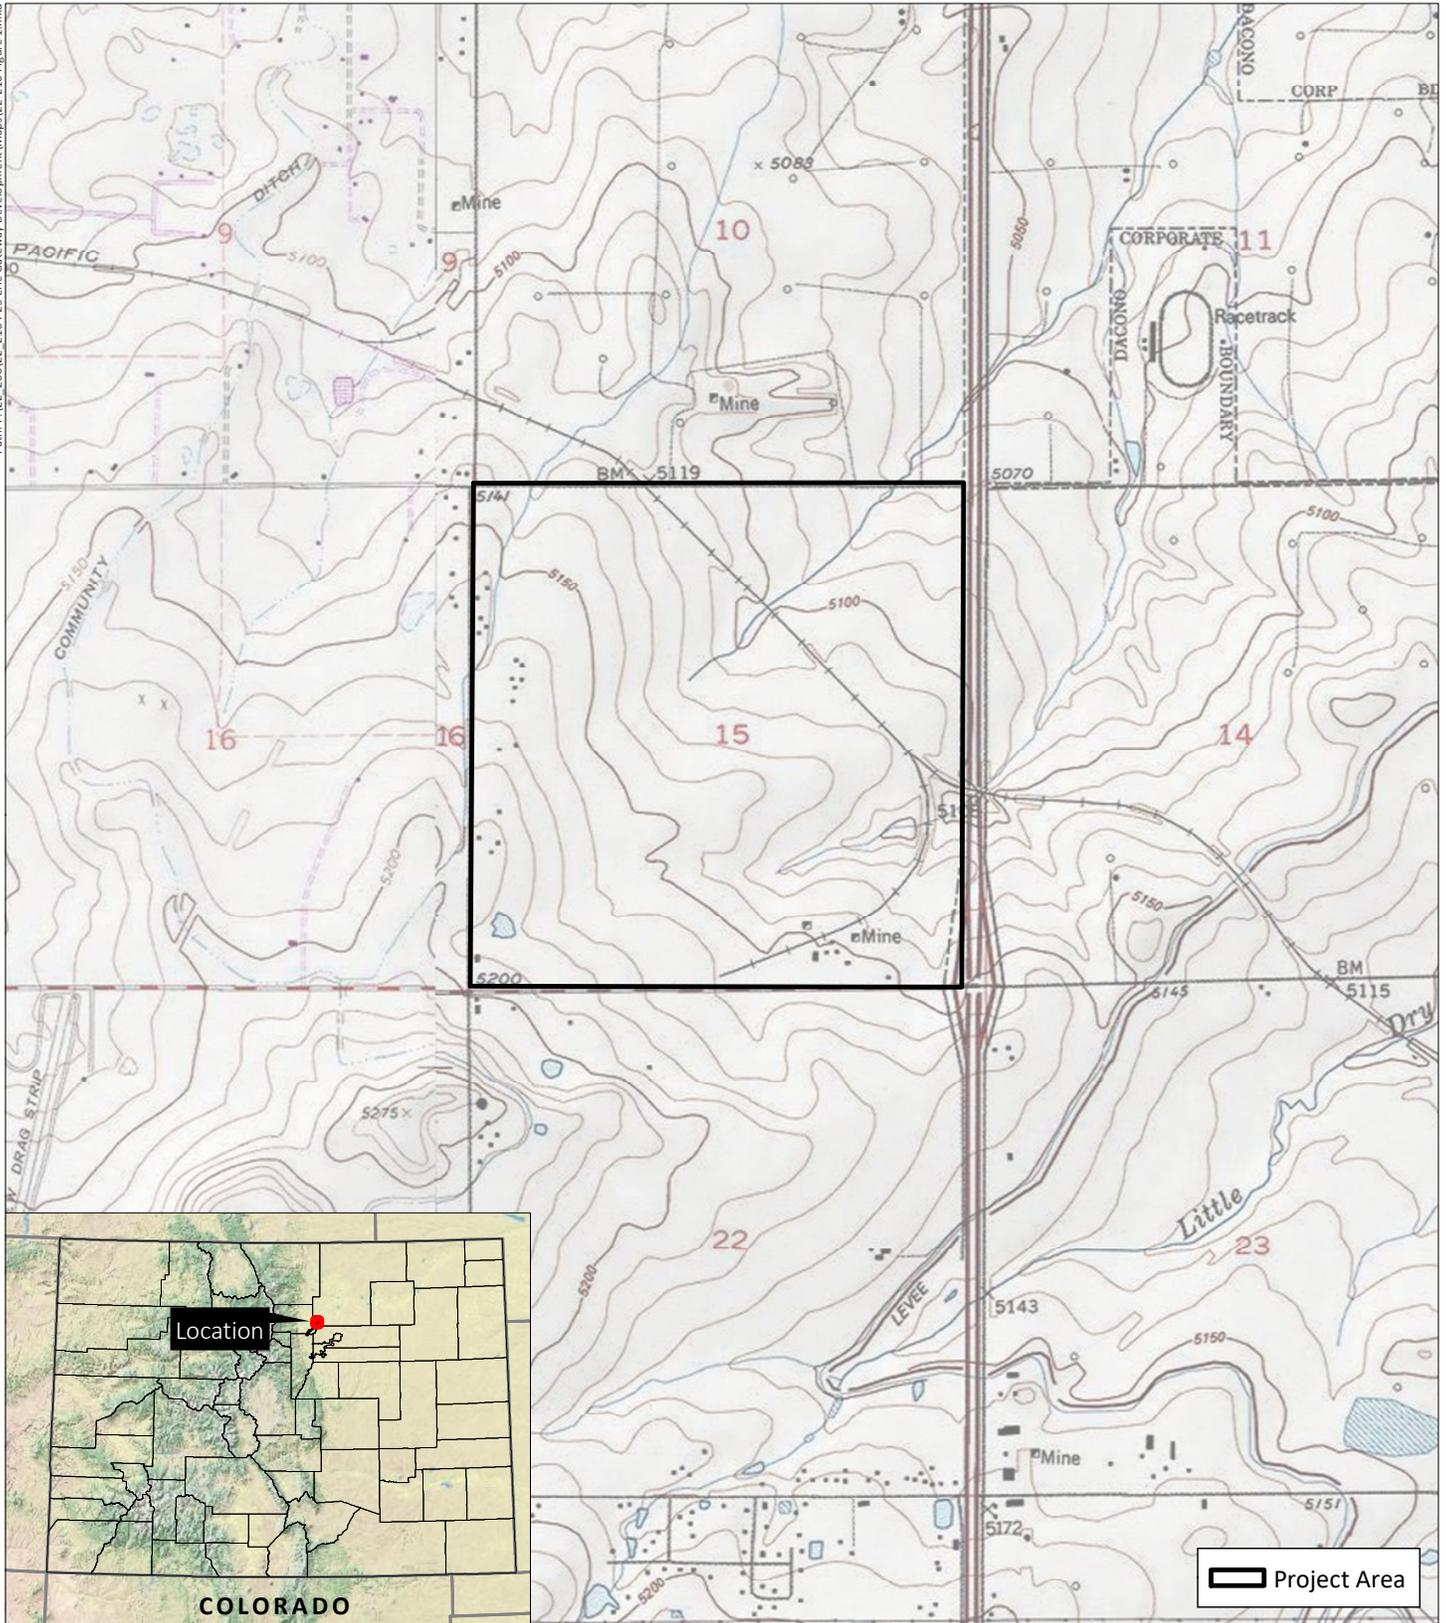
Figure 1
 Project Location

Parkway, east of CR 7, and south of CR 10. Agricultural land surrounds most of the project area, with modern residential developments located to the west. The project area is in Section 15, Township 1 North, Range 68 West of the 6th Principal Meridian in Erie, Weld County, Colorado (Figure 1, attached).

Figure 1. Project location (USGS 1:24,000 topographic quadrangle)

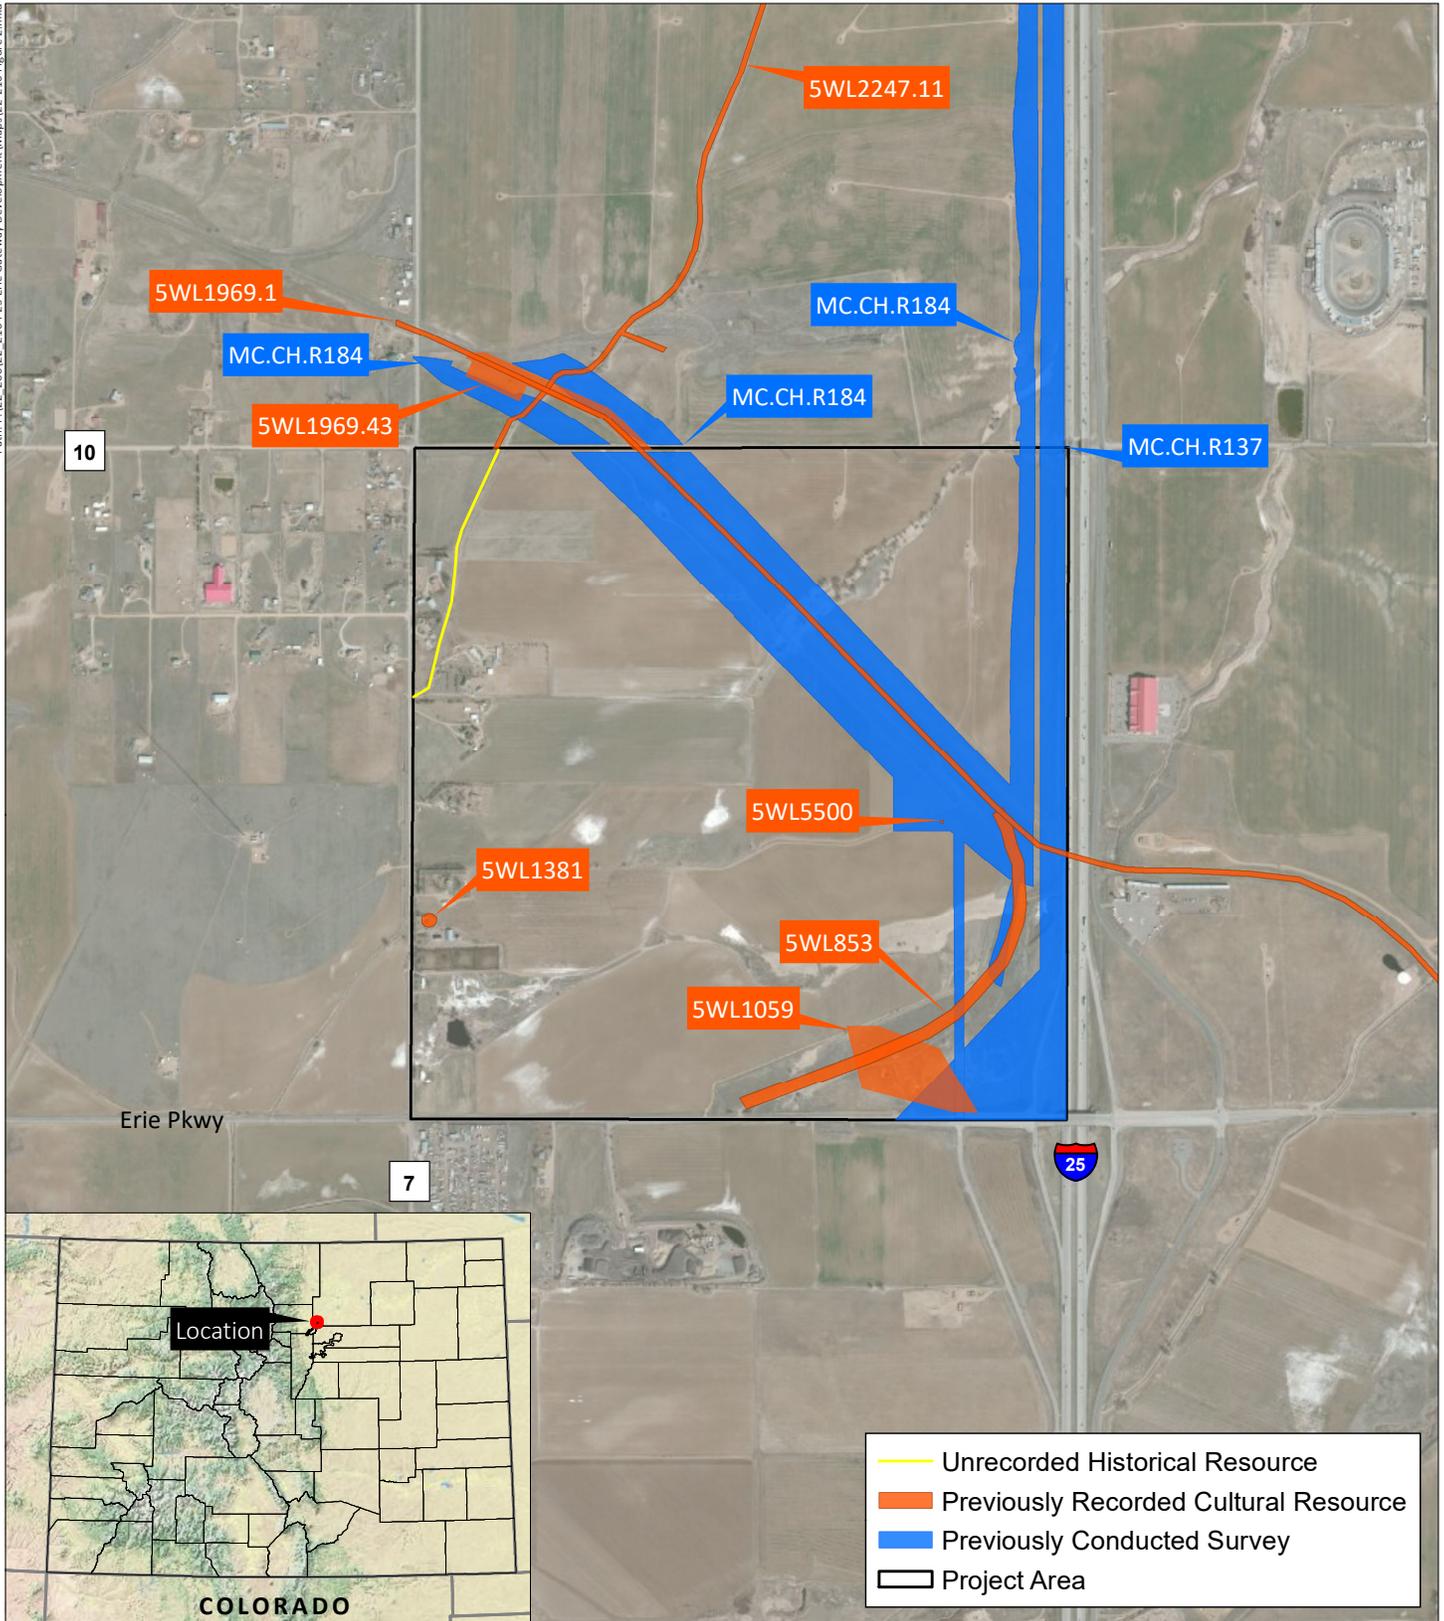
Figure 2
 Previously Conducted
 Cultural Resource Surveys and
 Recorded Cultural Resources

The file search identified two previous cultural resource surveys that intersect the project area (Figure 2, attached; Table 1). Previous surveys cover about 20 percent of the project area. The surveys consist of linear and block surveys that abut the project area that were completed by the Colorado Department of Transportation (CDOT). The surveys are related to the development and maintenance of I-25. All surveys were completed in 1993 and 2007.

The OAHP records indicate six previously documented cultural resources are in the project area (Figure 2; Table 2). The resources consist of three linear resources, two historical resources, and one historic isolated find (IF). The linear resources include two segments of the Union Pacific Railroad – Boulder

The project area intersects six previously documented cultural resources and one undocumented segment of the Community Ditch (Figure 2; Table 2). The resources consist of three linear resources, two historical resources, and one historic IF. Both the Union Pacific Railroad – Boulder Branch (5WL1969.1) and the Eagle Coal Mine Spur (5WL853) were determined not eligible. One segment of the Union Pacific Railroad (5WL1969.43) was recommended eligible. Eagle Mine (5WL1059) has not been assessed and Towndraw Place (5WL1381) was recommended not eligible for listing in the NRHP. The potential for undocumented Native American sites is unknown but possible. Existing eligibility recommendations may change following formal reevaluation.

Figure 2. Previously conducted cultural resource surveys and recorded cultural resources (1:18,000 aerial imagery)

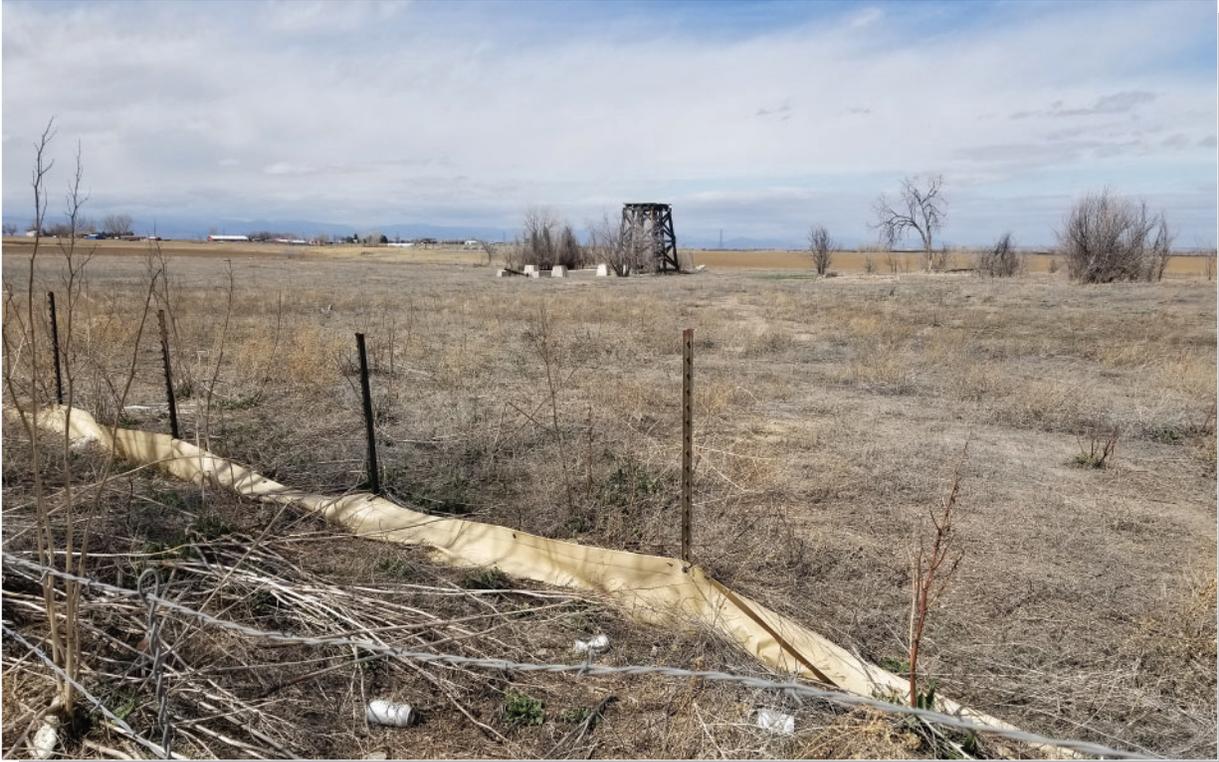
Photo 1 - Active prairie dog colony, disturbed uplands, and old mine structures in the southeastern portion of the project area. View is to the northwest.

Active and inactive black-tailed prairie dog (*Cynomys ludovicianus*) burrows occur in the southeastern (Photo 1) and northwestern portions of the project area (Figure 2). Five raptor nests and several dilapidated nests, including one active great horned owl nest and one possible red-tailed hawk nest (Photos 10 and 11, respectively), were observed in the project area vicinity during the 2023 site visits (Figure 2).

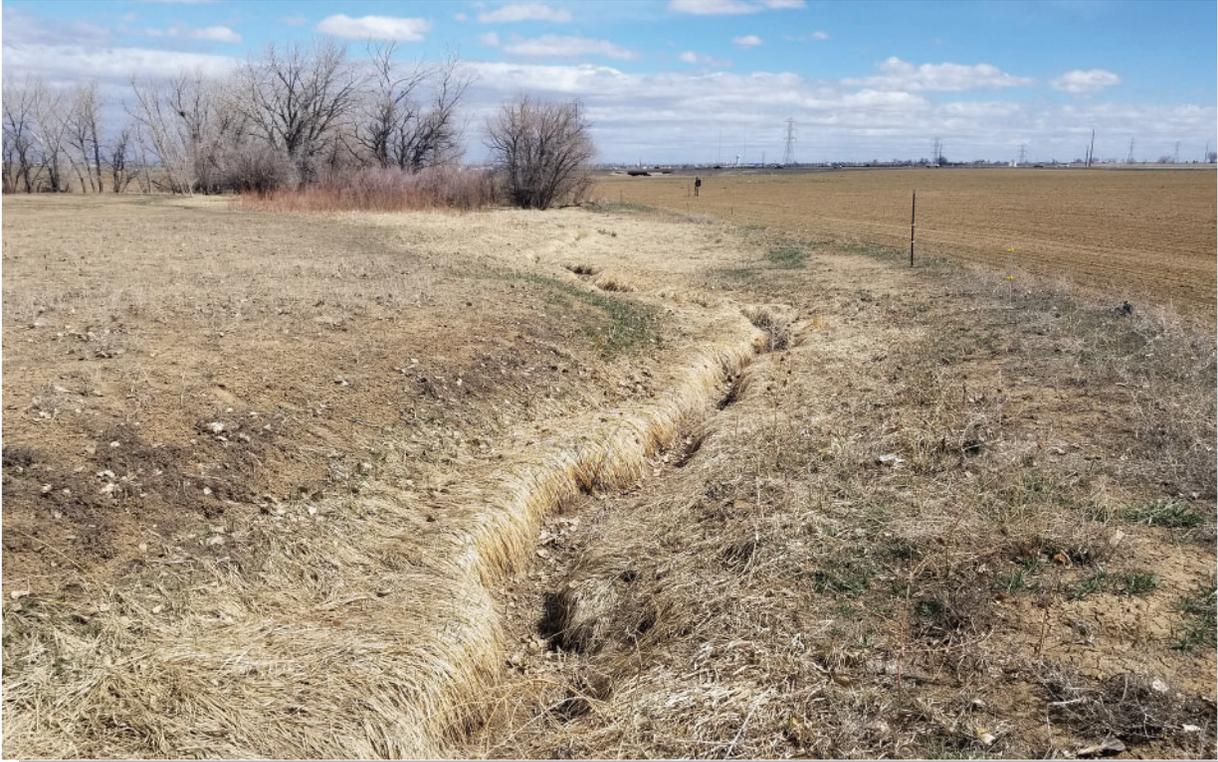
Photo 3 - OHHM 1 along Drainage 1 and fallow agricultural fields in the northeastern portion of the project area. View is to the northeast.

During the 2023 site visits, Drainage 1 consisted of a mesic riparian corridor with an intermittent ordinary high water mark (OHWM) (OHWM 1 through OHWM 5) (Figure 2; Photos 3 through 5). No open water or wetlands were observed in Drainage 1 during the 2023 site visits, as detailed below. Drainage 1 appears to receive water as overland flow runoff from the nearby agricultural fields to the west.

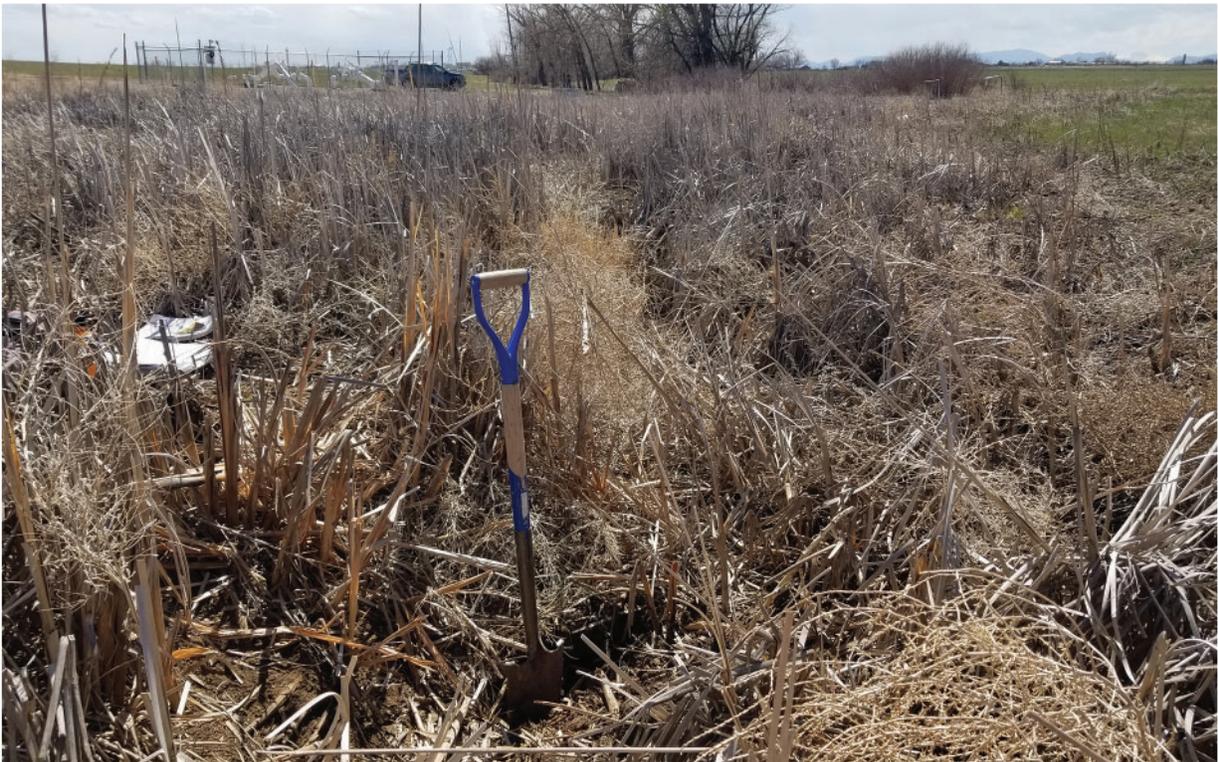
Photo 4 - DP7 along Drainage 1 in the northeastern portion of the project area. View is to the southwest.

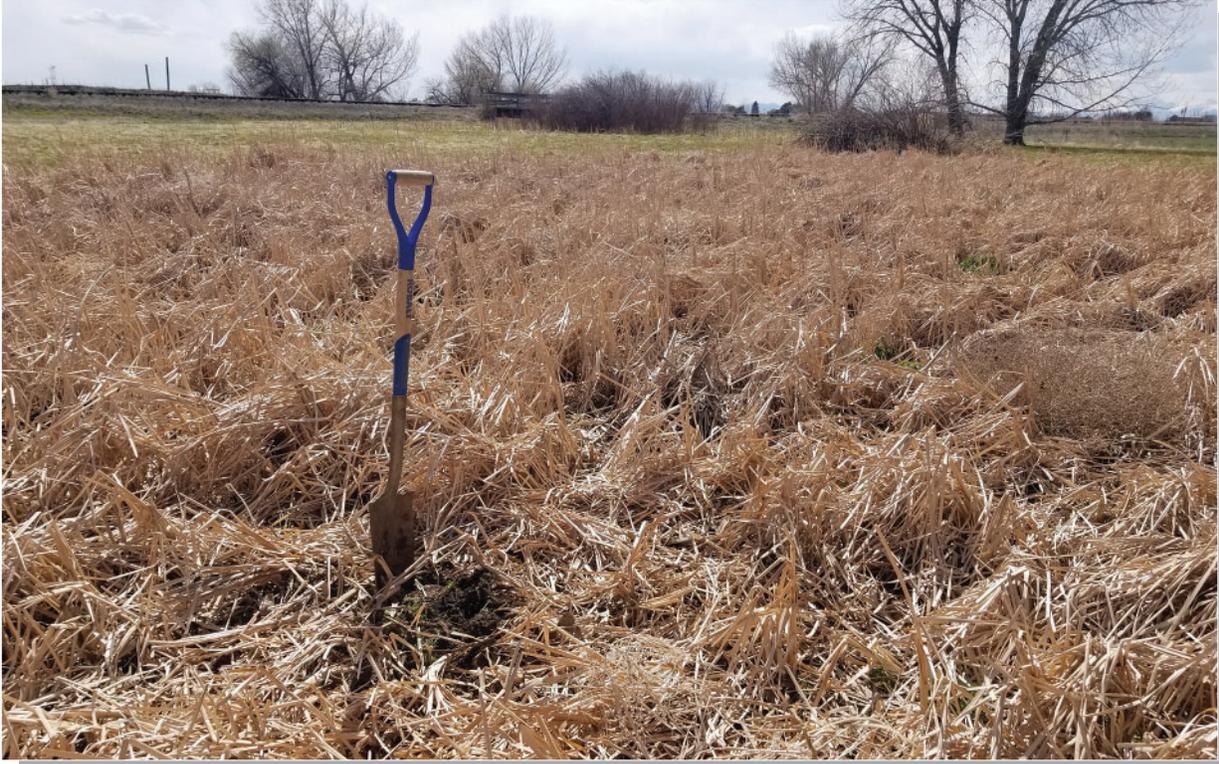
Photo 5 - DP8 along Drainage 1 in the northeastern portion of the project area. View is to the southwest.

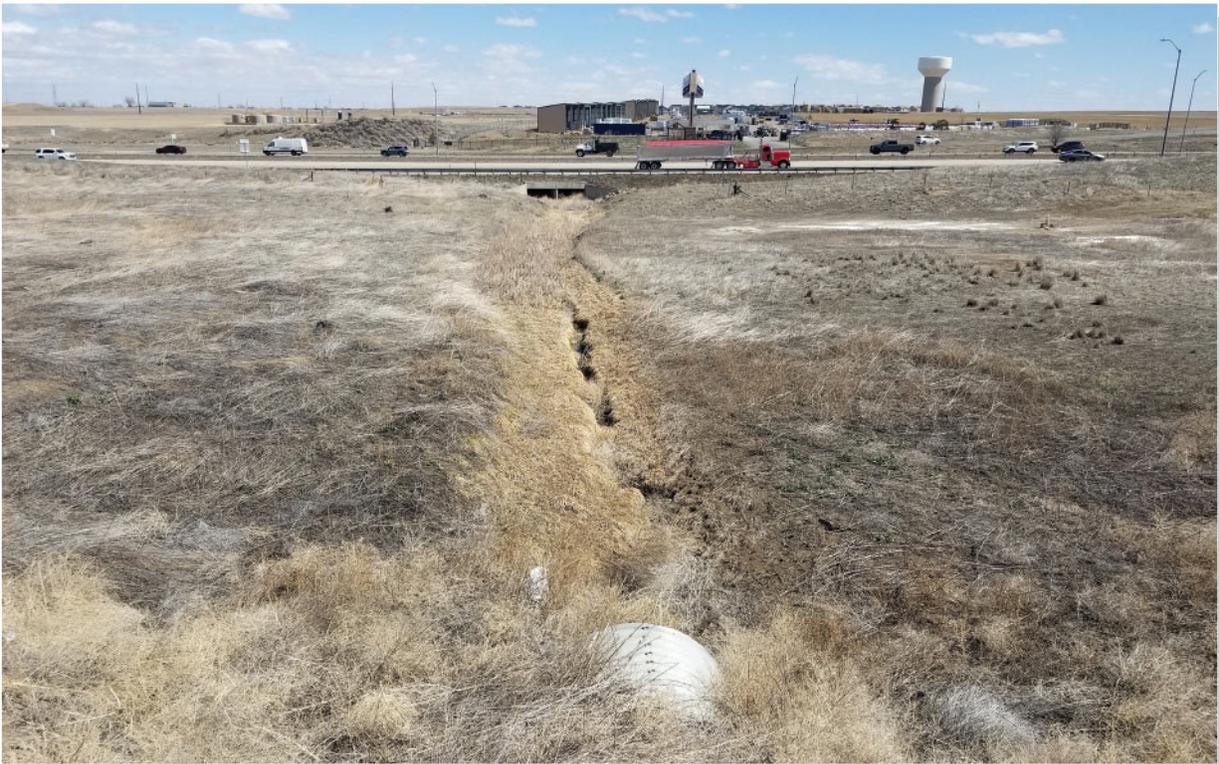
Photo 6 - Overview of Wetland 1 and OHWM 6 along Drainage 2 in the southeastern portion of the project area. View is to the northeast.

During the 2023 site visits, Drainage 2 consisted primarily of a disturbed upland swale with some areas of wetland (Wetland 1), open water (OHWM 6), and OHWM (OHWM 7) in the eastern portion along a

constructed drainageway, and an isolated OHWM (OHWM 8) in the western portion of the drainage swale (Figure 2; Photos 6 through 8). Drainage 2 appears to receive water as overland flow runoff from the nearby agricultural lands to the west.

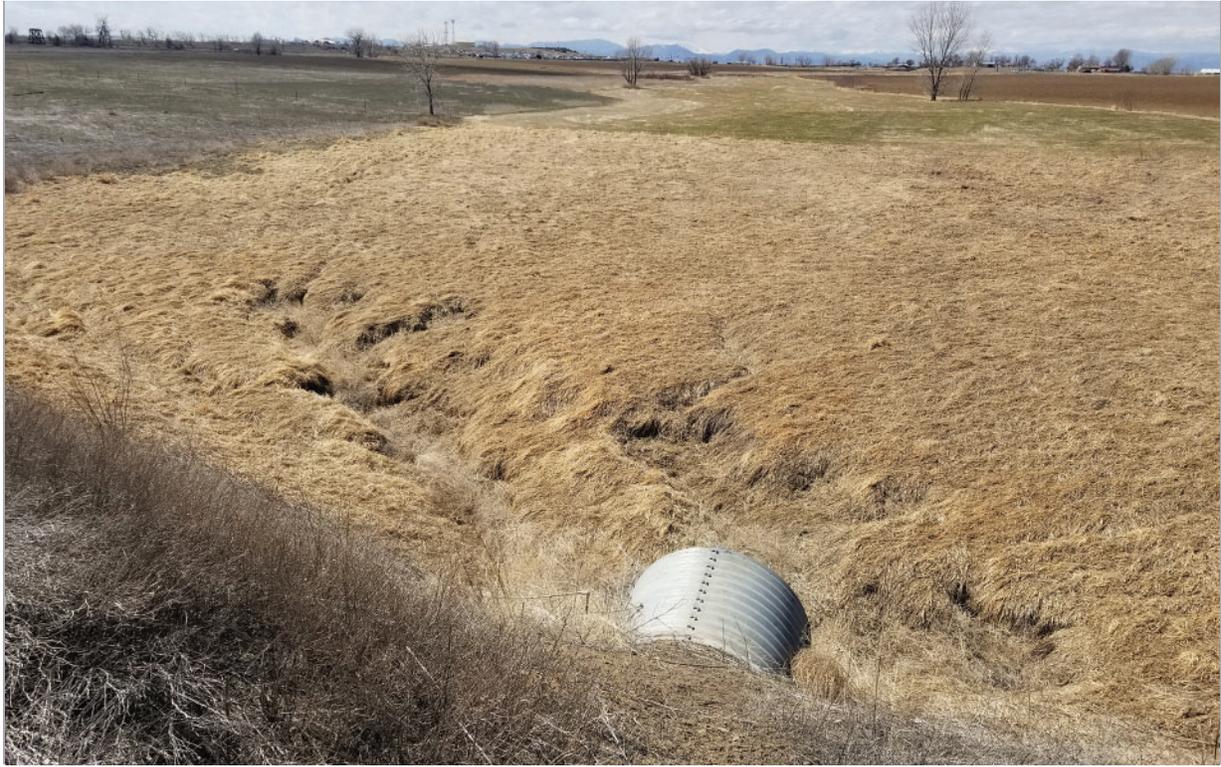
Photo 7 - Overview of DP3 and Drainage 2 upstream of culvert in the southeastern portion of the project area. View is to the southwest.

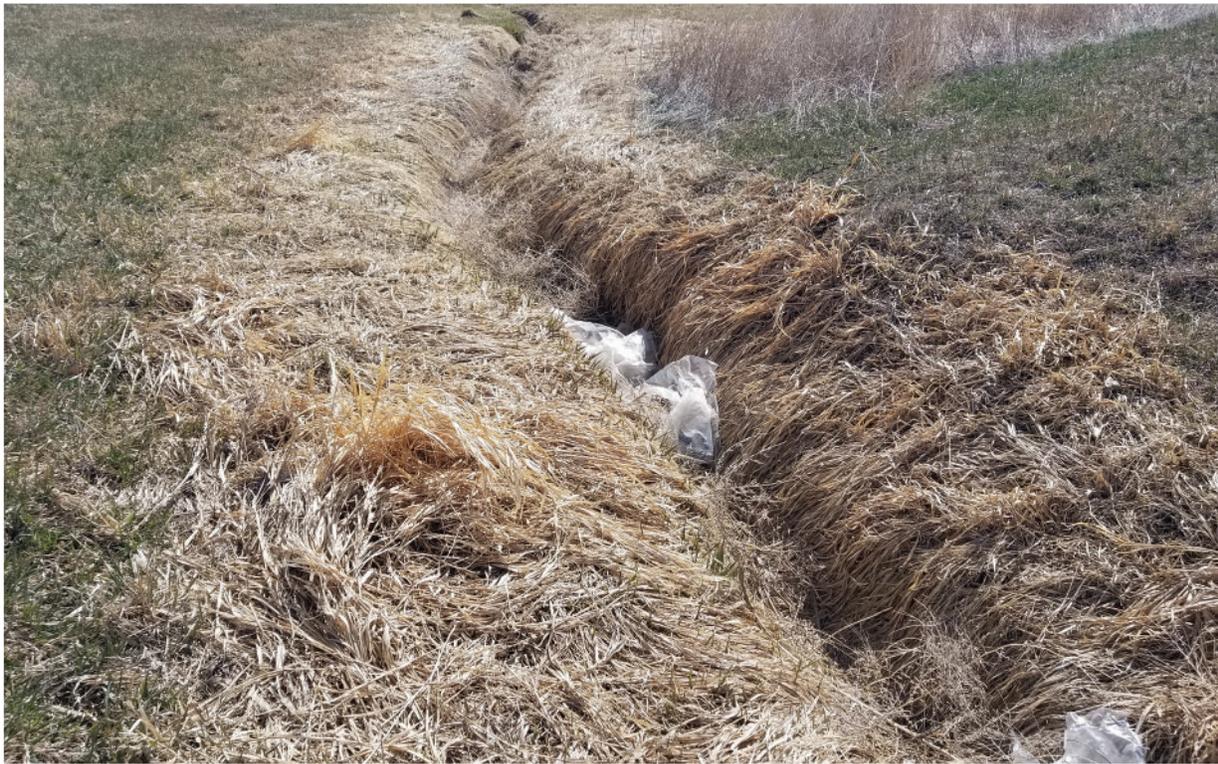
Photo 8 - OHWM 8 in the central portion of the project area. View is to the east.

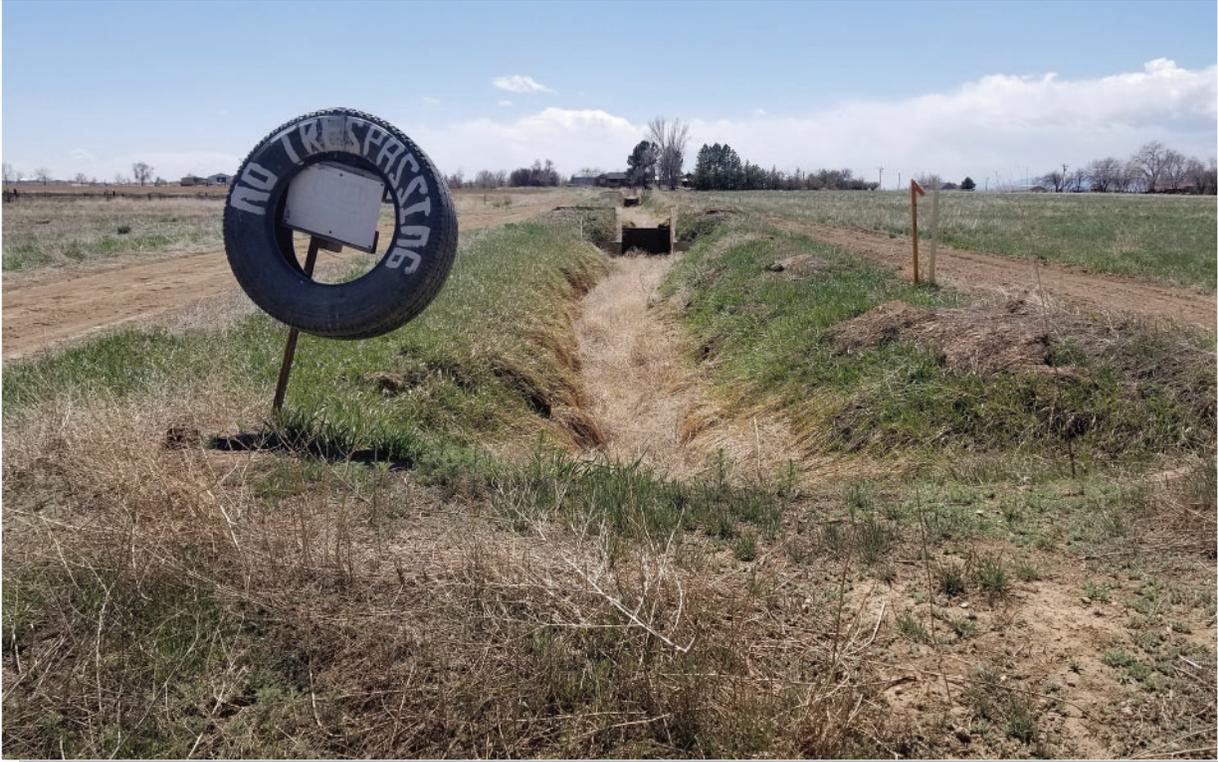
Photo 9 - Community Ditch in the northwestern portion of the project area. View is to the southwest.

Two unnamed drainages (Drainage 1 and Drainage 2), one named ditch (Community Ditch), and several lateral ditches occur in the project area (Figure 2). Drainage 1 consists of a mesic upland riparian corridor with no evidence of recent flows or wetlands (Photos 3 through 5). Drainage 2 consists predominantly of disturbed uplands and becomes a defined channel with wetlands near the eastern project area boundary (Photos 6 through 8; Figure 2). Both drainages lead to culverts that exit the project area to the north and east. Community Ditch occurs in the northwestern portion of the project area and consists of an approximately 2- to 3-foot-wide channel with wetland vegetation along the banks (Photo 9; Figure 2).

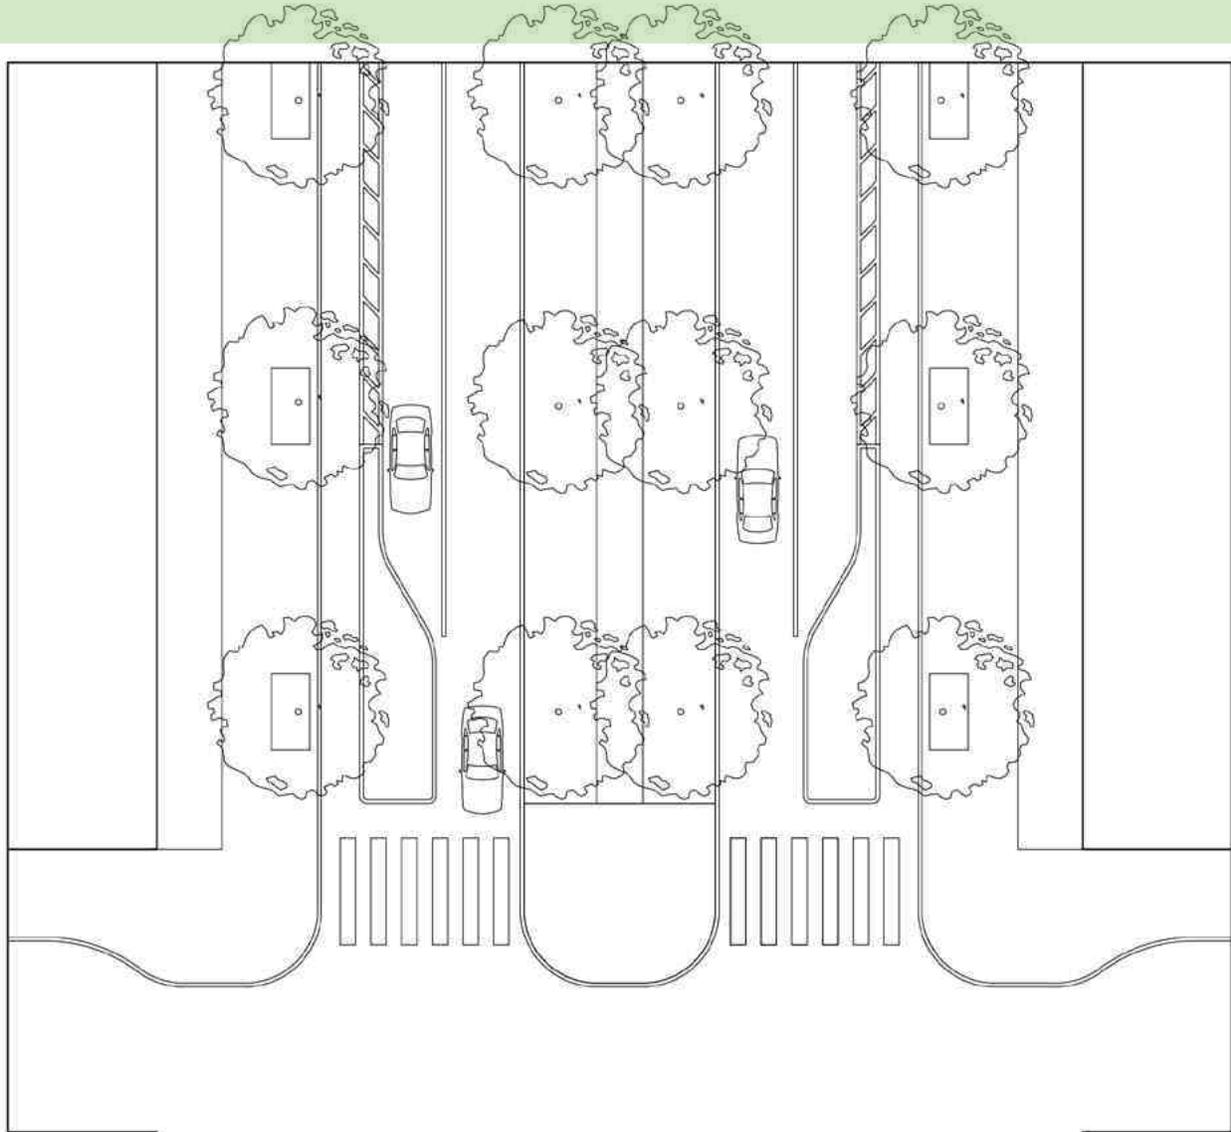
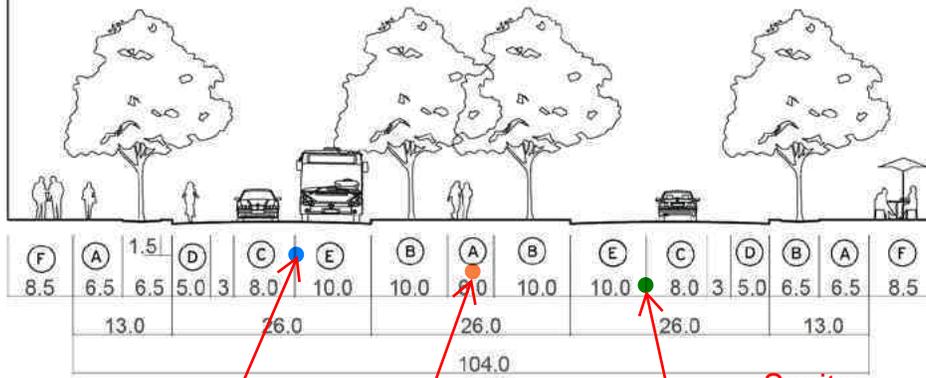
Figure 6-2 Greenway Boulevard Plan and Section

Water ———

Storm ———

Sanitary ———

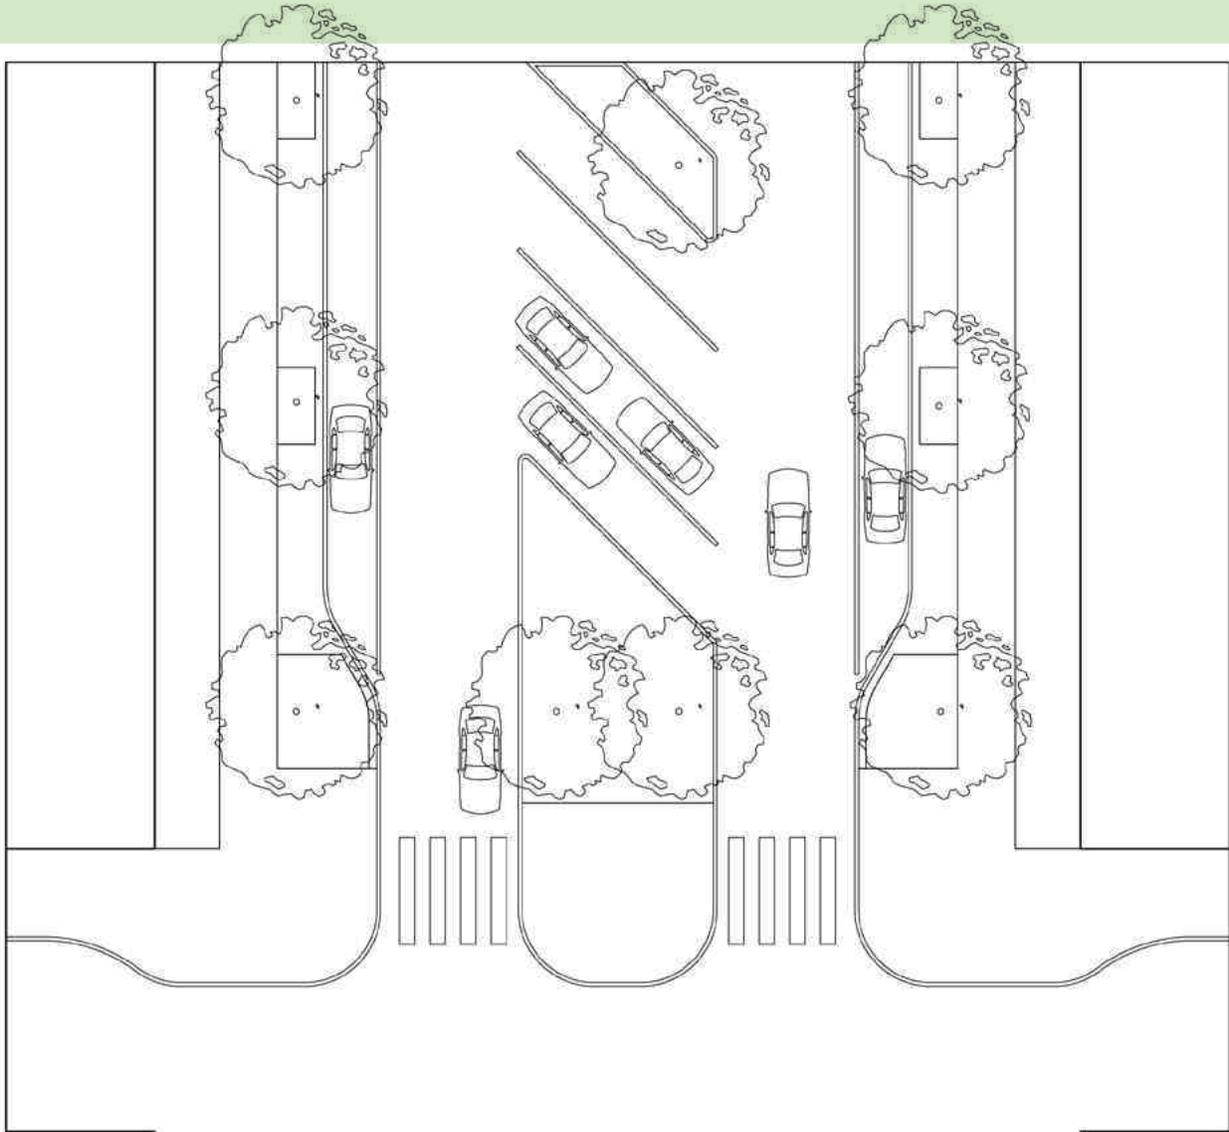
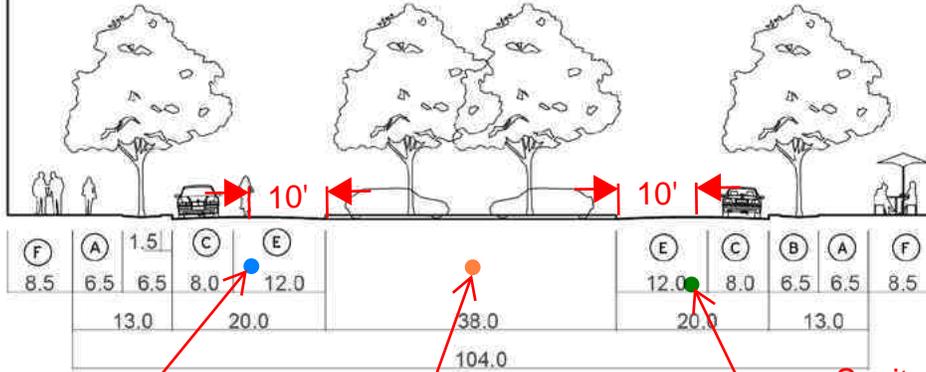
Figure 6-3 Main Street Plan and Section

Water ———

Storm ———

Sanitary ———

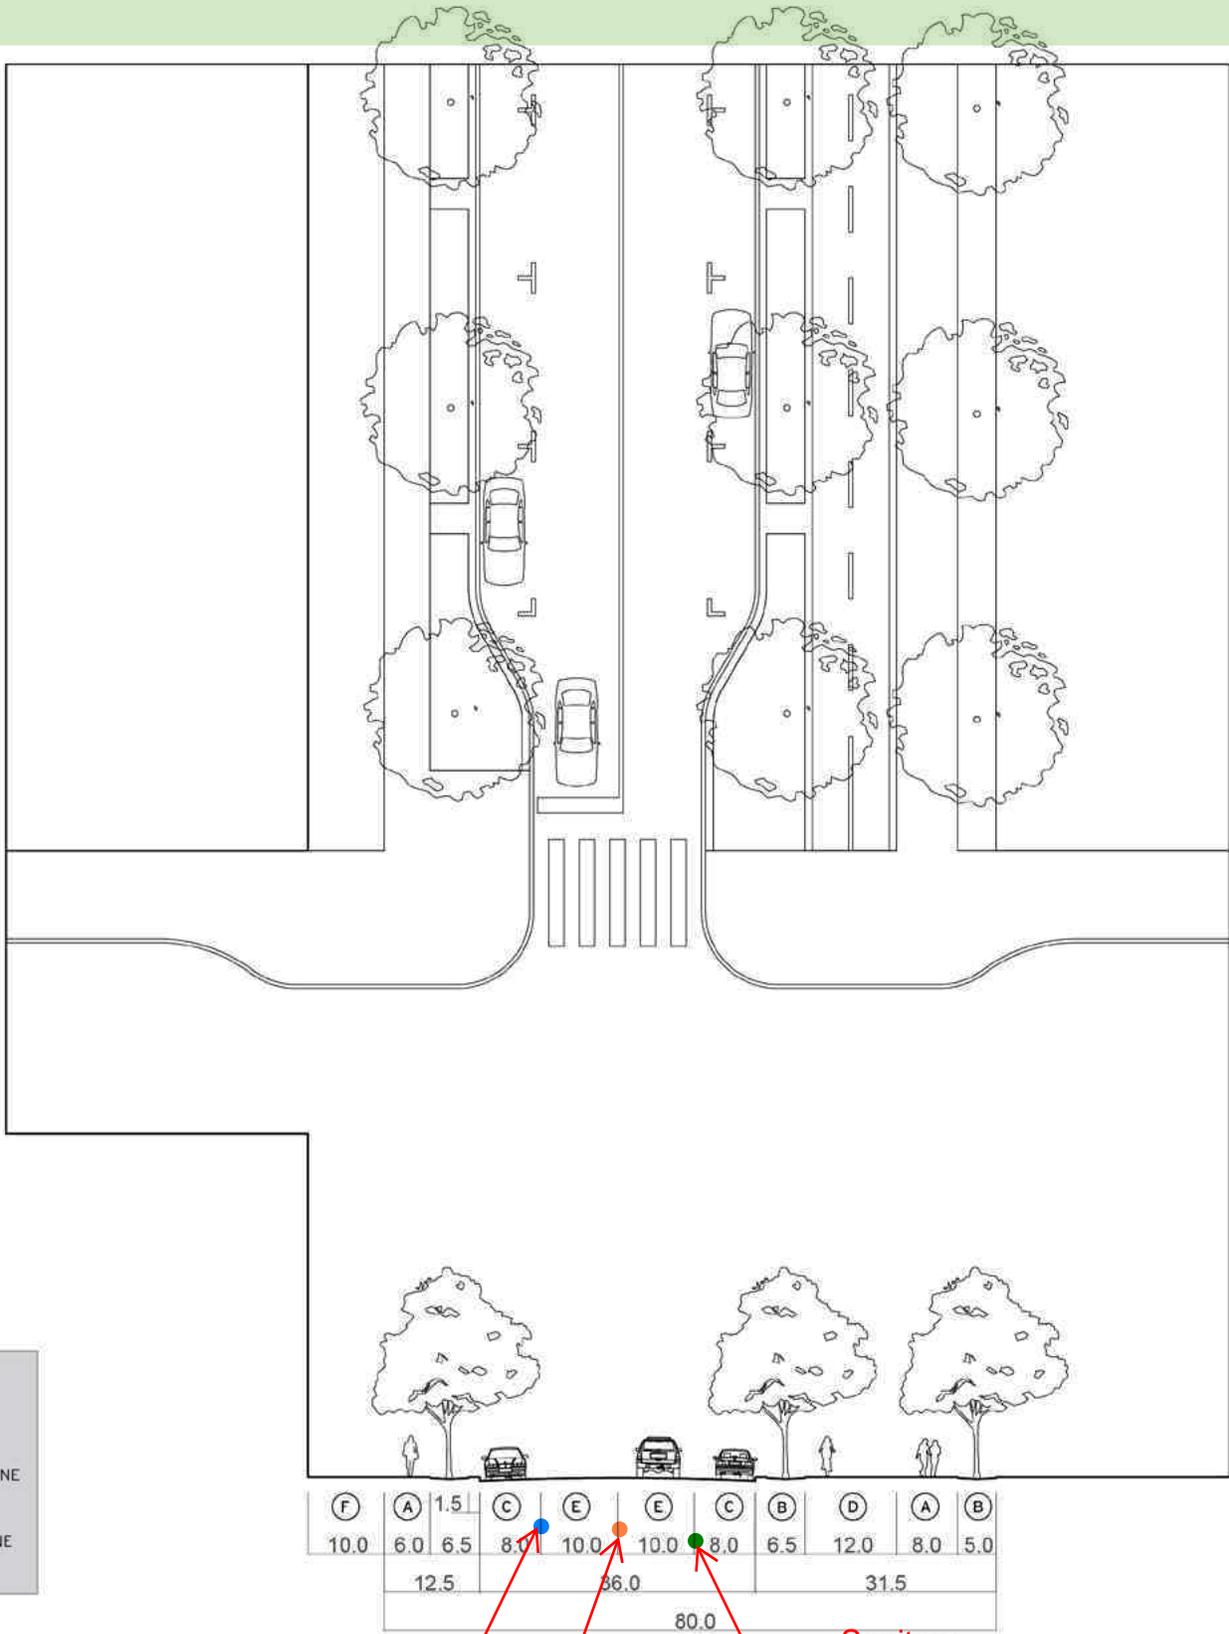
Figure 6-4 Parkside Street Plan and Section

Water

Storm

Sanitary

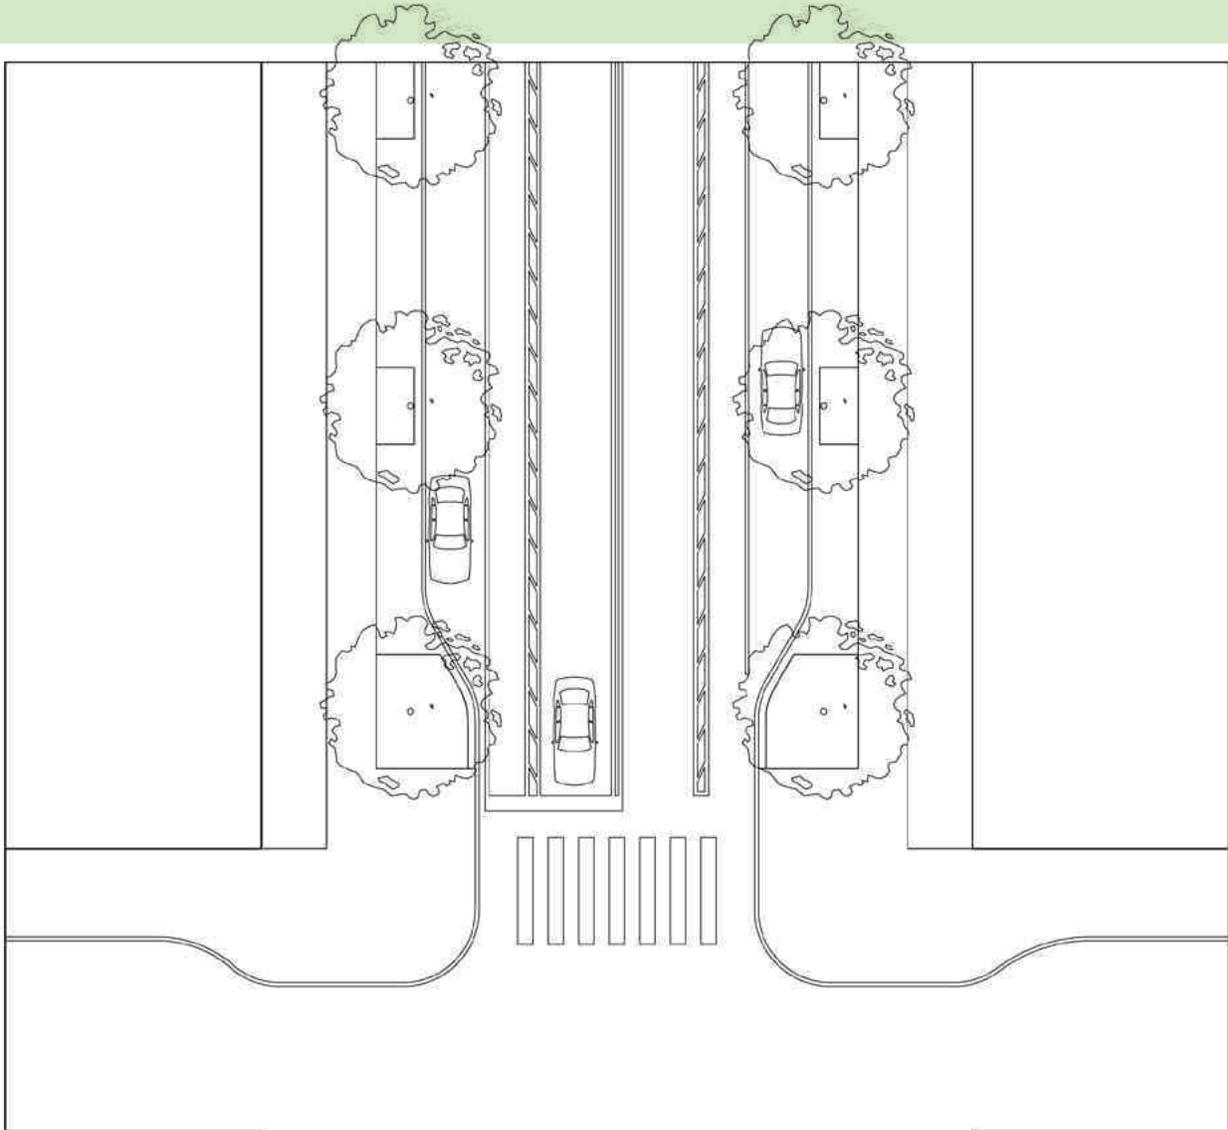
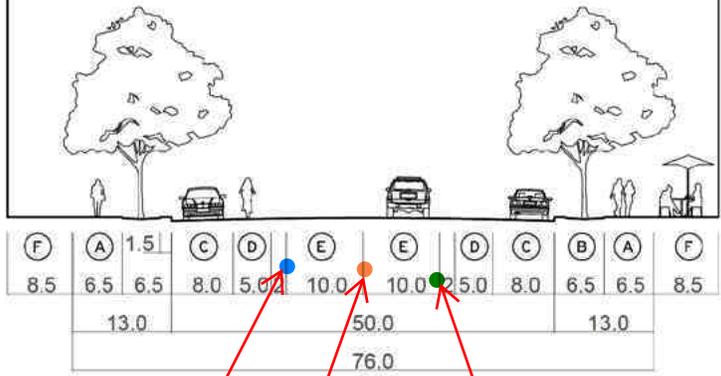
Figure 6-5 Primary Street Plan and Section

Water ———

Storm ———

Sanitary ———

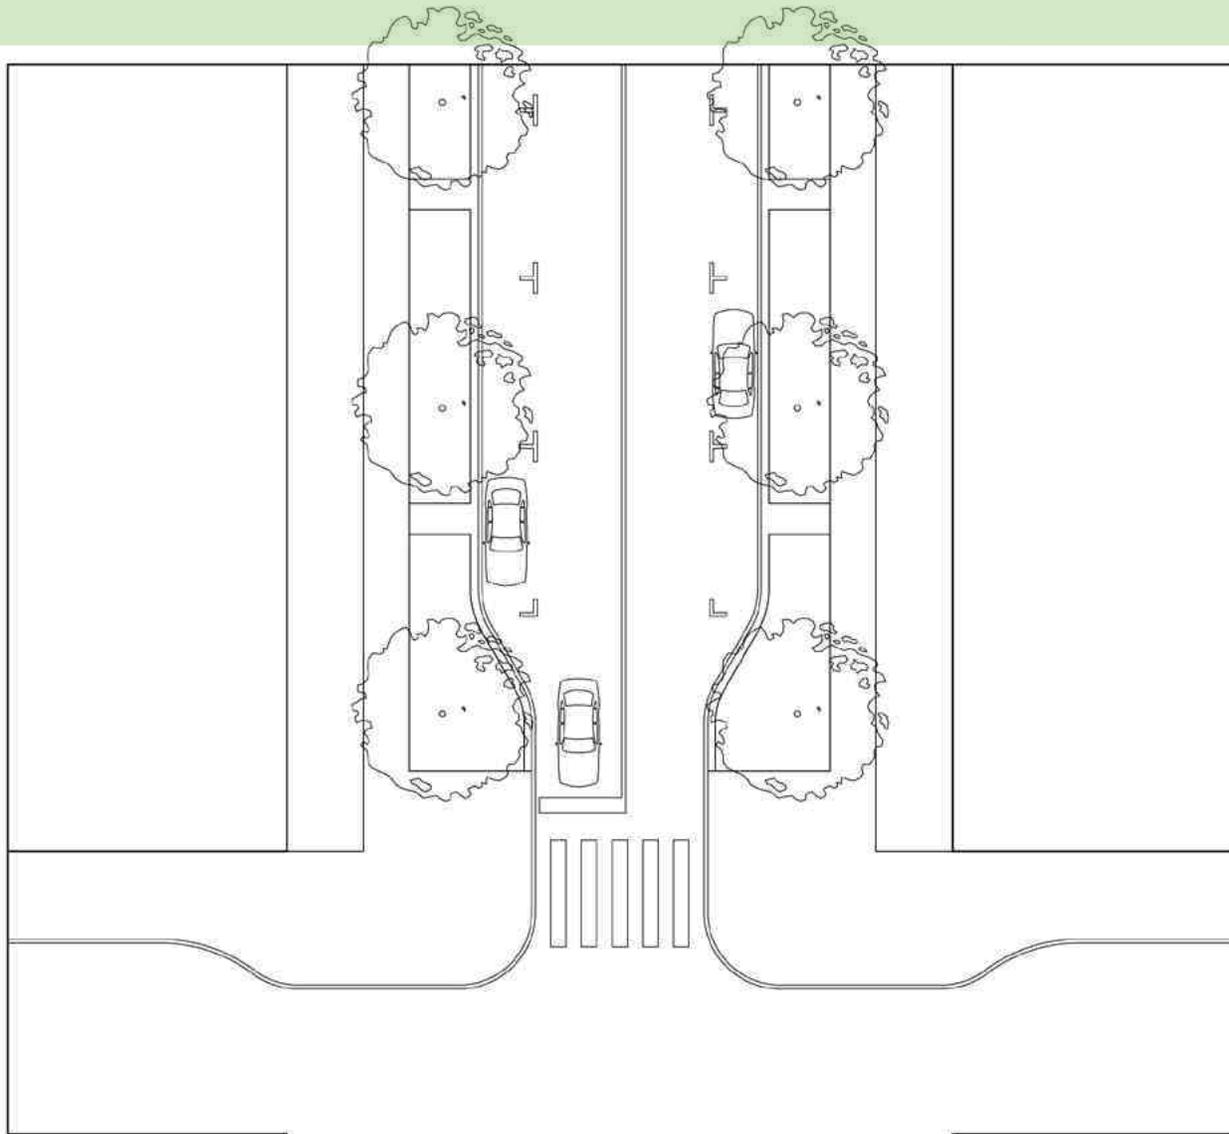
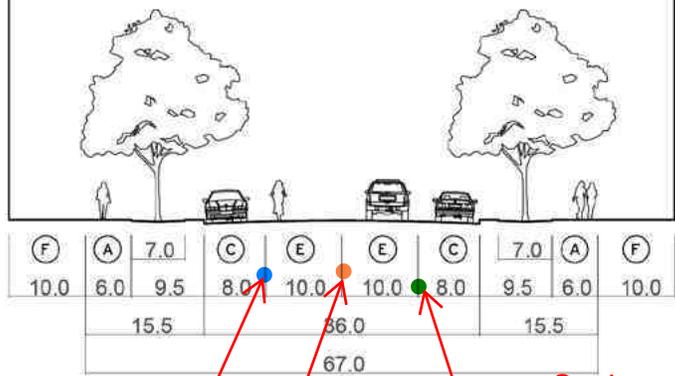
Figure 6-6 Typical Street Plan and Section

Water

Storm

Sanitary
