Technical Memorandum

File and Literature Review

I-25 Erie Gateway South PD District

Weld County, Colorado

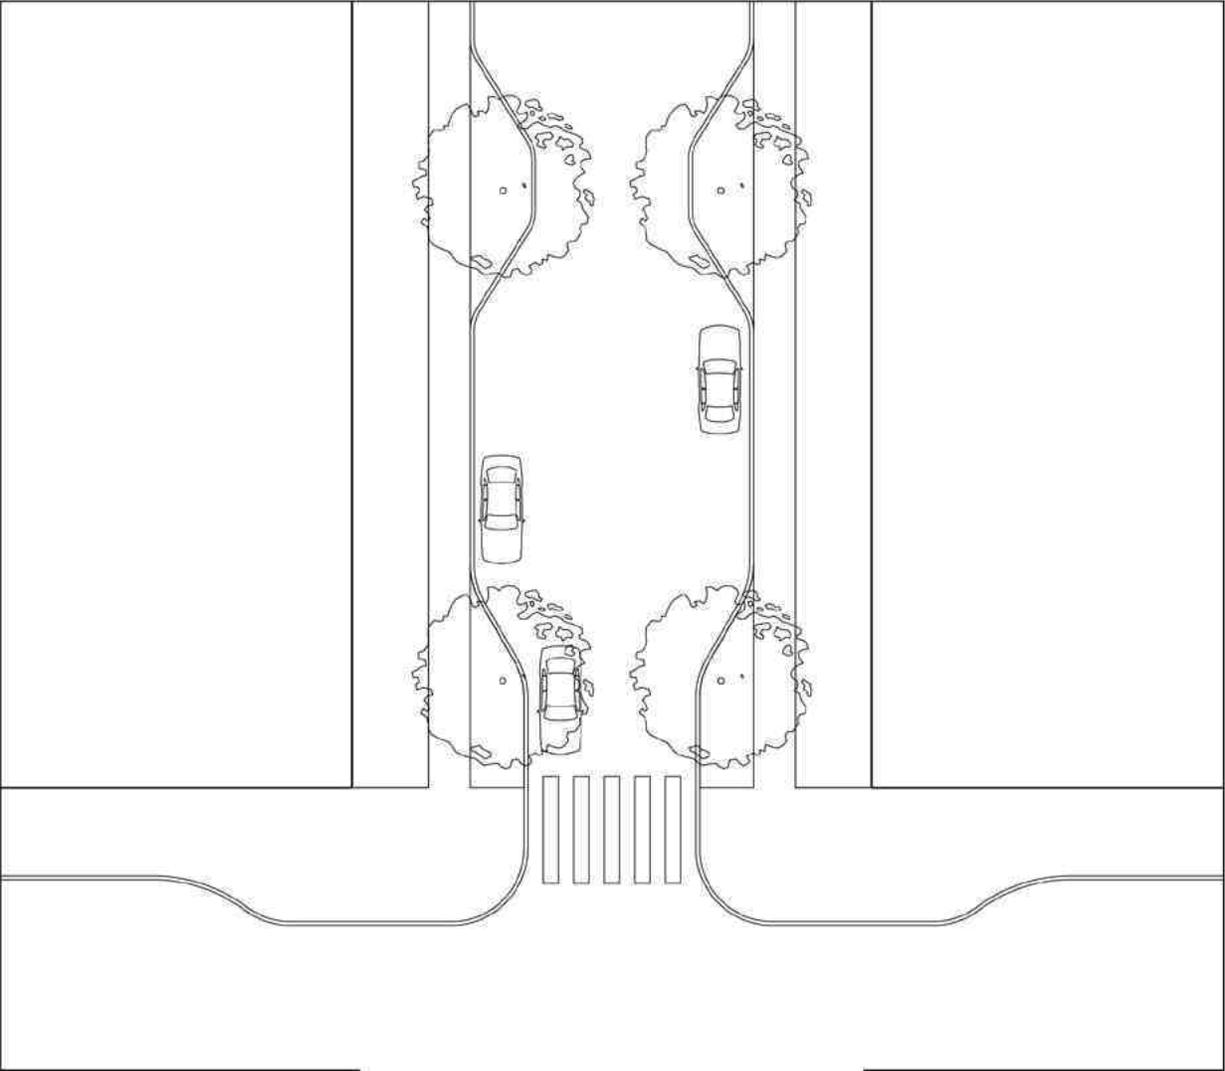
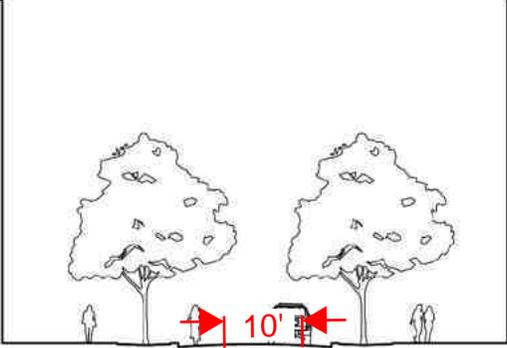
(A)	1.0	(E)	(B)(C)	(A)
	8.0	20.0	8.0	
6.0		36.0		6.0
		48.0

Water ● Sanitary ●
