**RE: CDPHE Approval of the Corrective Measures Design Report Rev. 1**  
Neuhauser Landfill, Erie, Colorado

*“Corrective Measures Design Report, Historic Landfill Site, Rev. 1;”* prepared for Stratus Redtail Ranch LLC (“Stratus”); prepared by Geosyntec Consultants (“Geosyntec”); dated May 1, 2020 (referred to herein as the “CMD Rev.1”).

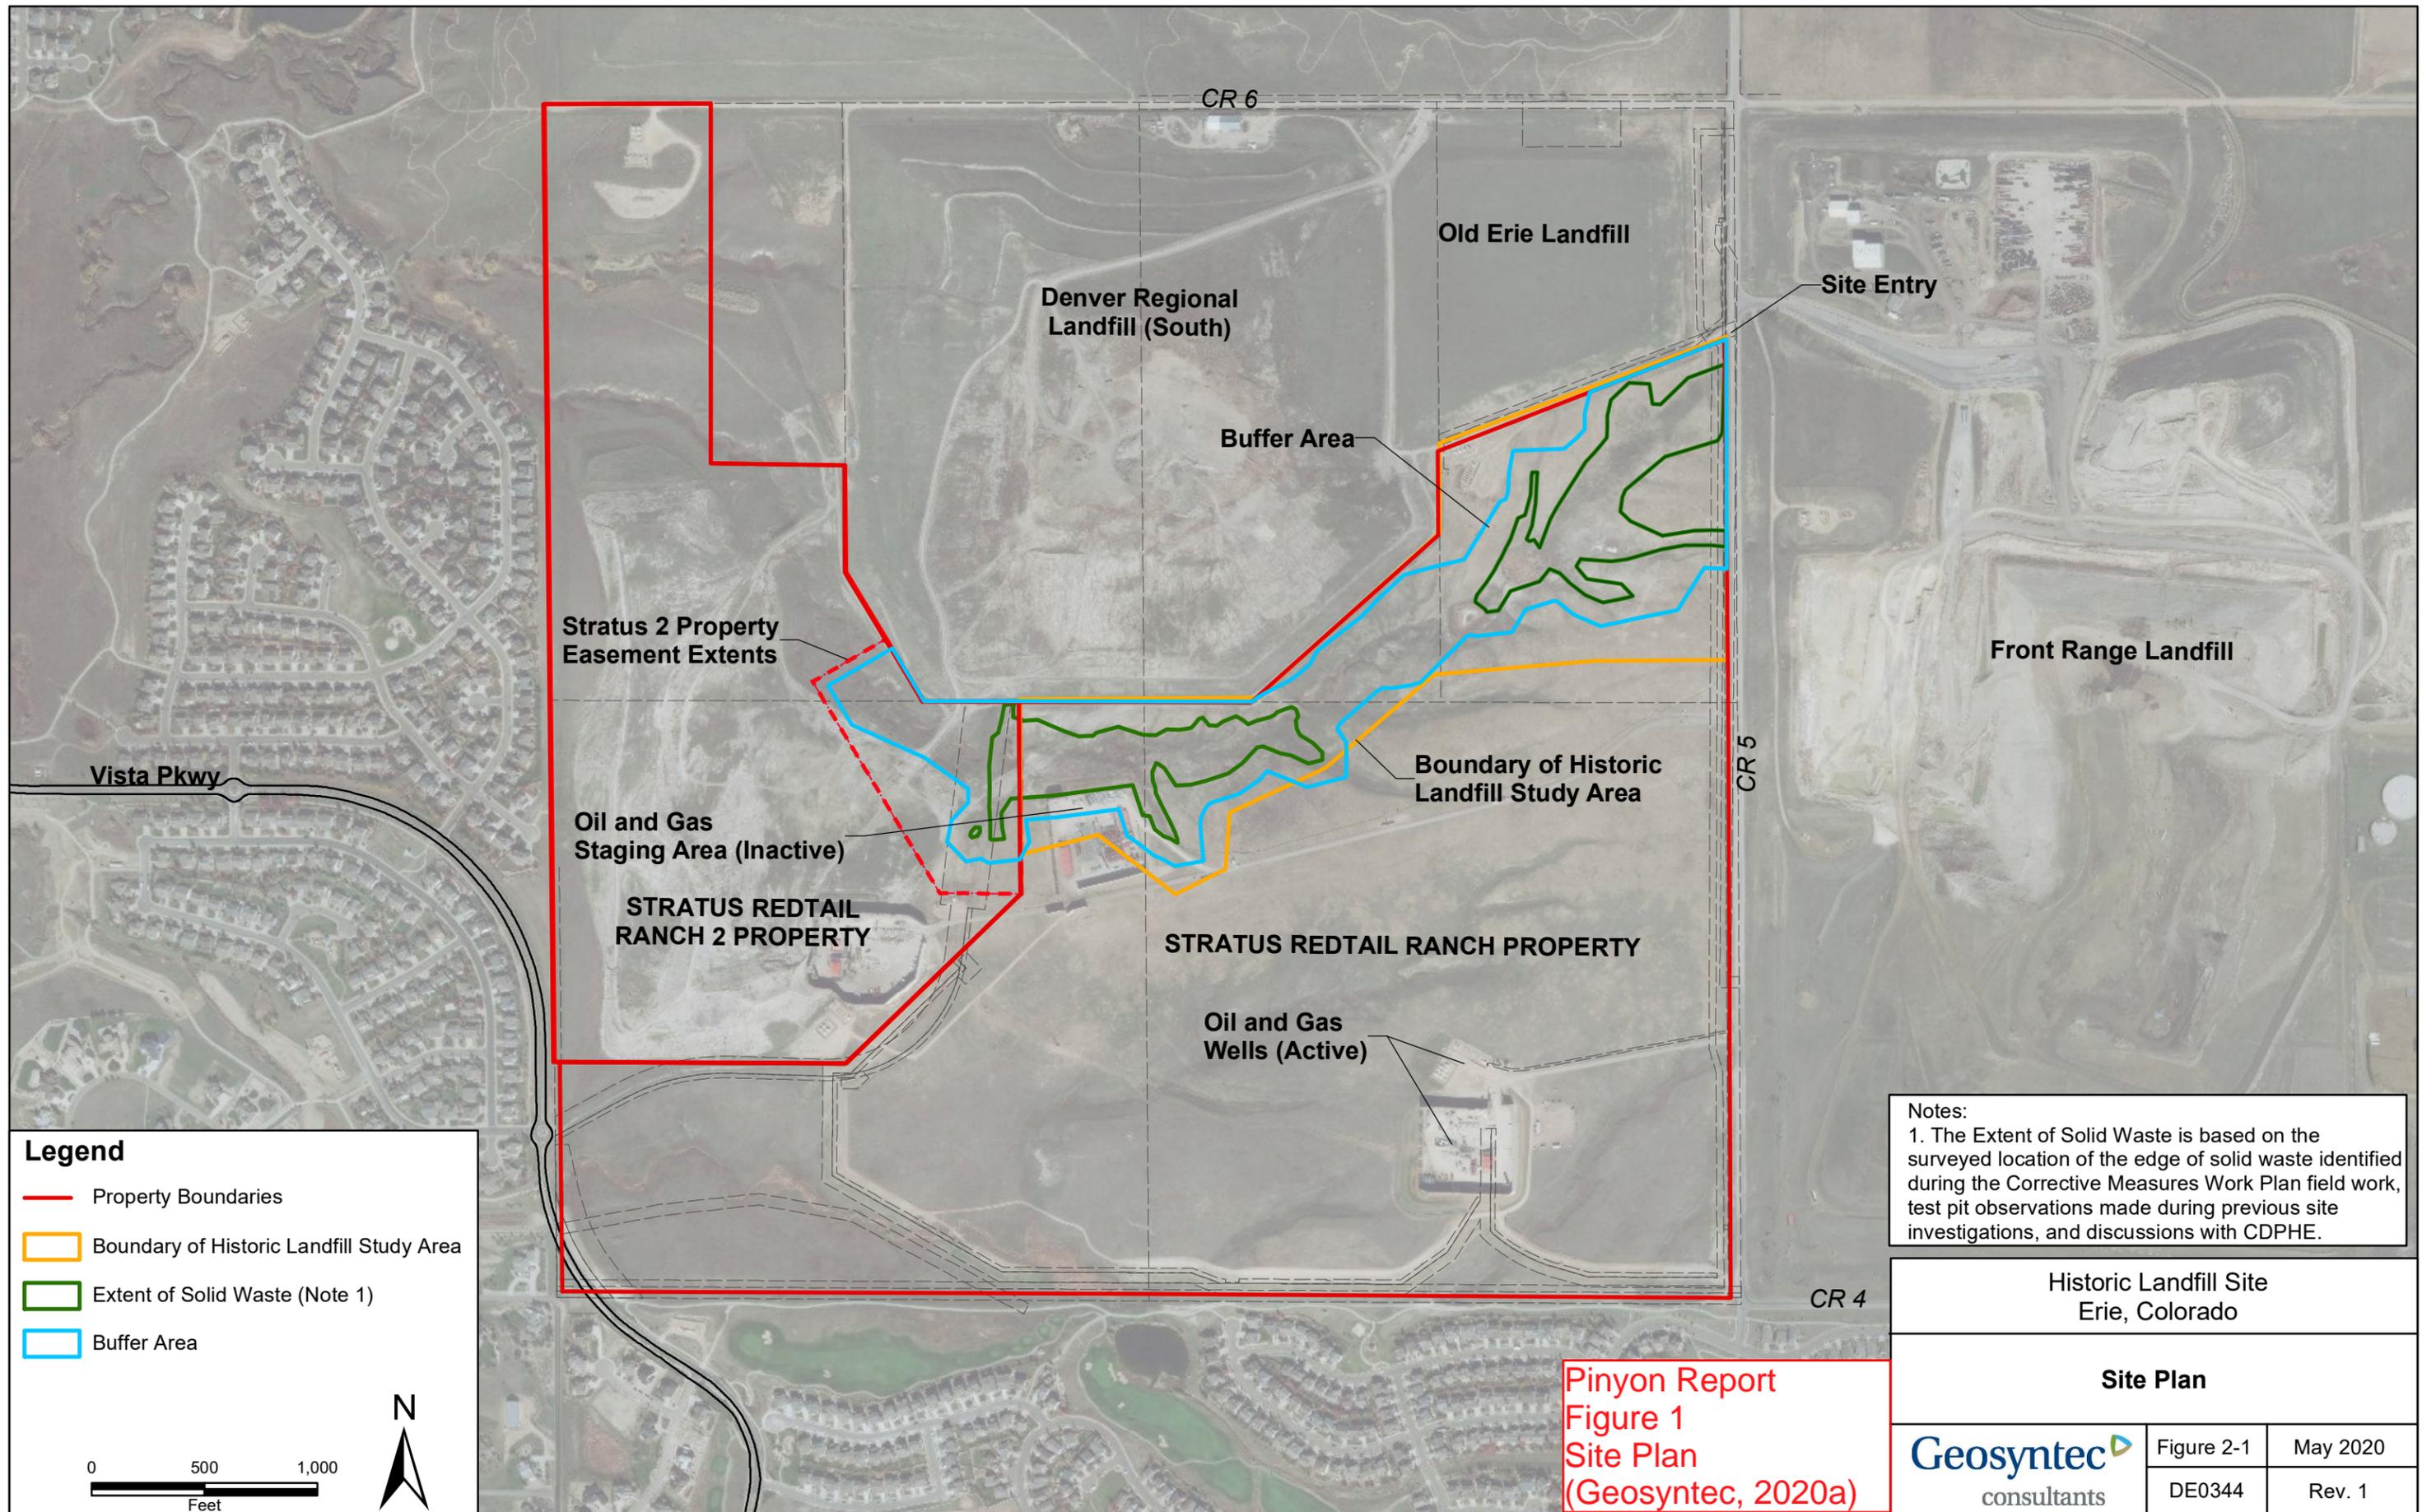
Pinyon Report  
 Figure 1  
 Site Plan  
 (Geosyntec, 2020a)

- 1964-1969: The northern portion of the Site was used as a landfill (Neuhauser Landfill) by Sanitation Engineering, Inc., from 1964 to 1969 (the green boundaries presented in Figure 1). Up to 1,500 drums containing approximately 84,000 gallons of chemical waste from IBM may have been disposed at the Neuhauser Landfill in the 1960's. The Neuhauser Landfill extended along the north/northeastern portions of the Site and extended west onto the adjacent Stratus Redtail Ranch 2 Property.
- 2007: Tetra Tech collected three soil vapor samples from the northeastern portion of the Site and found high levels of VOCs migrated from the Denver Regional and Old Erie Landfills. SEC completed additional

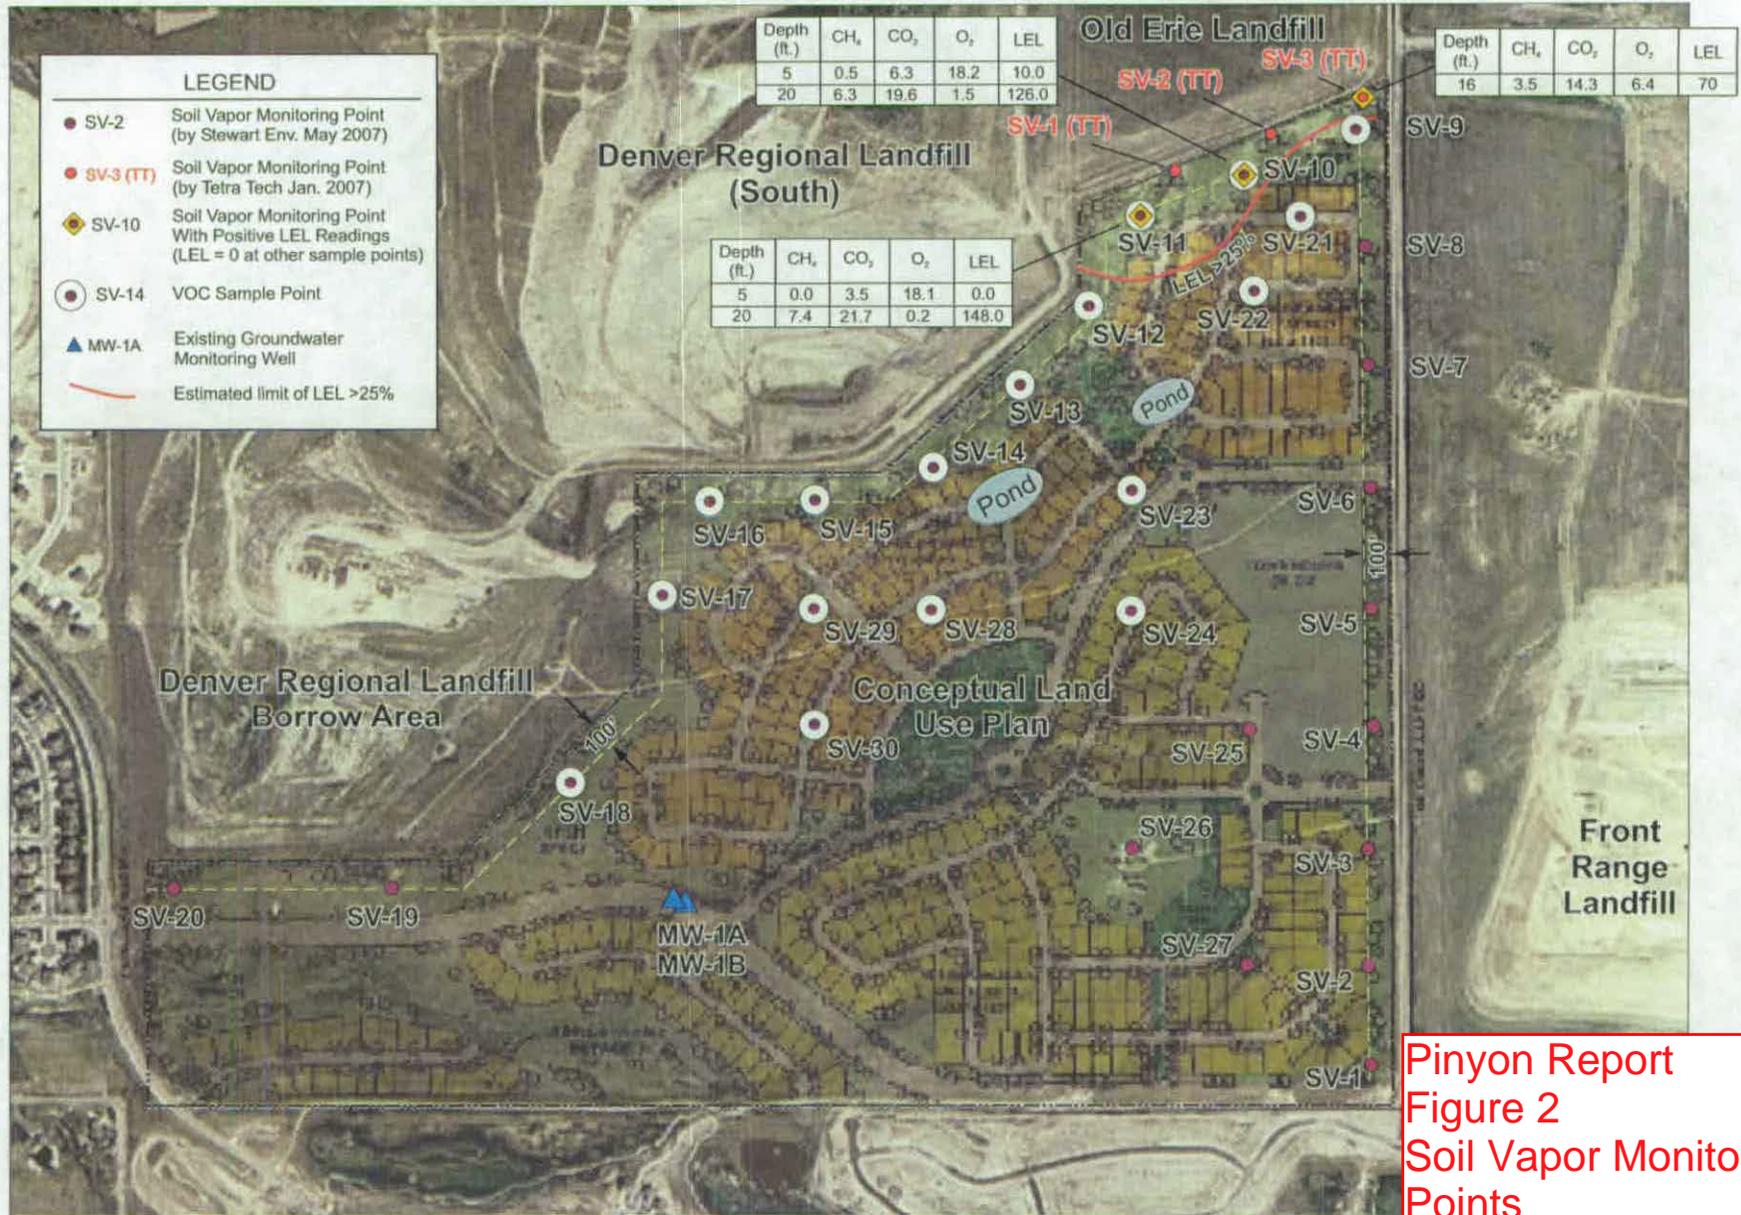
Pinyon Report  
 Figure 2  
 Soil Vapor Monitoring  
 Points  
 (SEC, 2011)

Three soil vapor monitoring points were installed on January 11, 2007, along the northeastern Site boundary, south of the Old Erie Landfill (Figure 2 [the red labels, SV-1 (TT), SV-2 (TT), and SV-3 (TT)]); soil vapor samples were collected on January 16, 2007 and were analyzed for landfill gas suites and volatile organic compounds (VOCs) by U.S. Environmental Protection Agency (EPA) Method AP-42. In addition to the soil vapor samples, two groundwater samples were collected from existing wells located south of the Old Erie Landfill on January 15, 2007. Groundwater was observed at depths between 18.50 and 54.62 feet below ground surface (bgs). The groundwater samples were analyzed for total petroleum hydrocarbons (TPH) and VOCs.

Based on the findings of the Tetra Tech soil vapor investigation, Stewart installed an additional 30 soil vapor sampling points throughout the northern and eastern portion of Parcel 1; no vapor points were installed on Parcel 2. The northern points were selected to evaluate soil vapor conditions migrating from the Denver Regional Landfill and Old Erie Landfill properties and the eastern points were used to evaluate potential soil vapor conditions migrating from the east adjacent Front Range Landfill. Most of the points were nested with two screen intervals at five feet, and between 15 to 20 feet bgs. Samples were collected and lab analyzed for VOCs from 16 of the vapor points along the northern portion of Parcel 1 (Figure 2). During this sampling event, TCE was detected above the risk-based screening level at SV-14, SV-16, and SV-22. Samples were not collected for lab analysis at the other vapor point locations; instead, the vapor points were field screened for landfill gases. Those included three locations immediately south of the Old Erie Landfill (SV-10, SV-11, and SV-3(TT)), which indicated methane concentrations above the lower explosive limit (LEL) (Figure 2). Methane was not detected at the other locations.

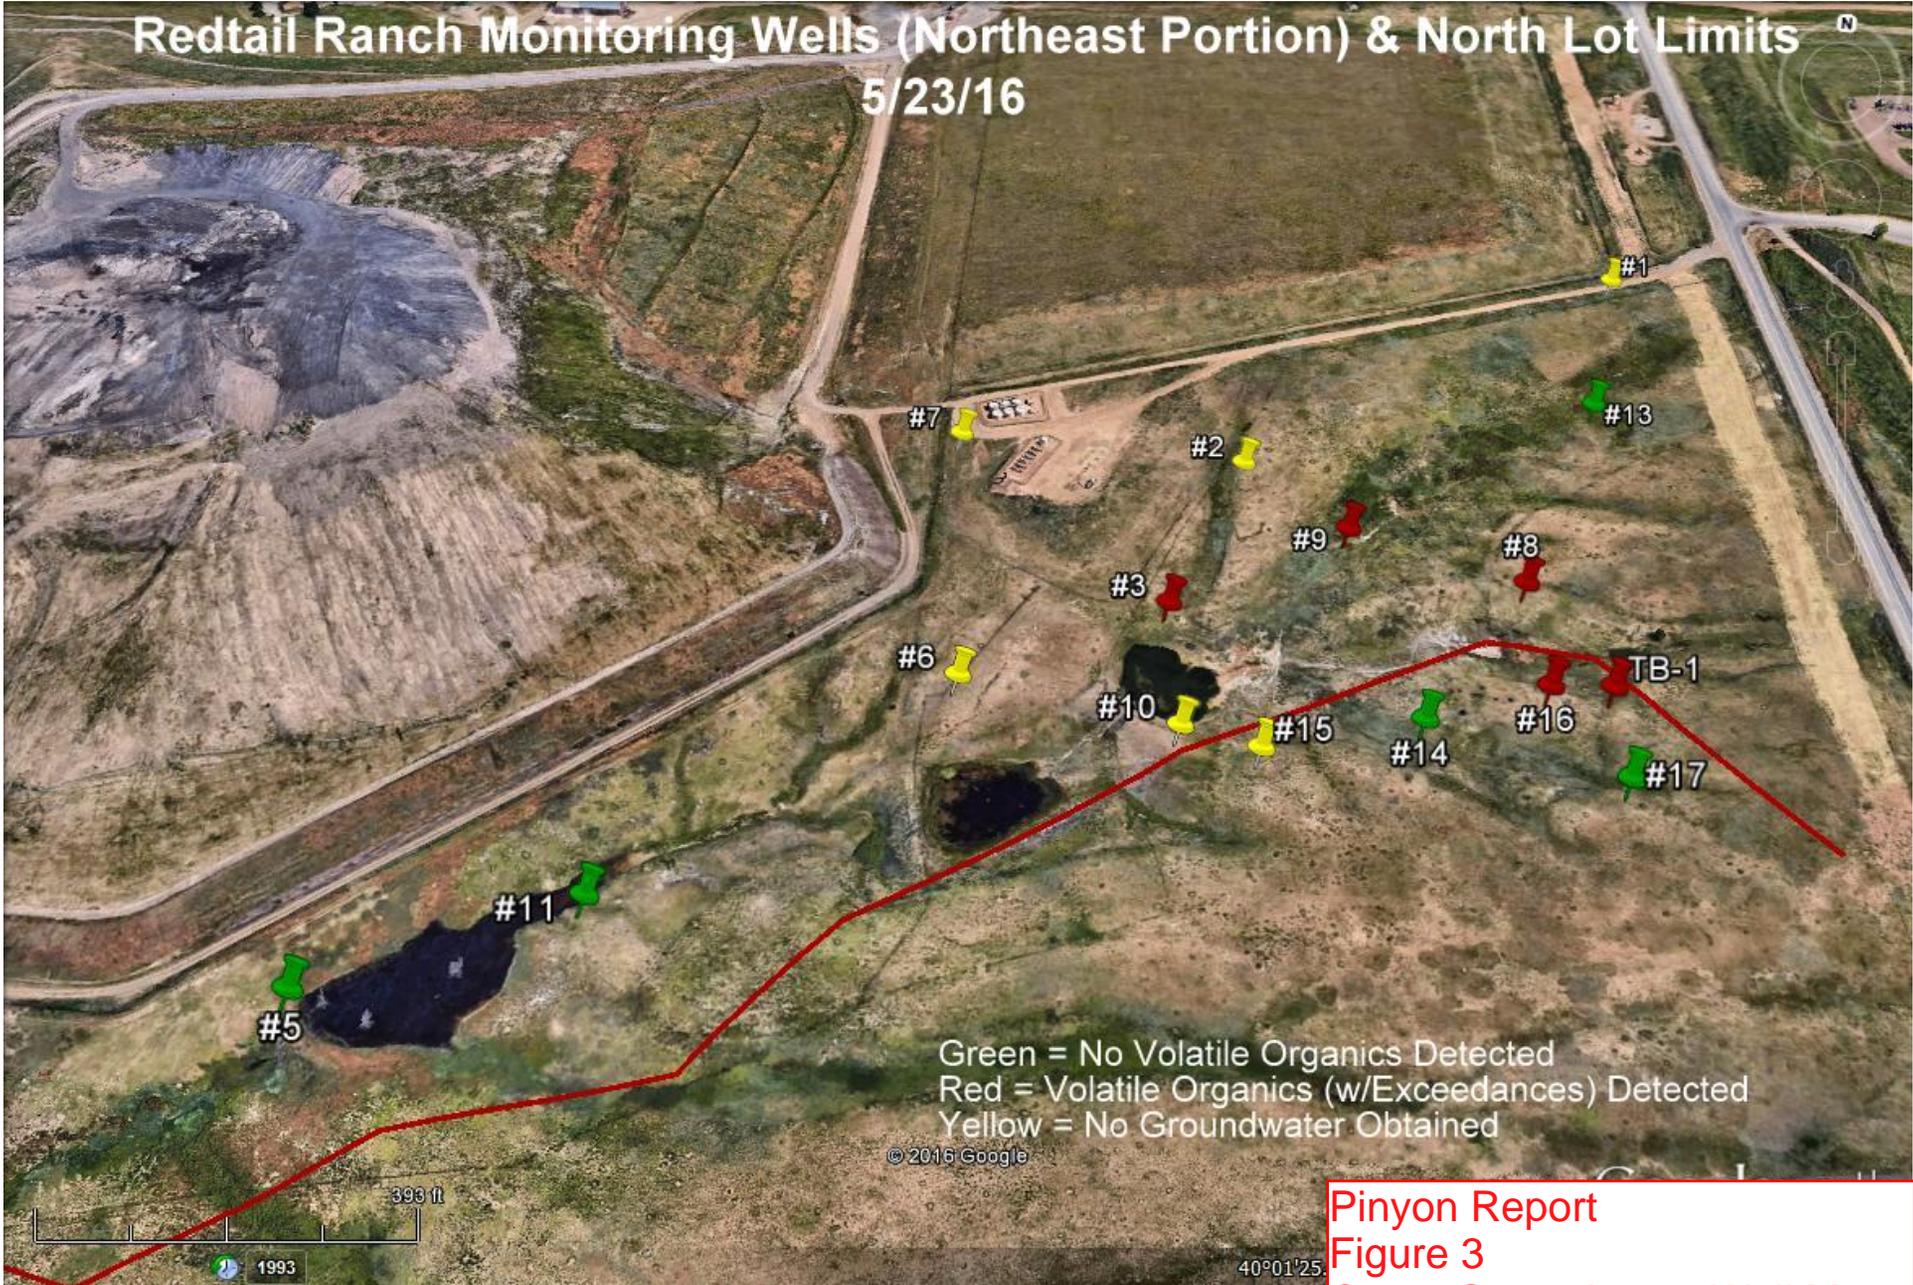
Pinyon Report  
Figure 3  
Quest Groundwater Well Map  
(Quest, 2016)

Based on the findings of its Phase I ESA, Quality Environmental Services and Technologies, Inc. (Quest), conducted groundwater monitoring at 17 locations, in three phases, at the north/northeast boundary of the Site (Figure 3). Eleven groundwater samples were collected and submitted for lab analysis for VOCs (six of the wells did not produce water). Quest's investigation noted that impacted soils were present along the northeastern portion of the Site. Elevated VOC concentrations exceeding the CDPHE Groundwater Standards

were noted at five locations (GW#3, GW#8, GW#9, GW#13, GW#16, and TB-1), each of which were collected from the northeastern portion of the Site (Figure 3).

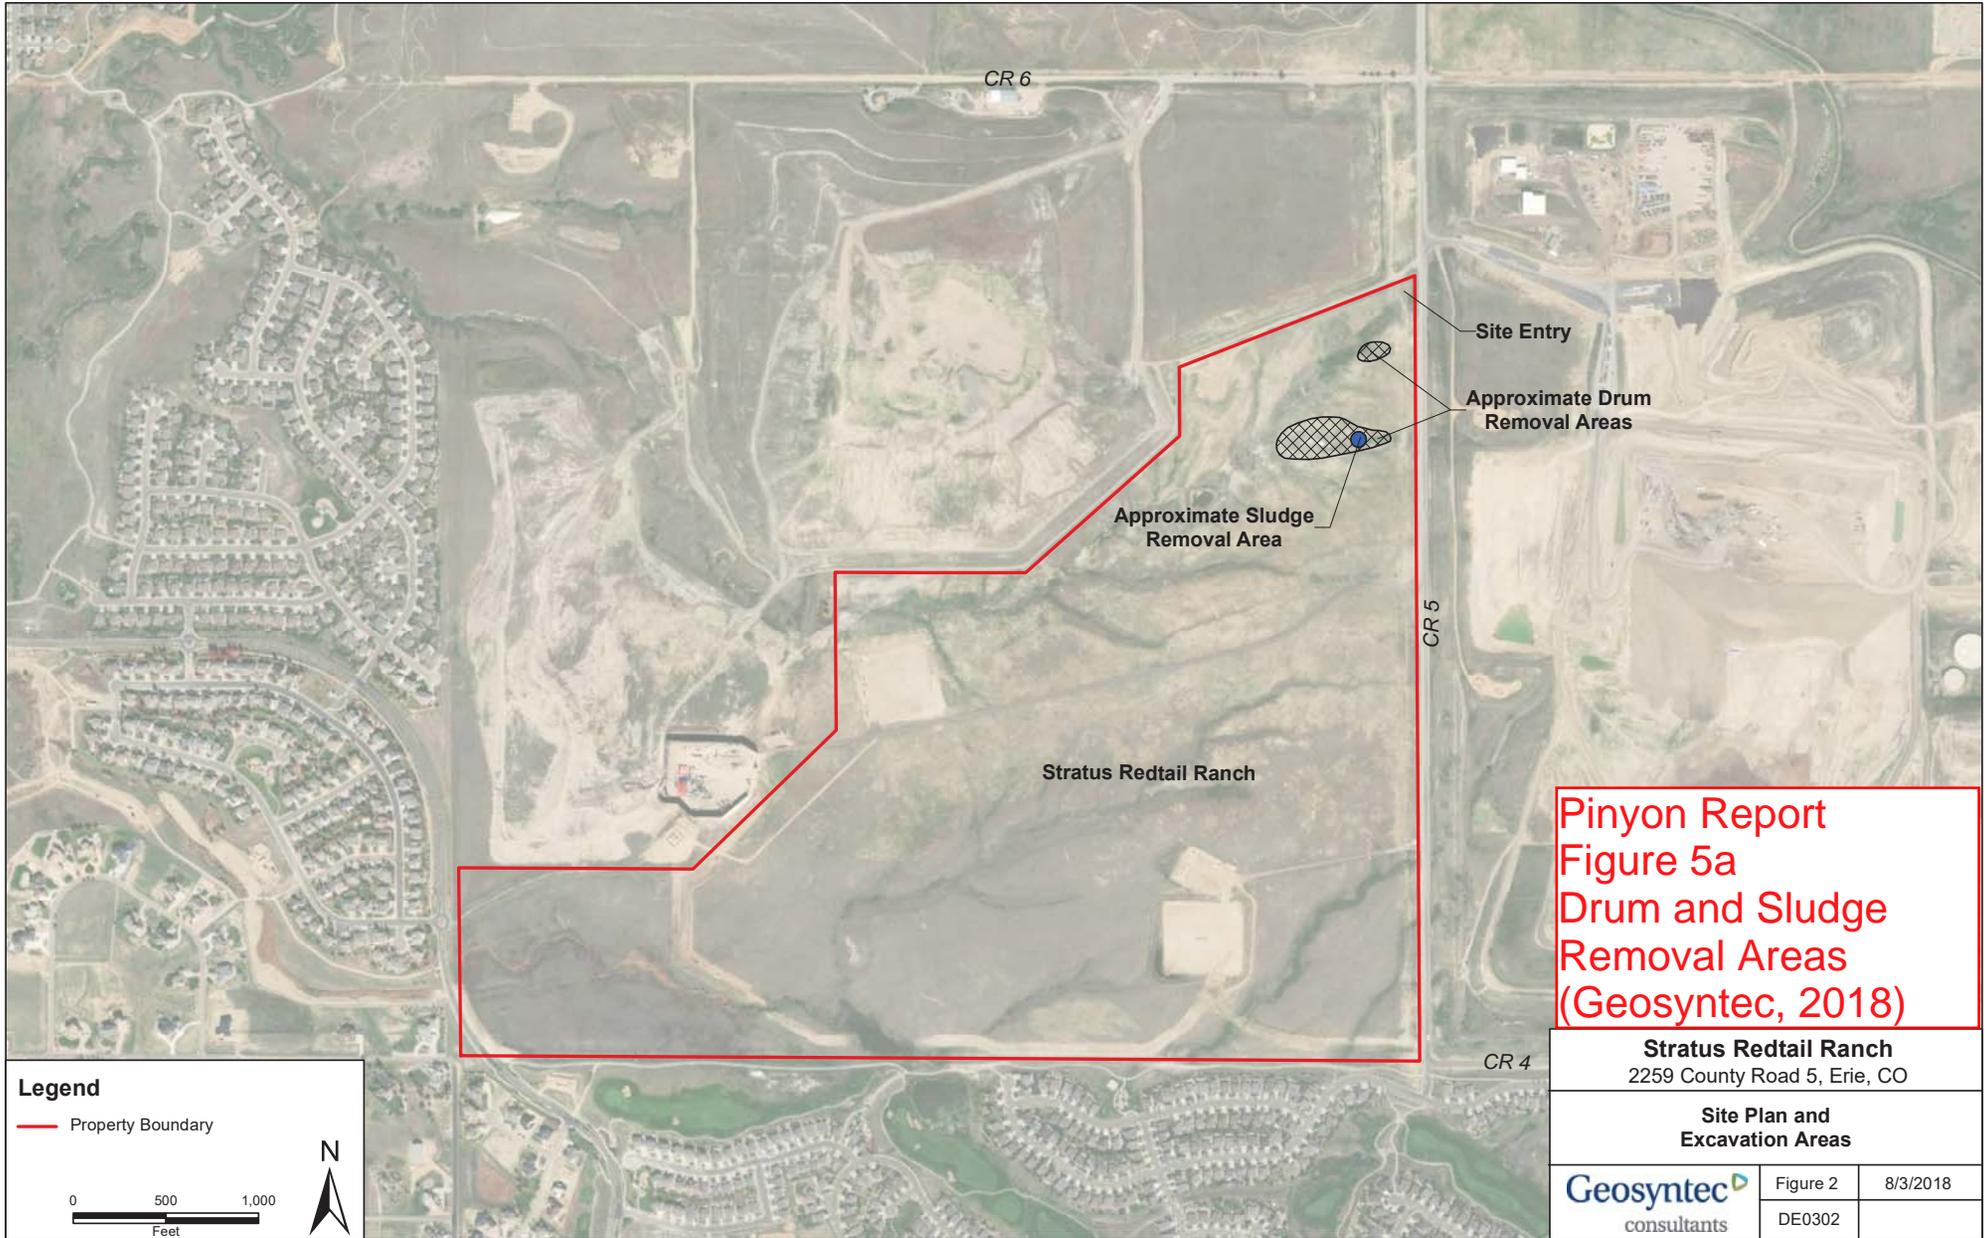
**Pinyon Report  
Figure 5a  
Drum and Sludge  
Removal Areas  
(Geosyntec, 2018)**

- Phase 2A – 444 cubic yards of material was excavated with 144.63 tons found to be impacted and disposed of offsite.
- Phase 2B – 2,643 cubic yards of material was excavated with 1,733.4 tons found to be impacted and disposed of offsite.

- Phase 3 – 1,700 cubic yards of material was excavated with 2,541.04 tons found to be impacted and disposed of offsite.
- An EM survey conducted by NGPRS in December 2017 identified nine additional drums in areas that fell outside of the four area (Phase 1, 2A, 2B, and 3).

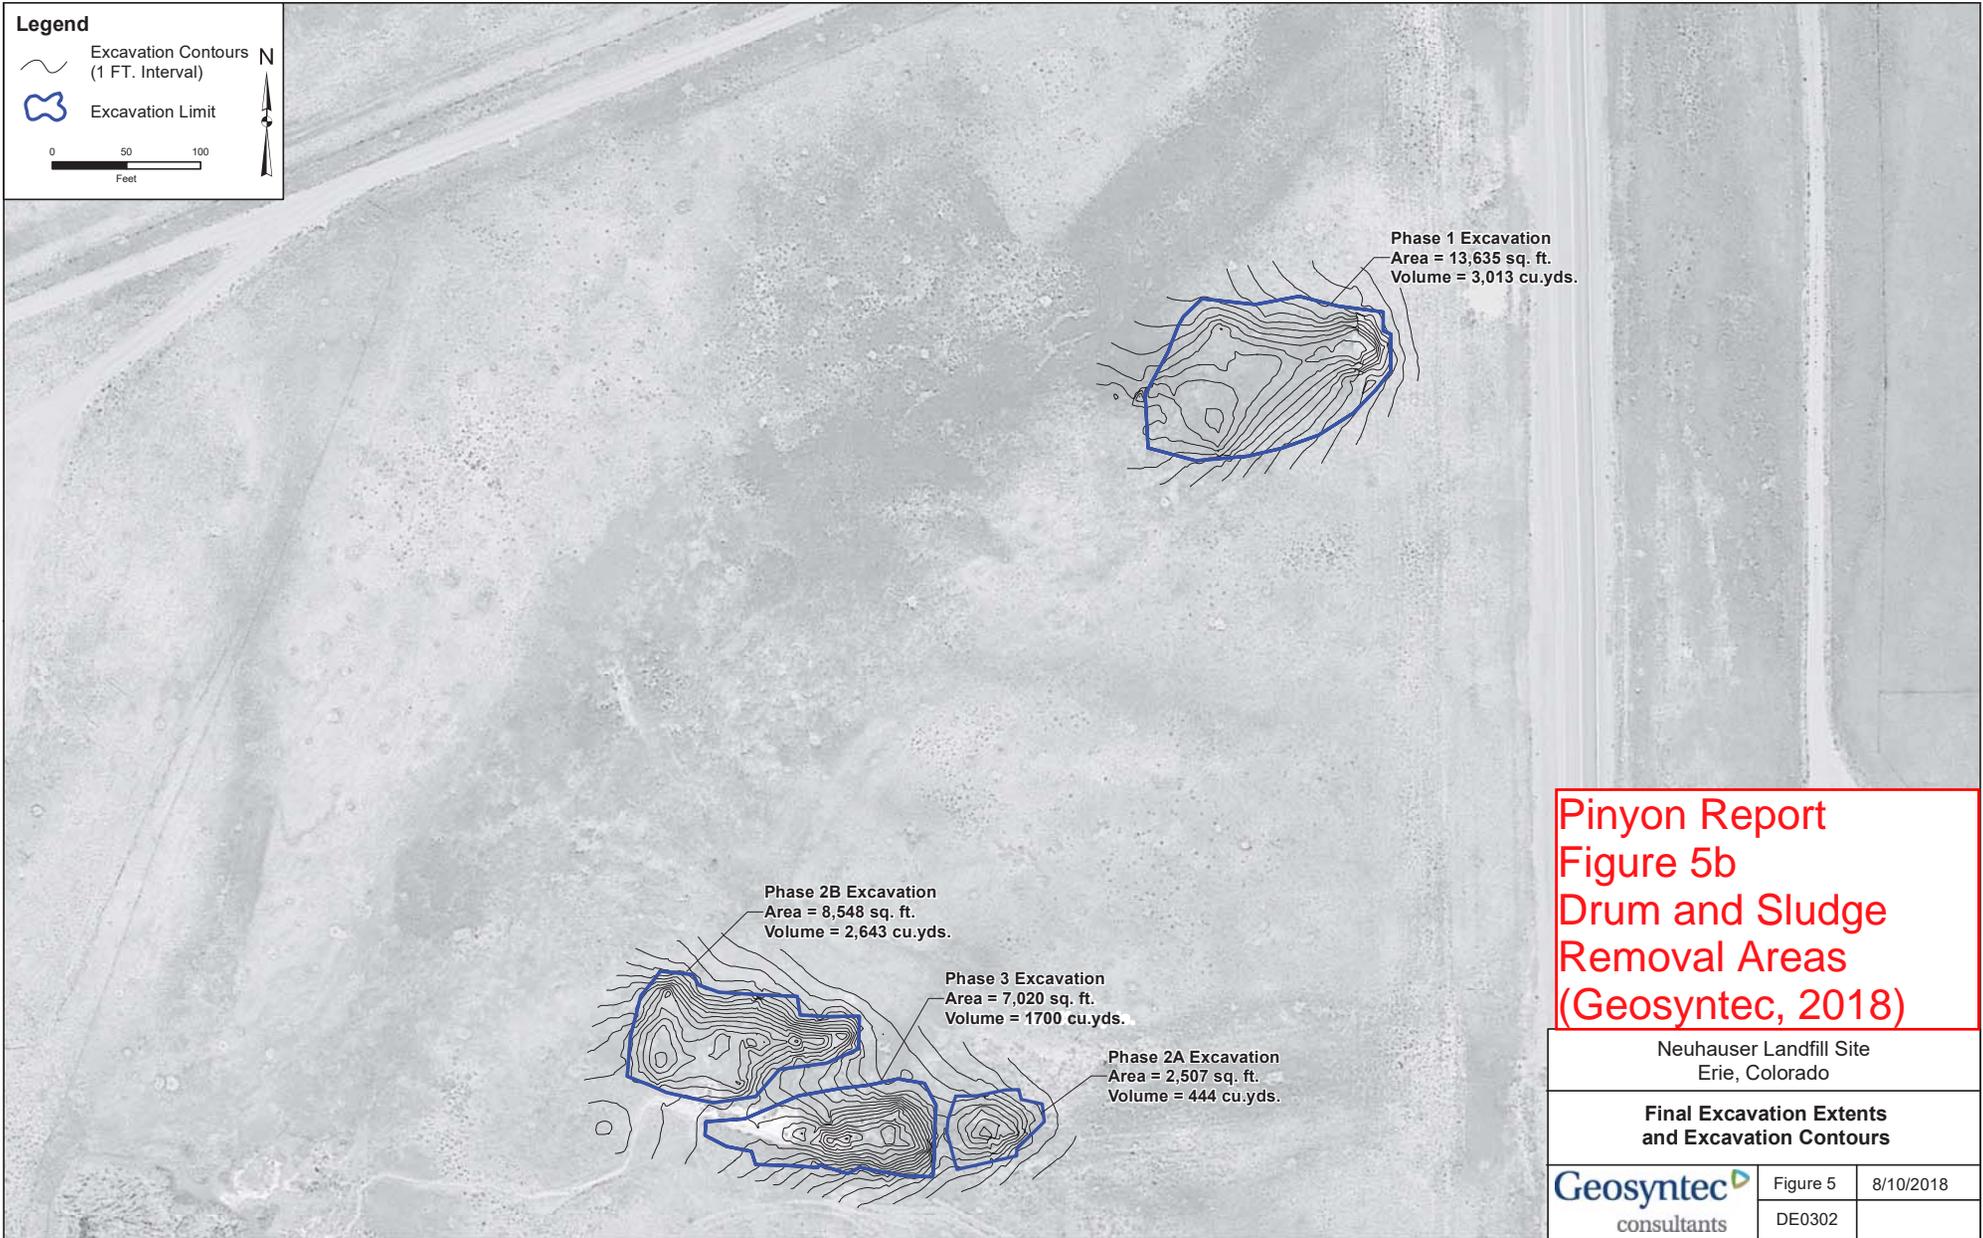
**Pinyon Report  
Figure 5b  
Drum and Sludge  
Removal Areas  
(Geosyntec, 2018)**

Neuhauser Landfill Site Erie, Colorado		
<b>Final Excavation Extents and Excavation Contours</b>		
Geosyntec consultants	Figure 5	8/10/2018
	DE0302

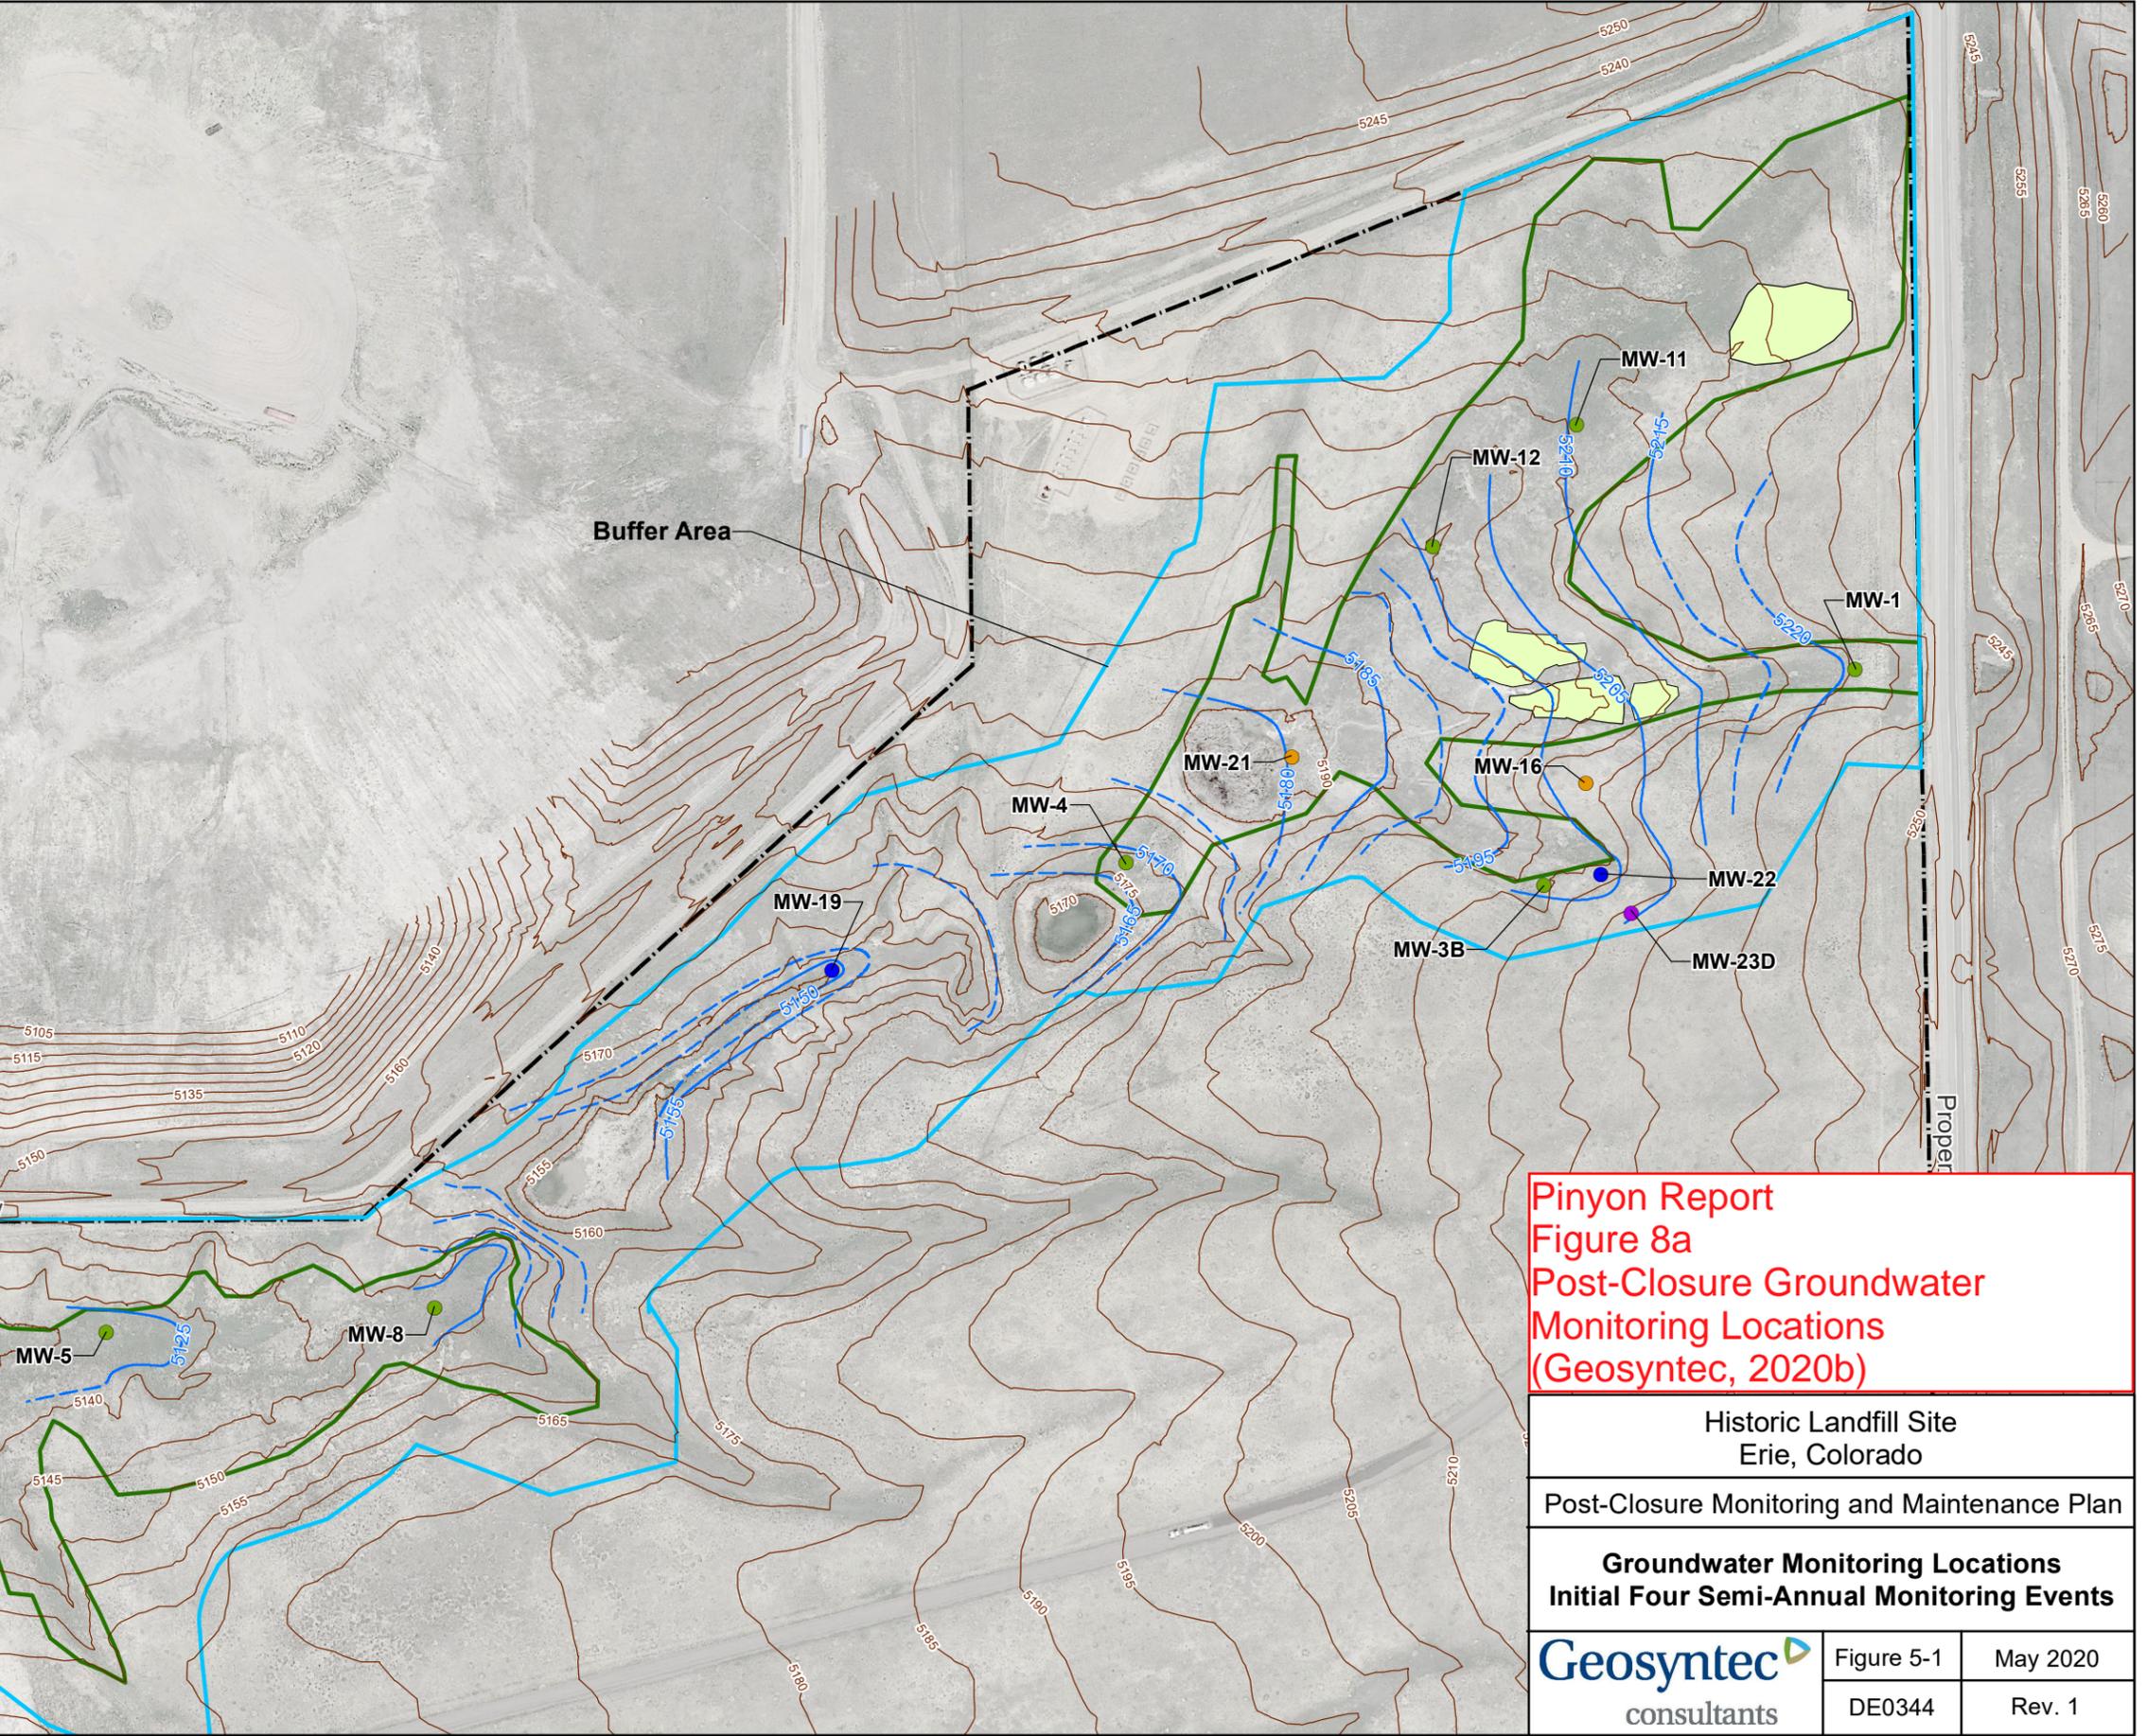
**Pinyon Report**  
**Figure 8a**  
**Post-Closure Groundwater**  
**Monitoring Locations**  
**(Geosyntec, 2020b)**

Monitored natural attenuation (MNA) will be used to demonstrate contaminants downgradient of Phases 1 and 3 are attenuating following removal of the drums and impacted soils. It will also be used to confirm contaminants downgradient of Phases 2A and 2B are attenuating, following ISCO. Natural attenuation is a method that relies on natural processes (i.e., biodegradation, sorption, dilution, evaporation, and chemical reactions) to take place to decrease contaminant concentrations. The contaminant concentrations are monitored with regular sampling to evaluate whether the natural processes result in decreases of the contaminant concentrations.

The MNA sampling locations would be used to evaluate the concentrations of the contaminants over time and will evaluate the geochemical trends to ensure conditions are conducive to successful natural attenuation. The short-term and long-term monitoring plan and frequency are discussed in Section 3.3 and are detailed in the PCMM Plan (Geosyntec, 2020b).

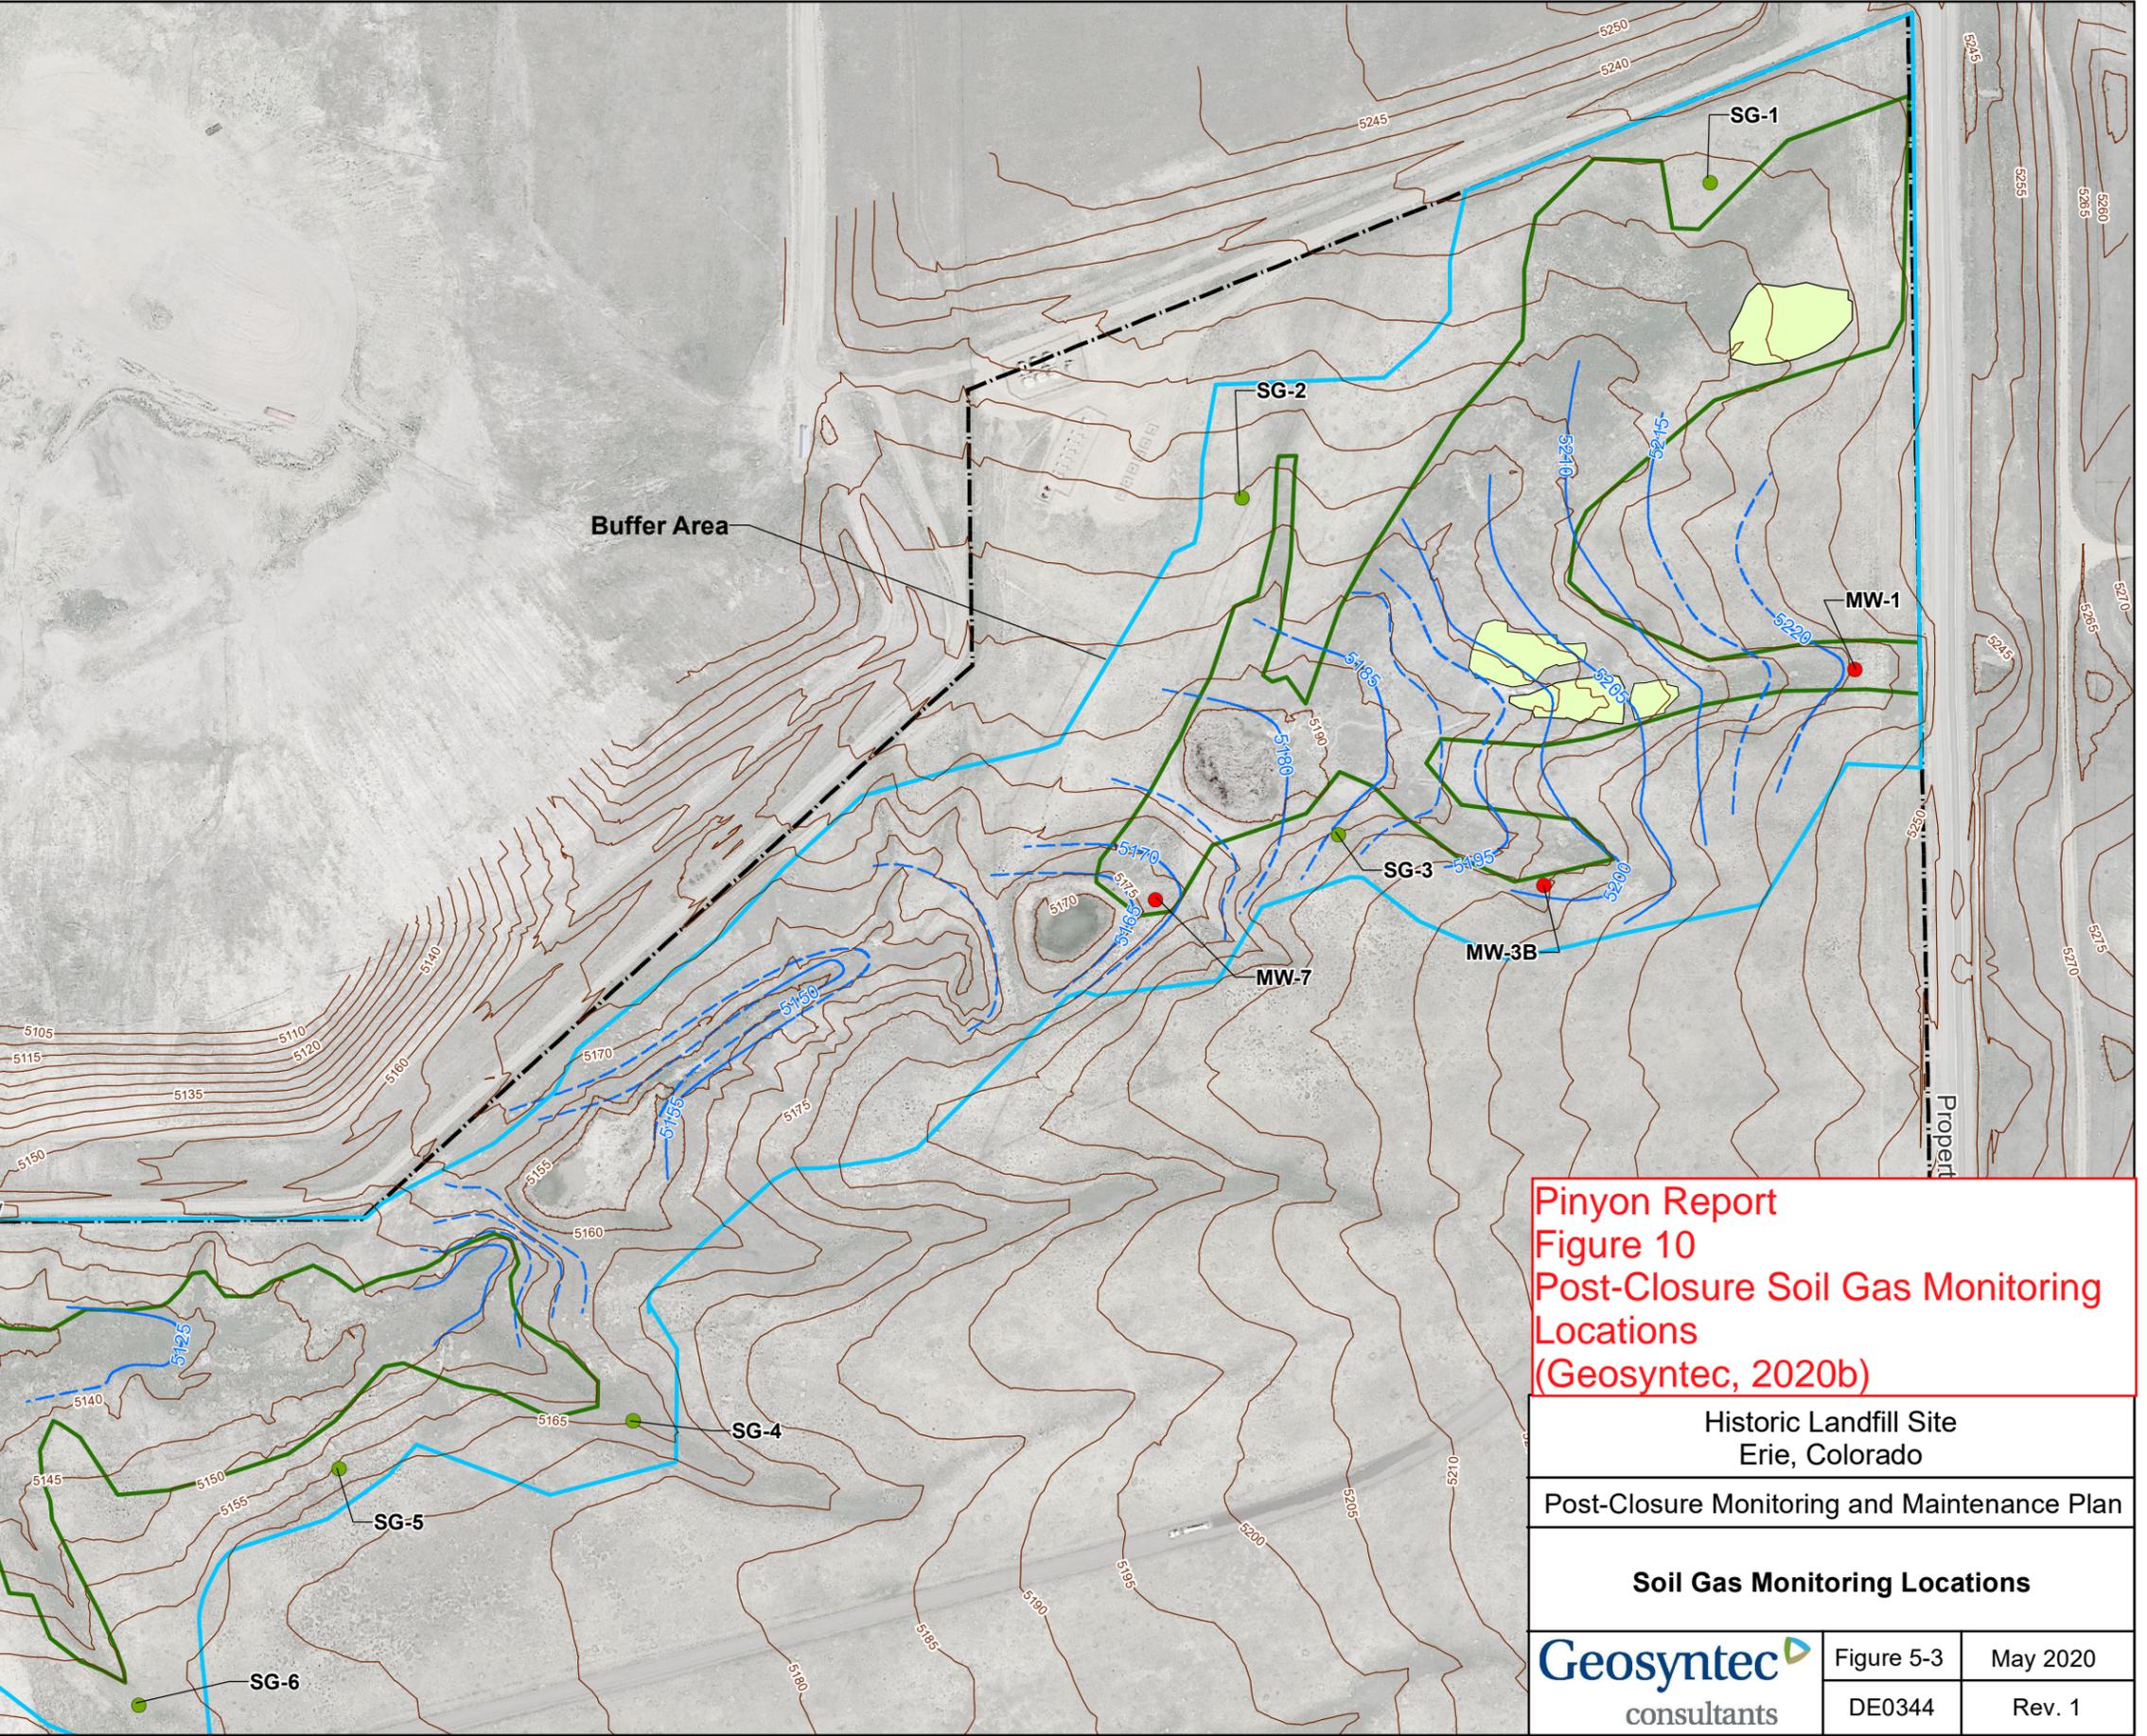
**Pinyon Report  
Figure 10  
Post-Closure Soil Gas Monitoring  
Locations  
(Geosyntec, 2020b)**

Historic Landfill Site Erie, Colorado		
Post-Closure Monitoring and Maintenance Plan		
<b>Soil Gas Monitoring Locations</b>		
Geosyntec consultants	Figure 5-3	May 2020
	DE0344	Rev. 1
