**RE: CDPHE Approval of the Corrective Measures Design Report Rev. 1**  
Neuhauser Landfill, Erie, Colorado

*“Corrective Measures Design Report, Historic Landfill Site, Rev. 1;”* prepared for Stratus Redtail Ranch LLC (“Stratus”); prepared by Geosyntec Consultants (“Geosyntec”); dated May 1, 2020 (referred to herein as the “CMD Rev.1”).

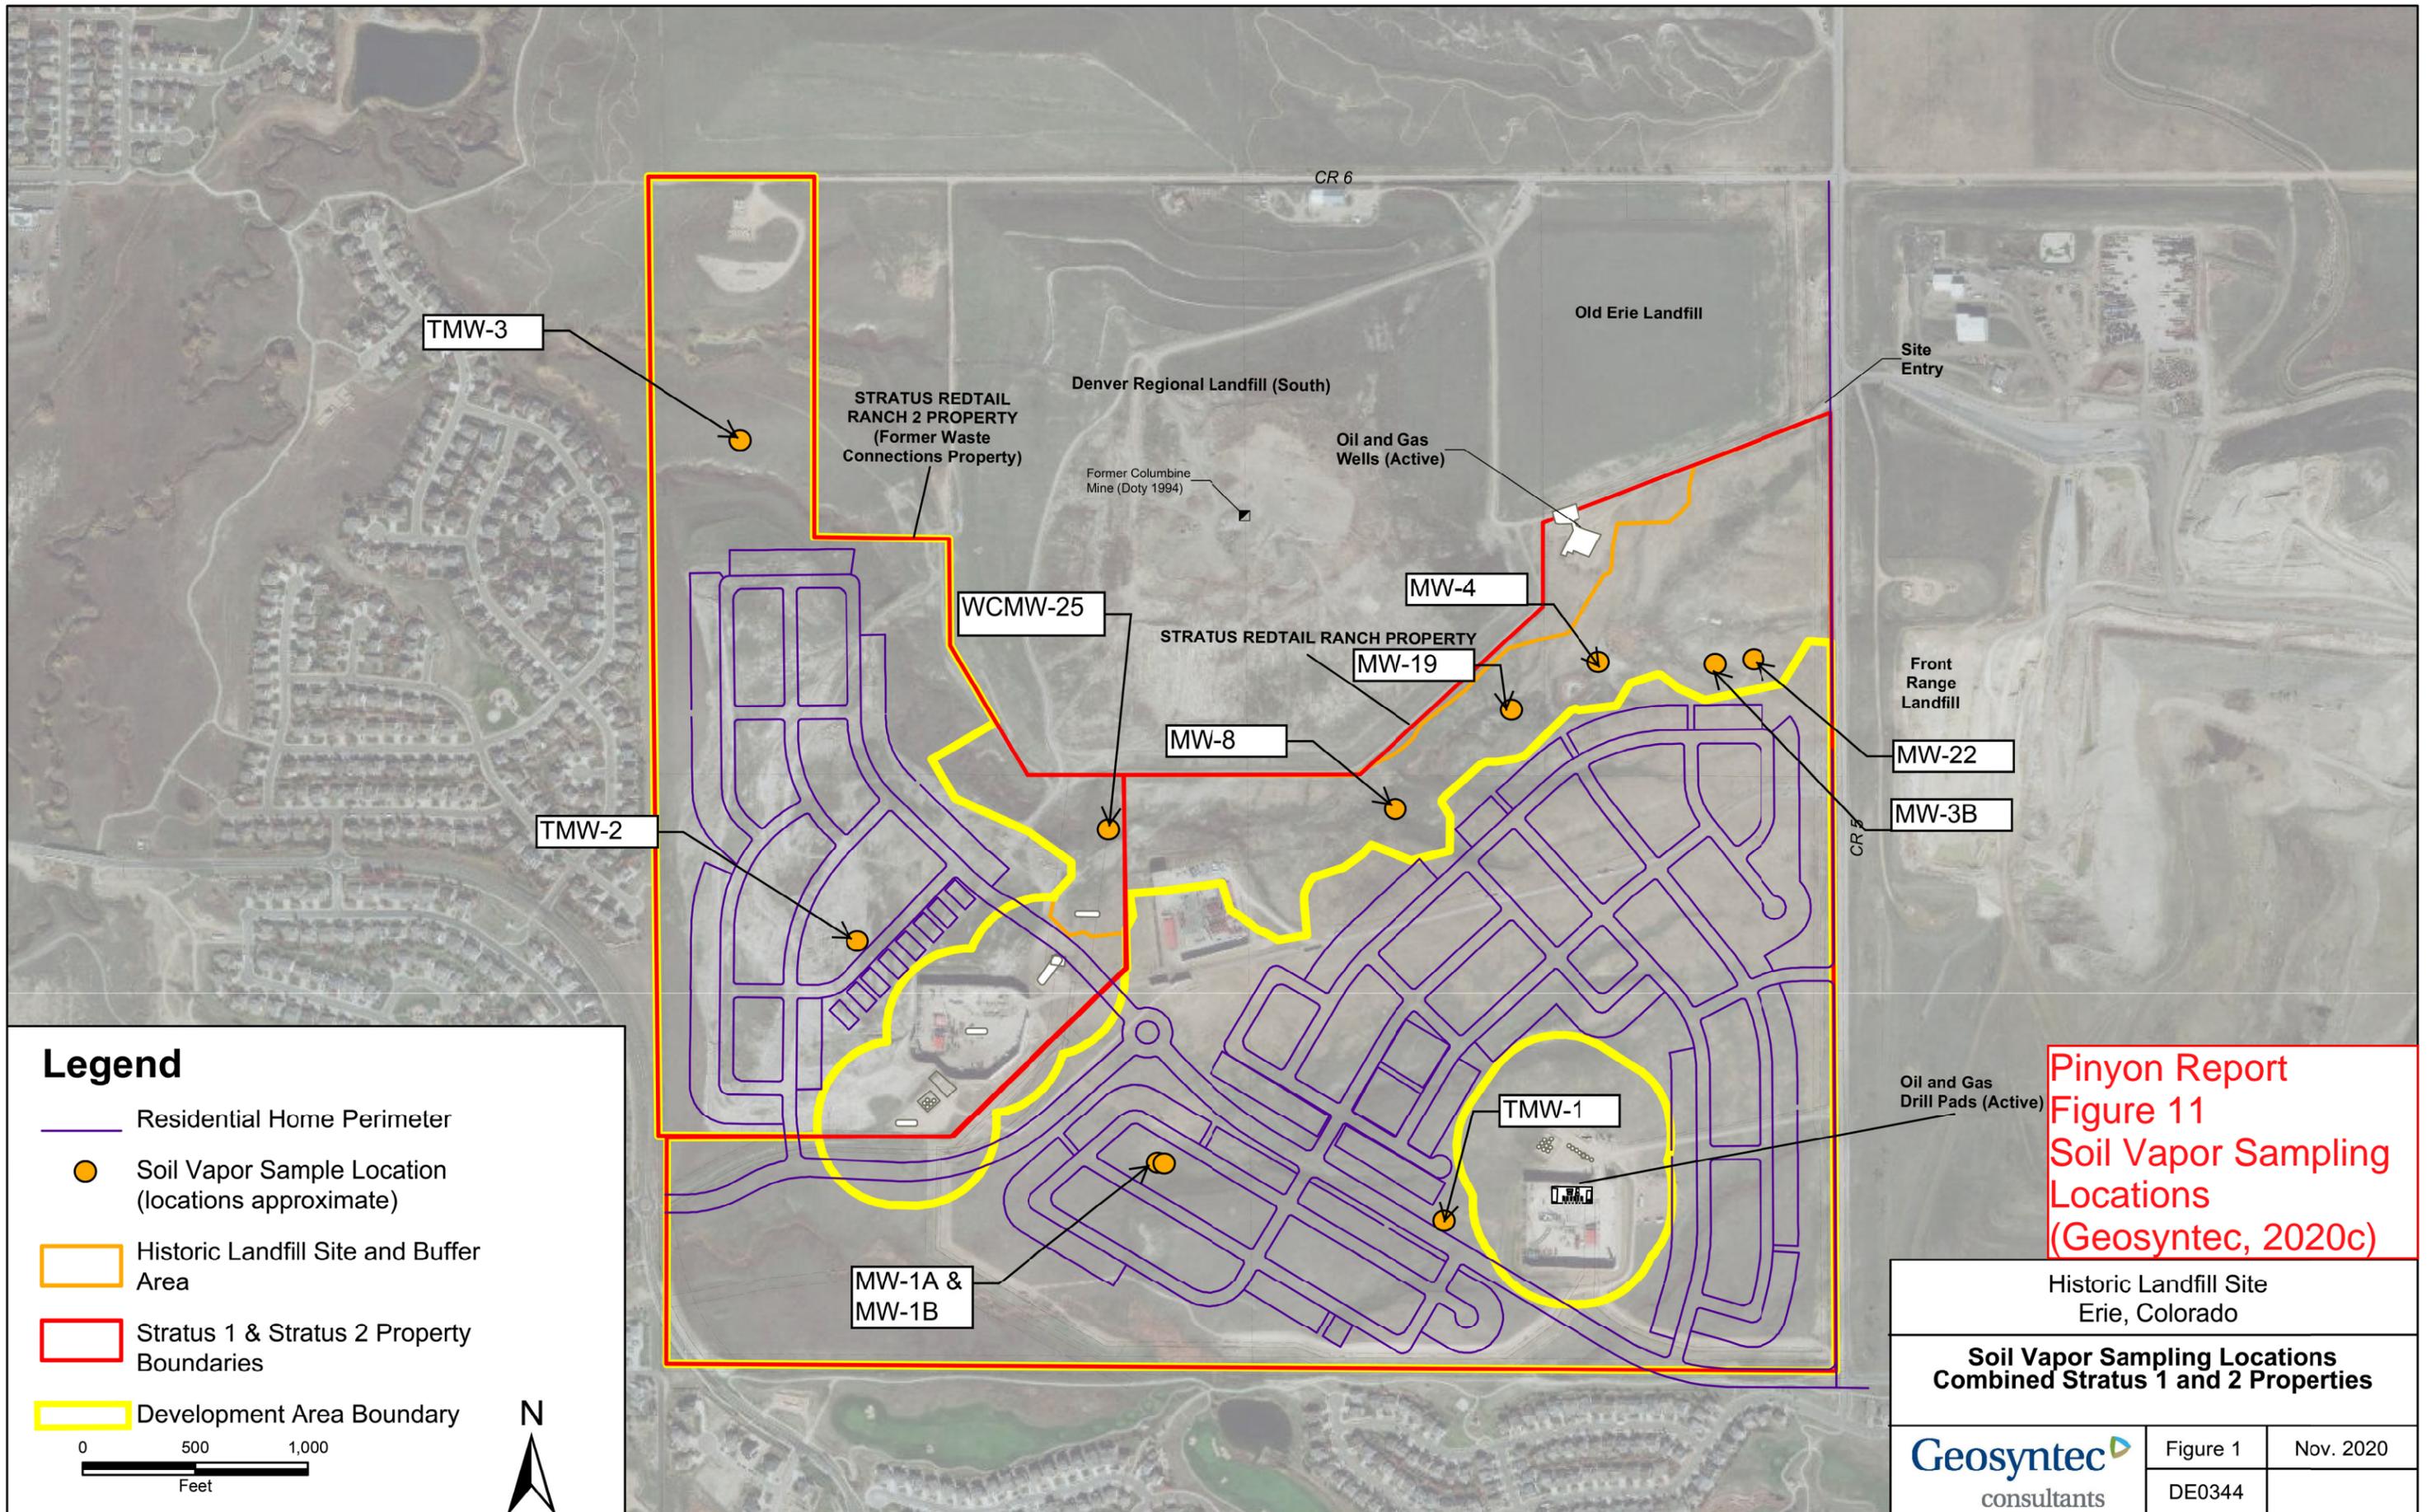
Historic Landfill Site Erie, Colorado		
<b>Soil Vapor Sampling Locations Combined Stratus 1 and 2 Properties</b>		
Geosyntec consultants	Figure 1 DE0344	Nov. 2020

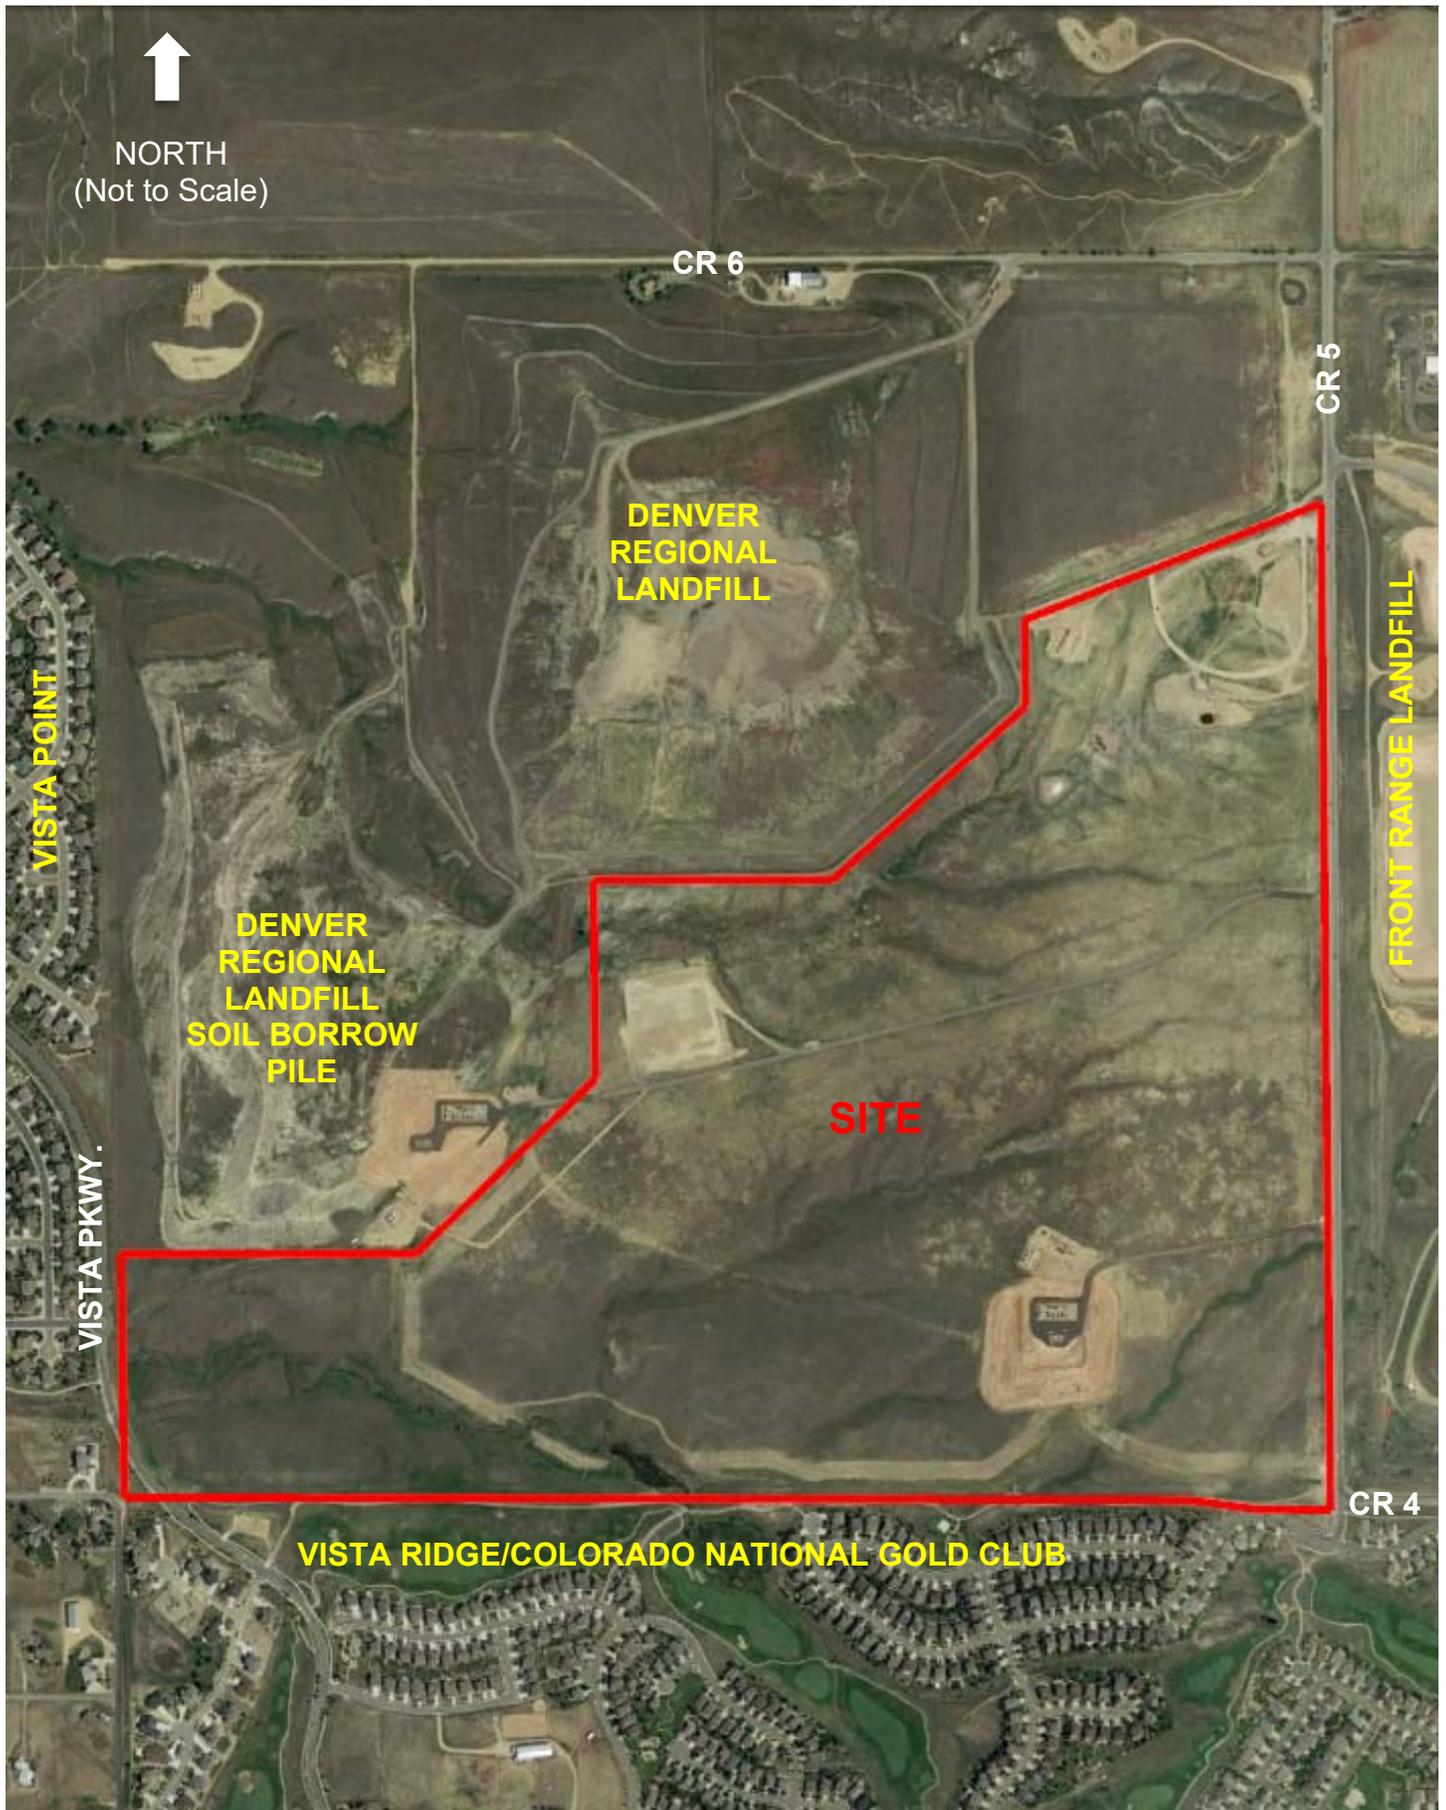
**Figure 2**

EXISTING CONDITIONS AERIAL PHOTO

The 295-acre Site is in the Town of Erie, Boulder County, Colorado. The Site is located within Section 29, Township 1 North, Range 68 West. Please refer to Figure 1, USGS Site Location Map and Figure 2, Existing Conditions Aerial Photo for location and general site conditions. The longitude and latitude of the Site at its center are 105.025000° west and 40.019275° north.

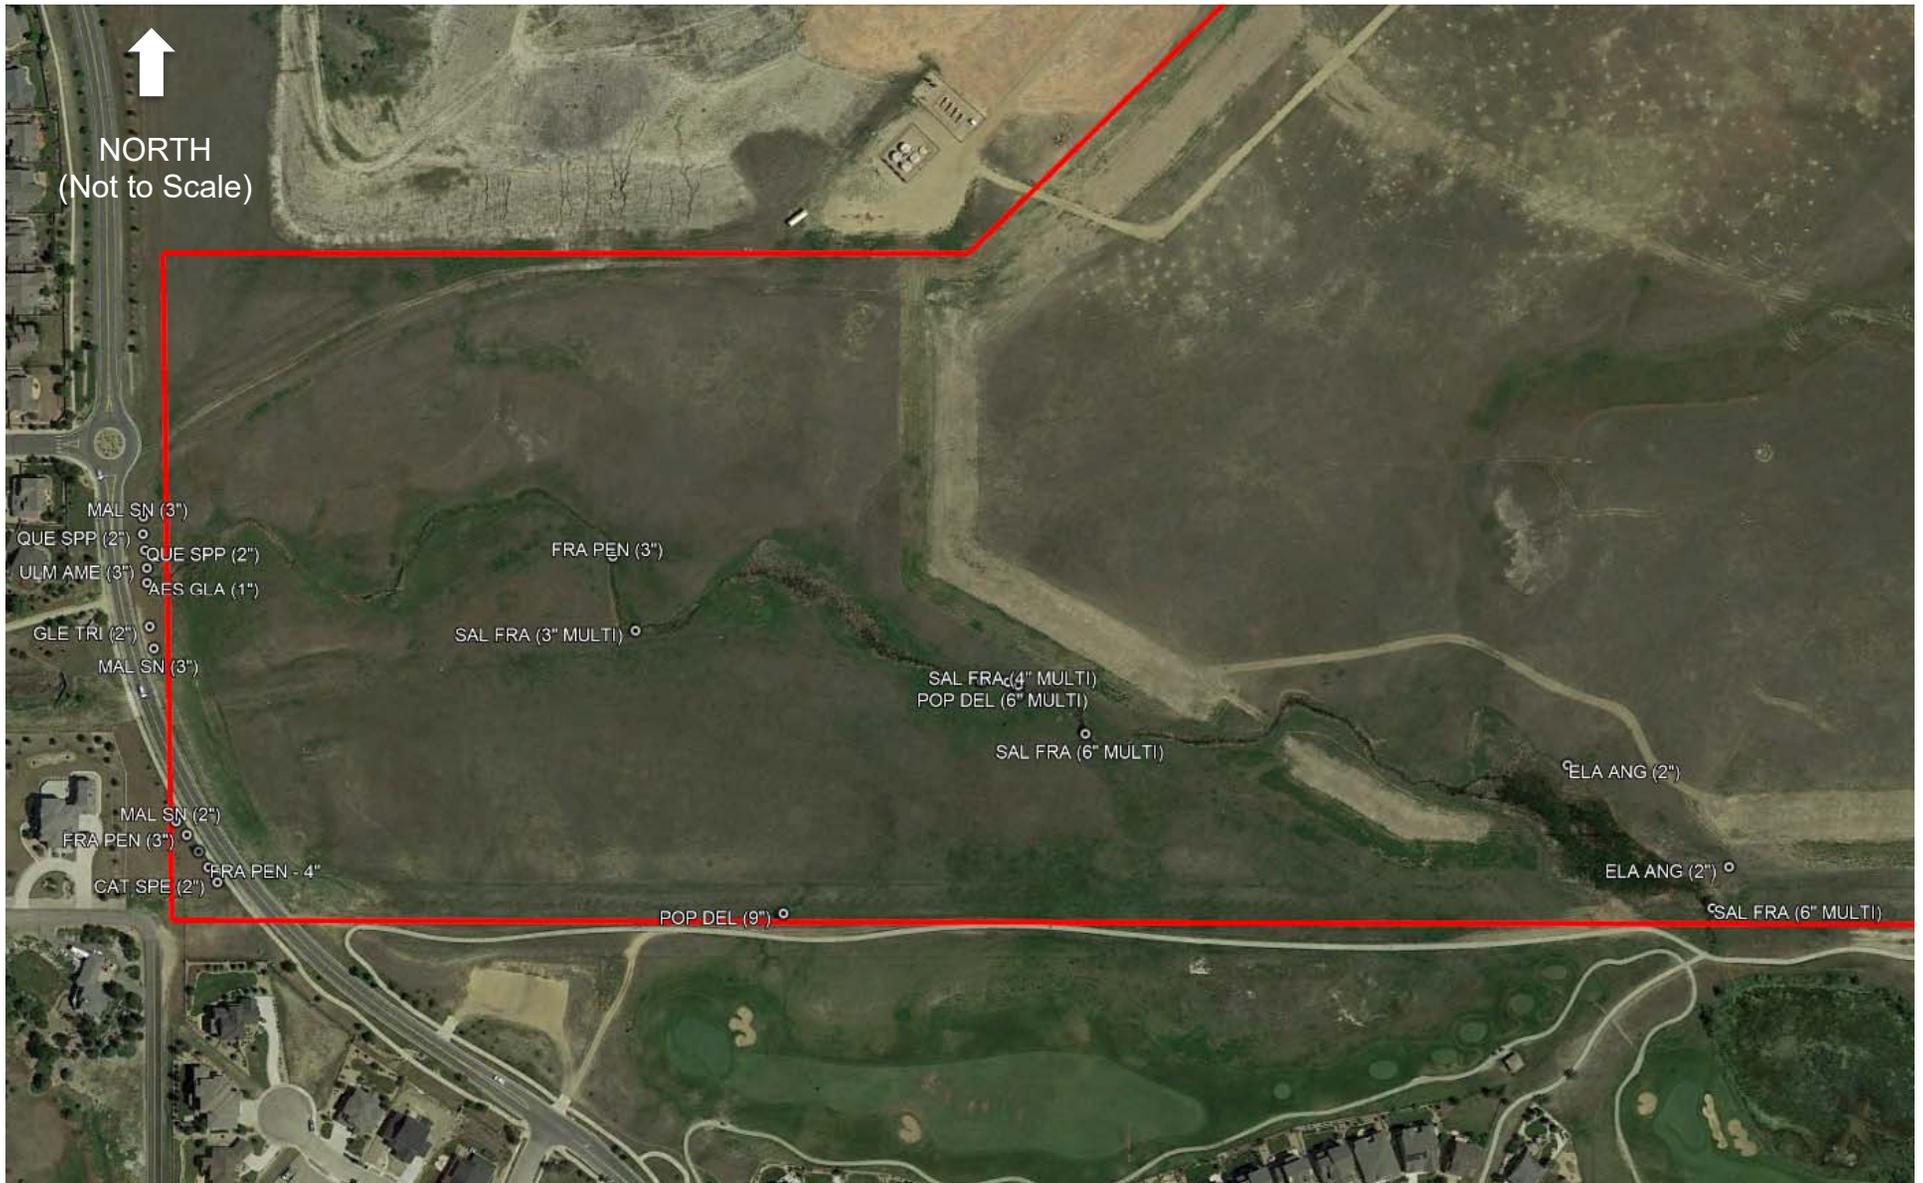
**Figure 4**

NATIVE & SPECIMEN TREE MAP

The current Stratus development plan does not propose impacts to any existing trees on the Site. However, if plans change, all native and specimen trees were inventoried as described below, including those that are under 4-inches diameter at breast height (DBH) such that a Native and Specimen Tree Protection Plan may be prepared. Existing trees are illustrated on Figure 4, Native and Specimen Tree Map.

Please refer to Figure 4, Native and Specimen Tree Map for locations of trees that may provide potential habitat for raptors and migratory birds.

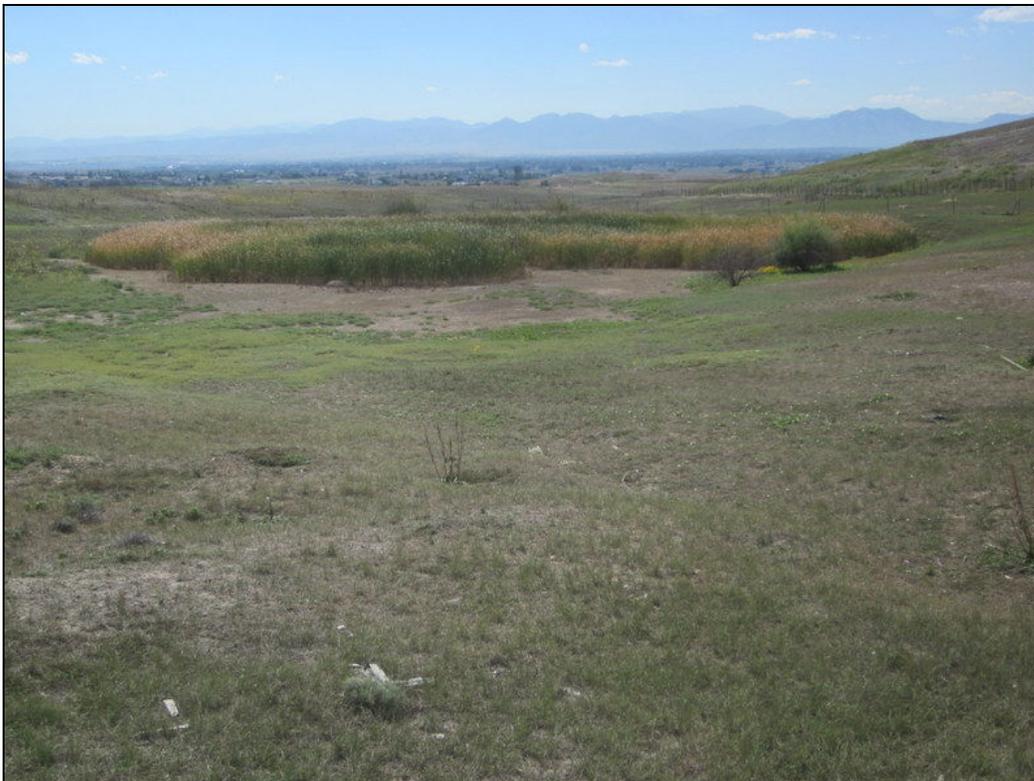
Photo 10: Wetland and Pond B, looking southwest

North Unnamed Tributary Water Features: There are four other water features present in the North Unnamed Tributary, including three ponds and one channel below the seasonal spring (**Photos 10—17 in Appendix B**). All of the ponds (Ponds B, C, and D) are associated with the corresponding wetlands and appear to be hydrologically isolated as a result of the landfill downstream of the study area. They are all man-made and vary in depth. Depth of water during the field visit varied from 6 inches to approximately 3 feet. The ponds appear to be intermittent or ephemeral, and likely only fill with water seasonally or after major precipitation events. Ponds B and C appear to

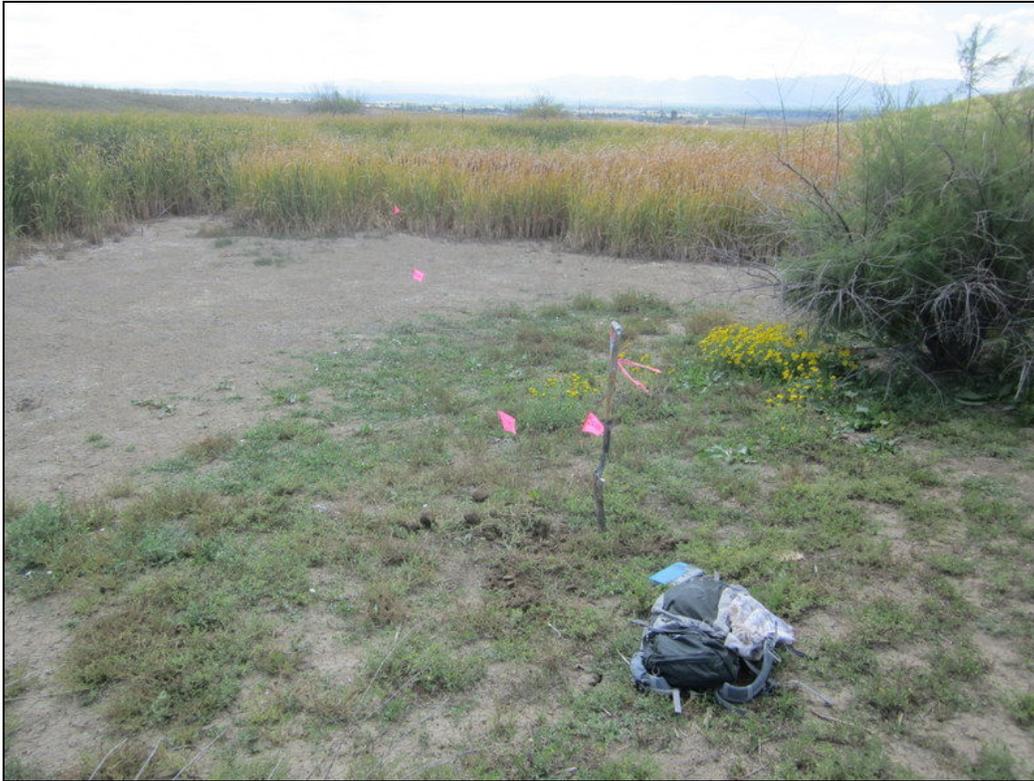
Photo 11: Wetland and Pond B, looking southwest at SP-B2 (double flag)

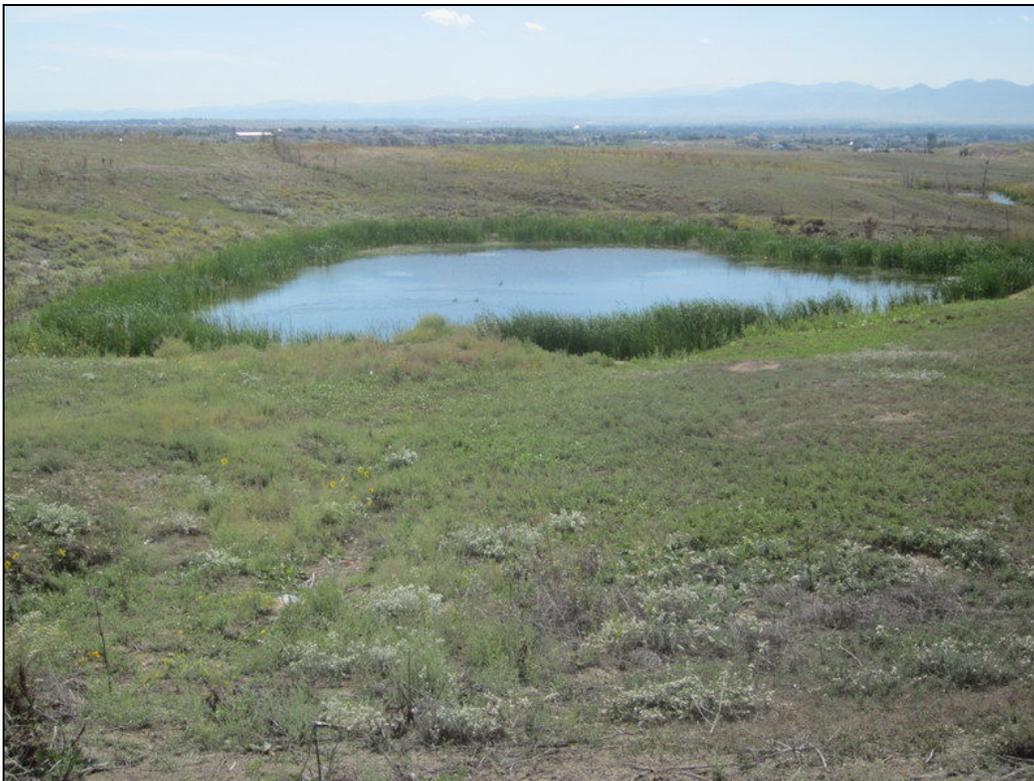
Photo 12: Wetland and Pond C, looking southwest from the Pond B dam

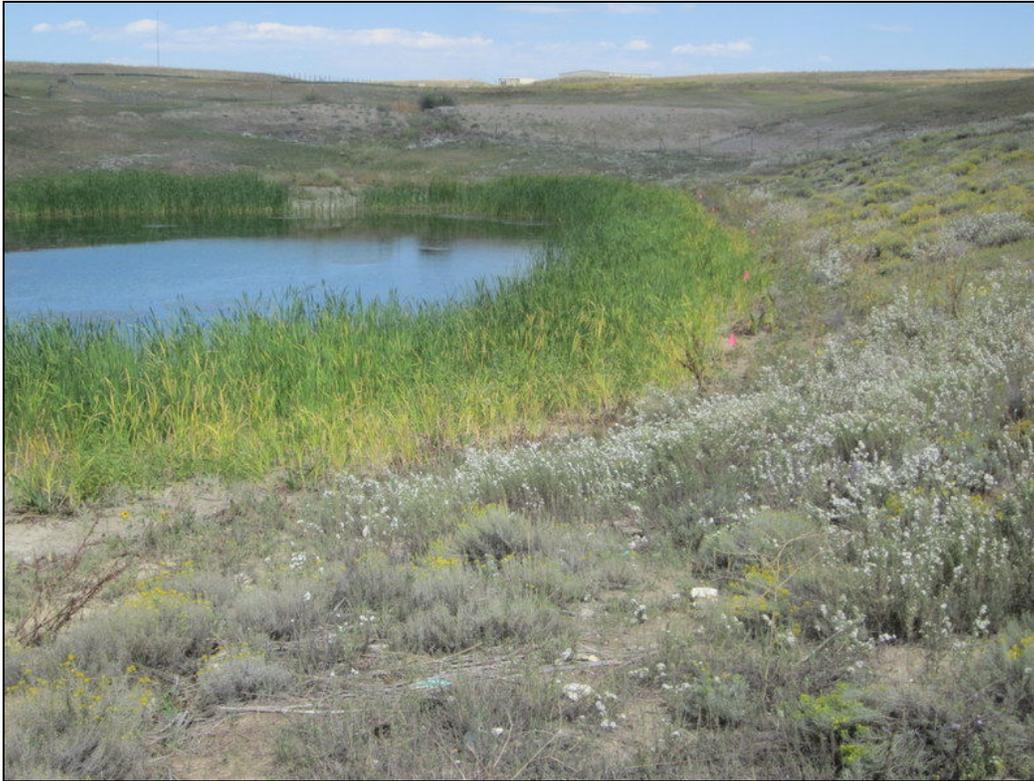
Photo 13: Wetland and Pond B, looking northeast

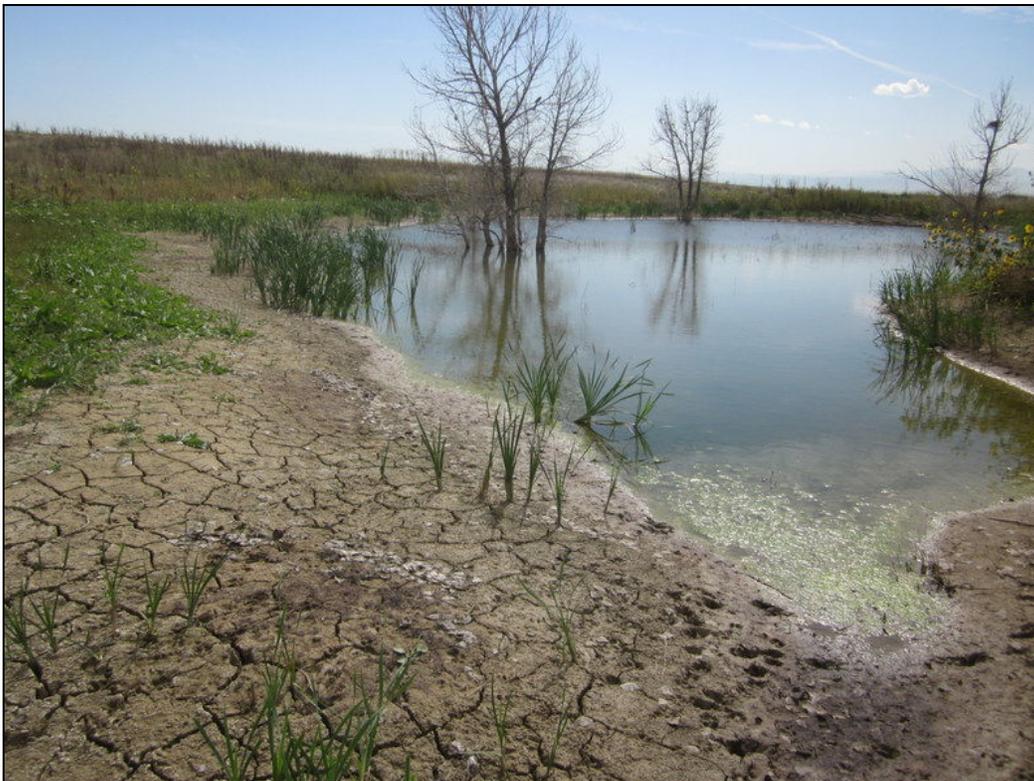
Photo 14: Pond C, looking southwest from the inlet

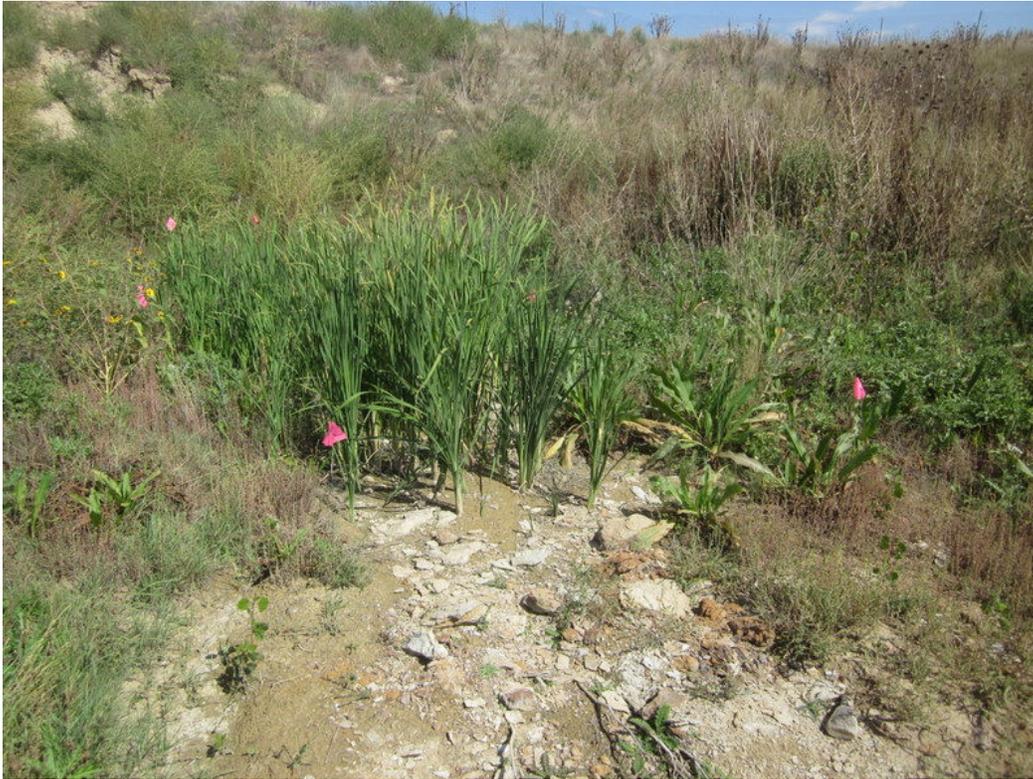
Photo 15: Wetland below Pond C, looking northeast

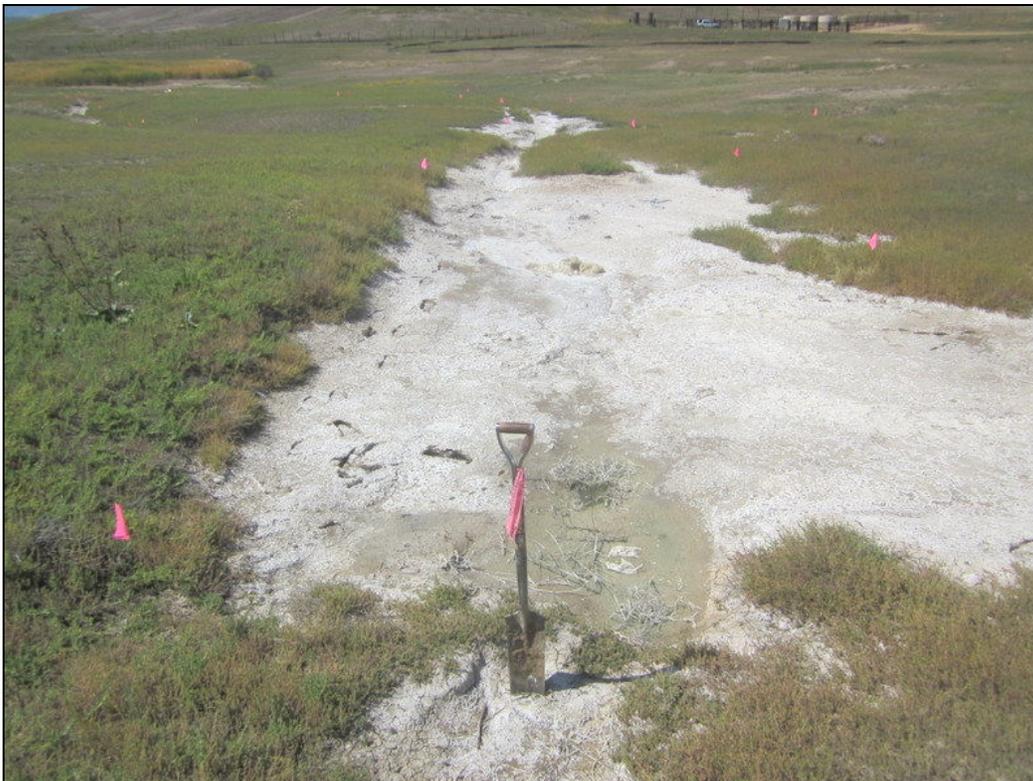
Photo 16: Start of Channel B (at spring; marked by shovel), looking west

The channel in this tributary connects the seasonal spring to Pond B and is intermittent or ephemeral. There are substantial salt deposits present at the spring, along the flatter parts of the channel, and in Pond B (**Photos 16 and 17 in Appendix B**), indicating the evaporation of standing water. The channel has a clay bottom and is very narrow, with an average width of around 2 feet. It flows from east to west and terminates in Pond B.

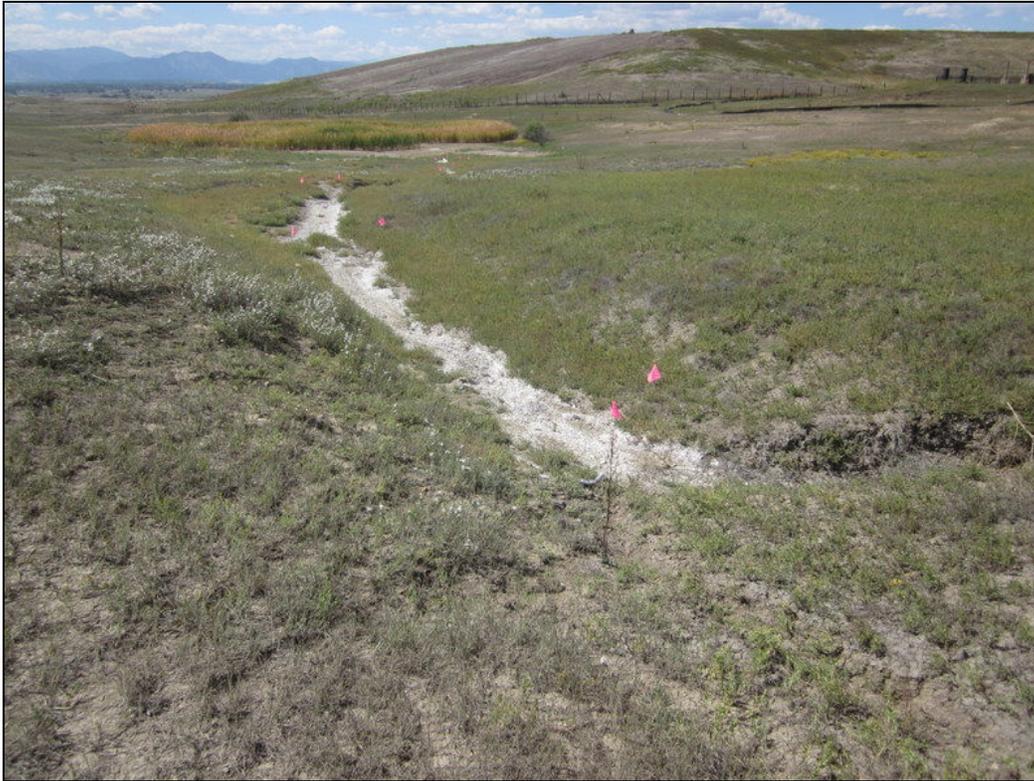
Photo 17: Channel B between spring and Pond B, looking southwest

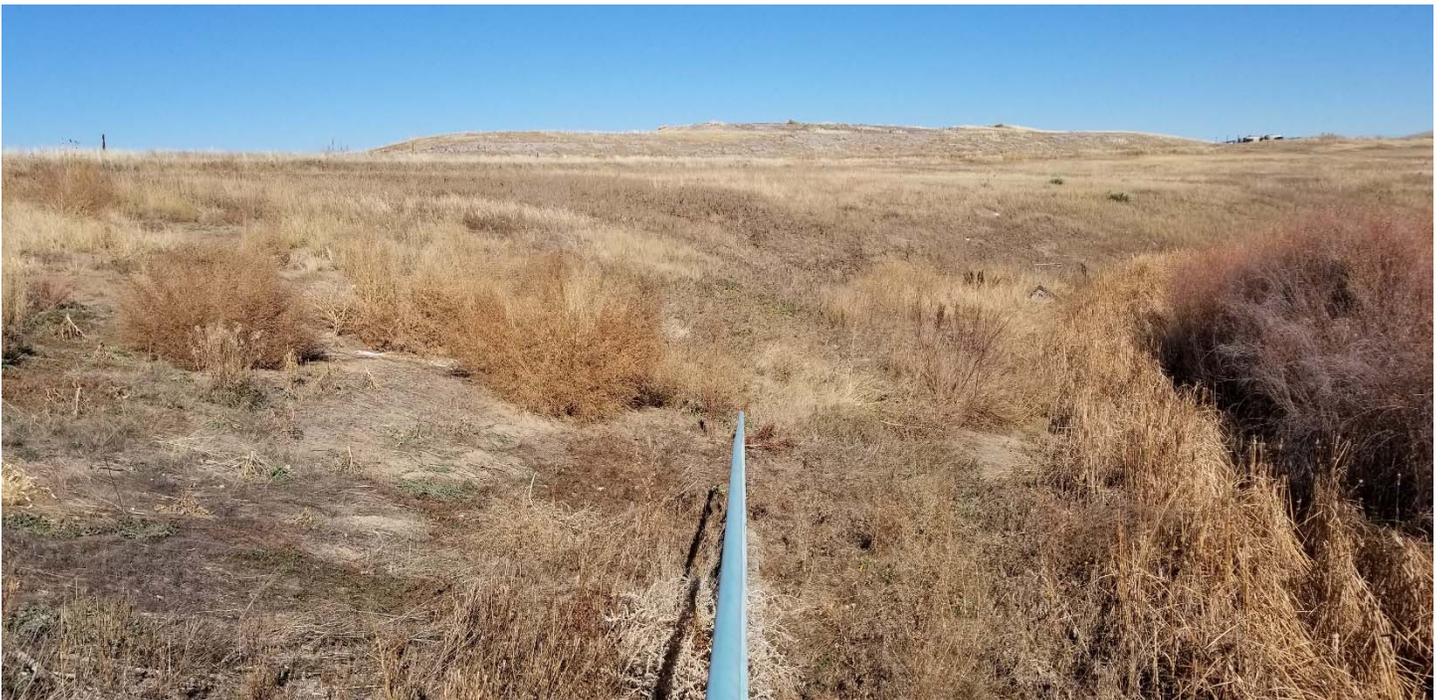
Photo Point #10: View northeast of southern channel/wetlands and abutting midgrass prairie at Vista Parkway culvert from western property line.

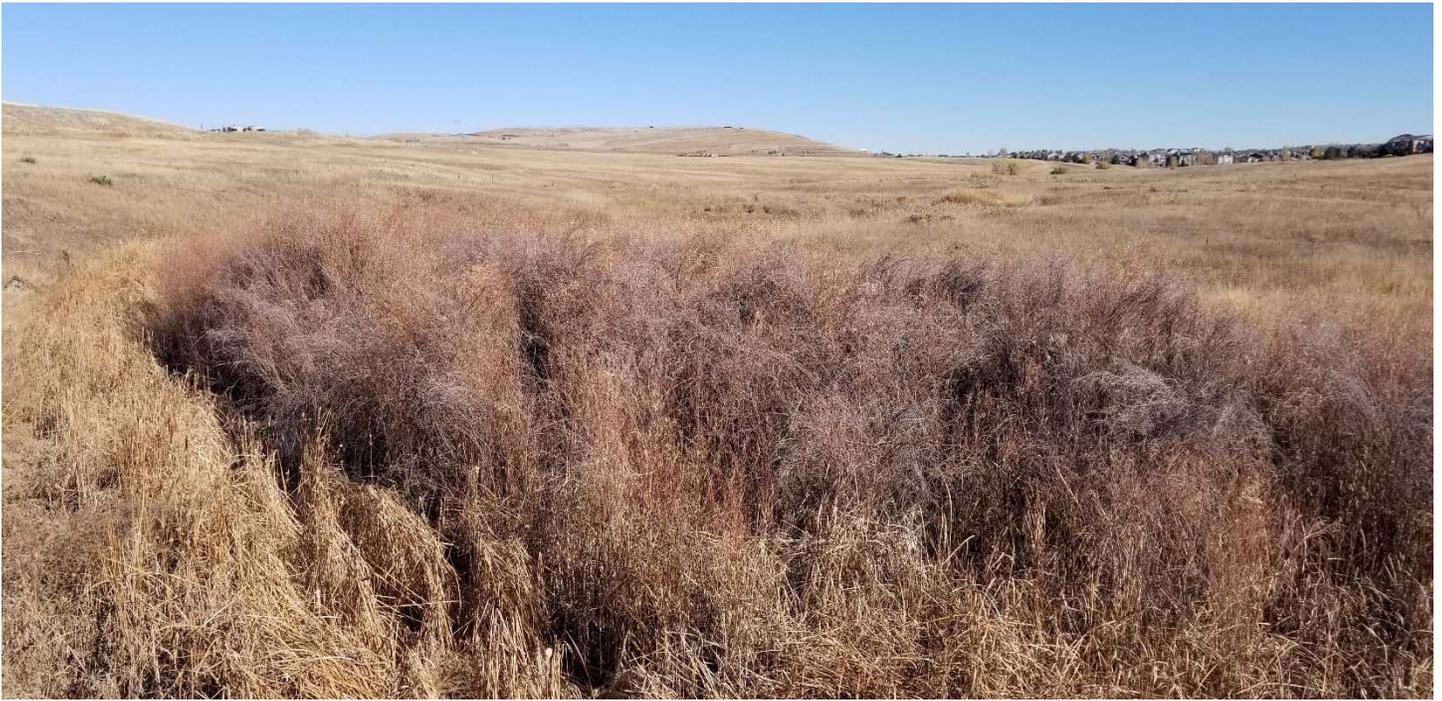
Photo Point #10: View east of southern channel/wetlands and abutting midgrass at Vista Parkway culvert from western property line.

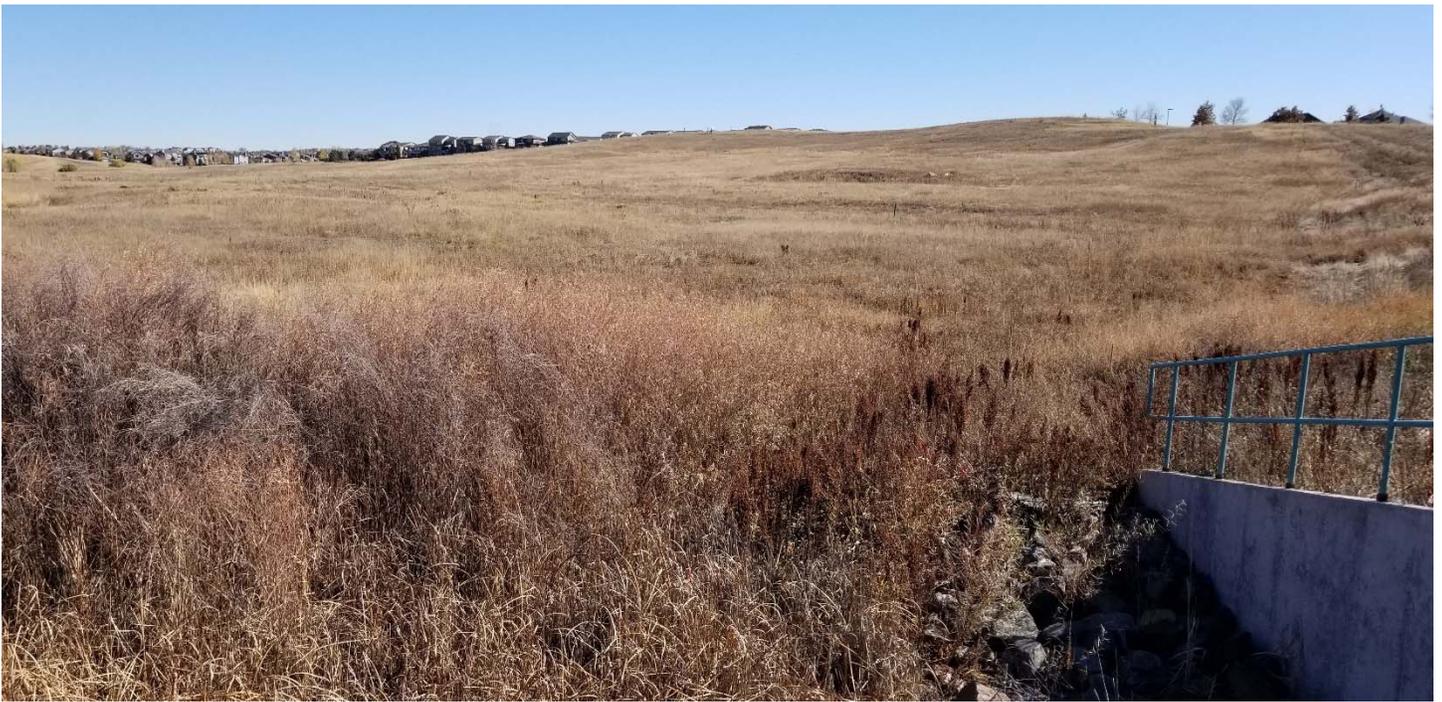
Photo Point #10: View southeast of southern channel/wetlands and abutting midgrass at Vista Parkway culvert from western property line.
