TOWN OF ERIE

LAND USE APPLICATION

PROJECT/BUSINESS NAME: Proposed Unnamed Community

PROJECT DESCRIPTION: Sketch Plan application for the proposed development of a mixed use community comprised of single-family, attached homes and commercial uses. The total number of proposed residential units is 800 with approximately 6 acres of commercial and mixed-use area..

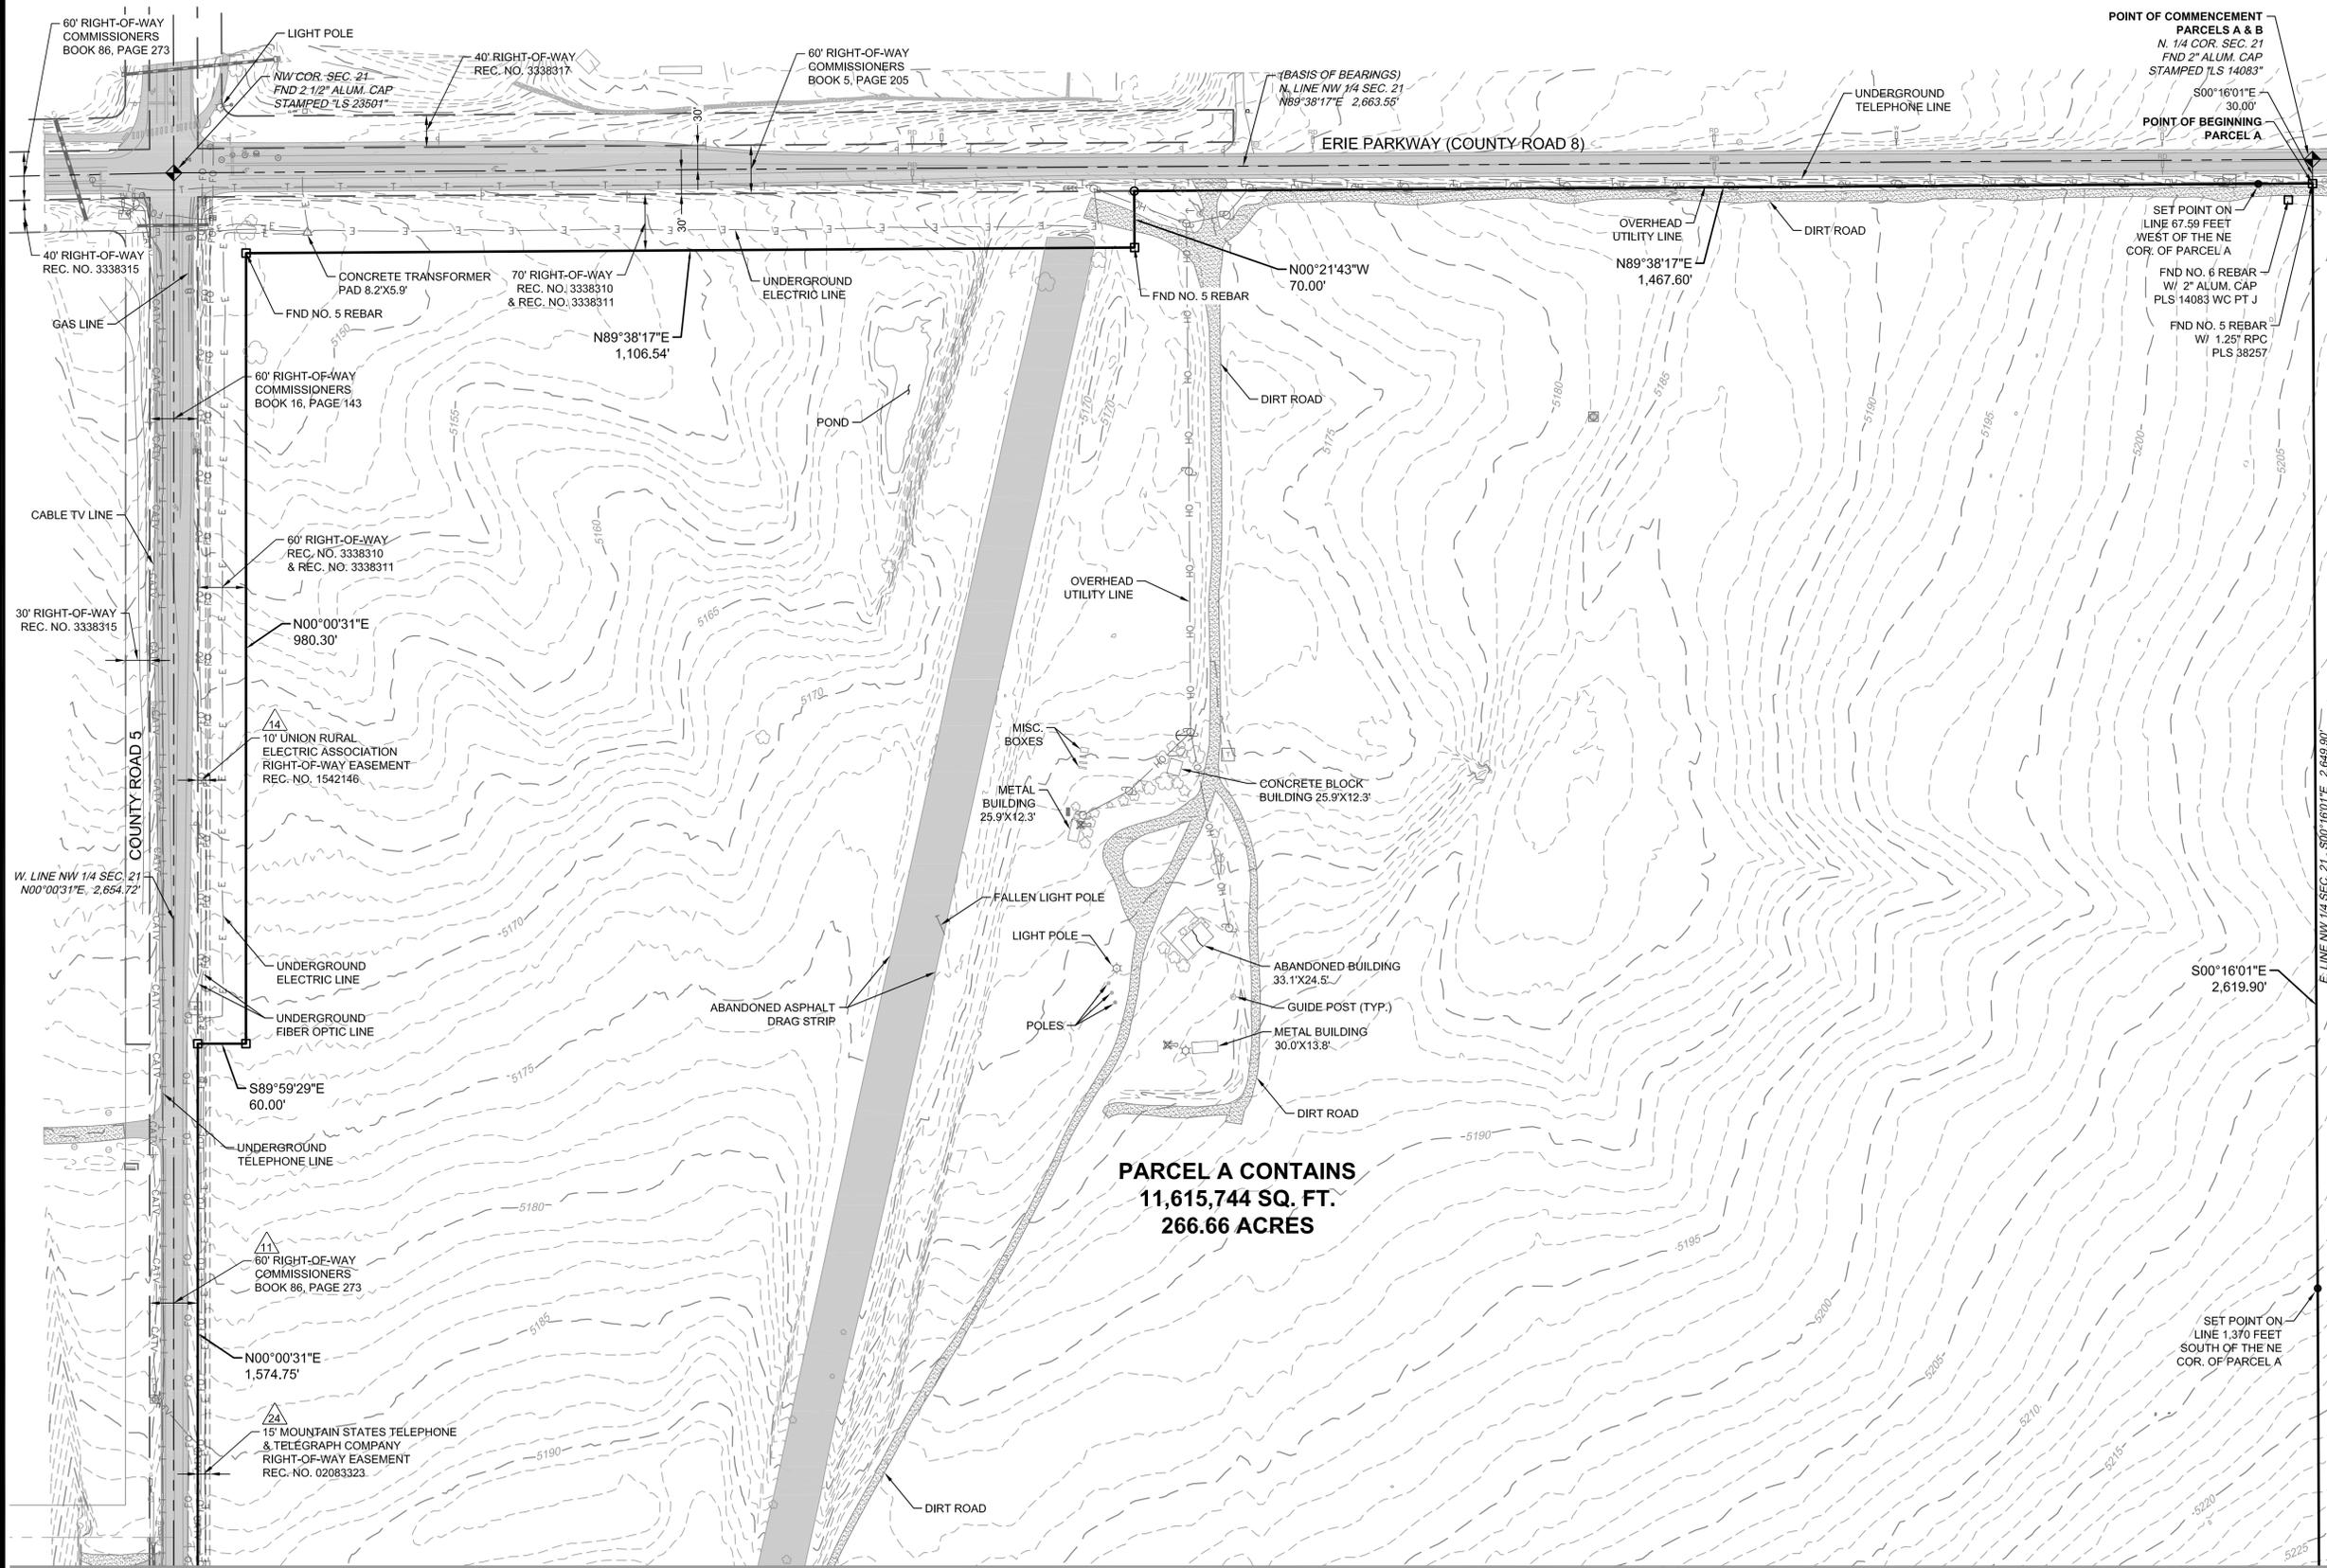
LOCATED IN THE WEST HALF OF SECTION 21, TOWNSHIP 1 NORTH, RANGE 68 WEST OF THE SIXTH PRINCIPAL MERIDIAN,
TOWN OF ERIE, COUNTY OF WELD, STATE OF COLORADO
SHEET 3 OF 5

**PARCEL A CONTAINS
11,615,744 SQ. FT.
266.66 ACRES**

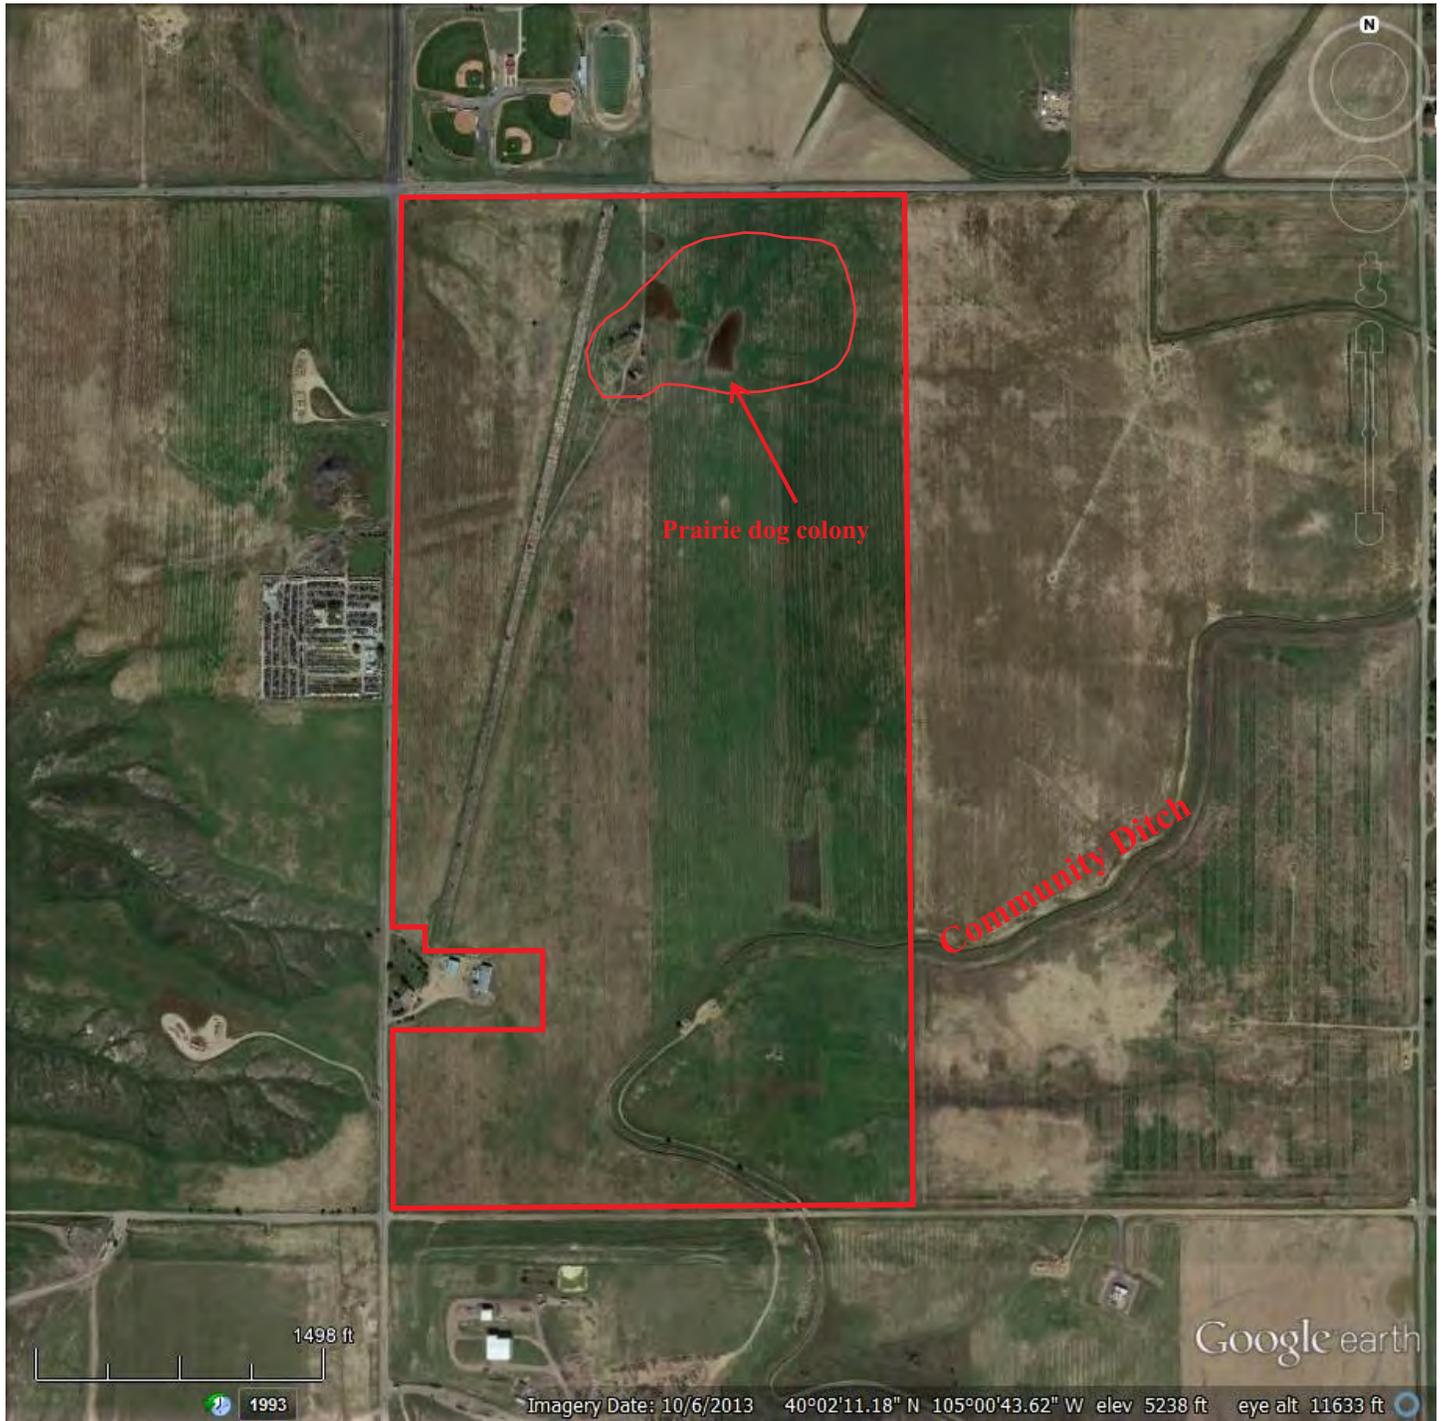
Figure 1 - Project Location Map
306 Acres in the West 1/2 of Section 21,
Township 1 North, Range 68 West,
Erie, Colorado 80516

Aerial Photograph from GoogleEarth

This General Ecological Resource Survey was conducted for approximately 306 acres of agricultural land in the west ½ of Section 21, Township 1 North, Range 68 West, of the 6th P.M., in incorporated Erie, Colorado (Figure 1). The site is located southeast of the intersection of Erie Parkway and Weld County Road 5. The southeastern portion of the property is bisected by the Community Ditch (Figure 2). According to the Weld County Assessors Office, the property is zoned for agricultural use. The majority of the site is currently in active cultivation. A burned-out house, two abandoned sheds and a sheet metal stable are present on the property. High tension electric transmission power lines run diagonally across the southwestern corner of the site in a southeast to northwest direction. High pressure natural gas lines run adjacent to the property along Weld County Roads 5 and 6. Also, a buried fiberoptic cable follows the boundary of the property on the west and north along Weld County Road 5 and Erie Parkway. Records maintained by the Colorado Oil and Gas Conservation Commission (COGCC) identify one petroleum production site and associated ancillary equipment located near the Community Ditch at the southern end of the property. A single family residence borders the property on the west, and the adjoining property to the east is in agricultural use.

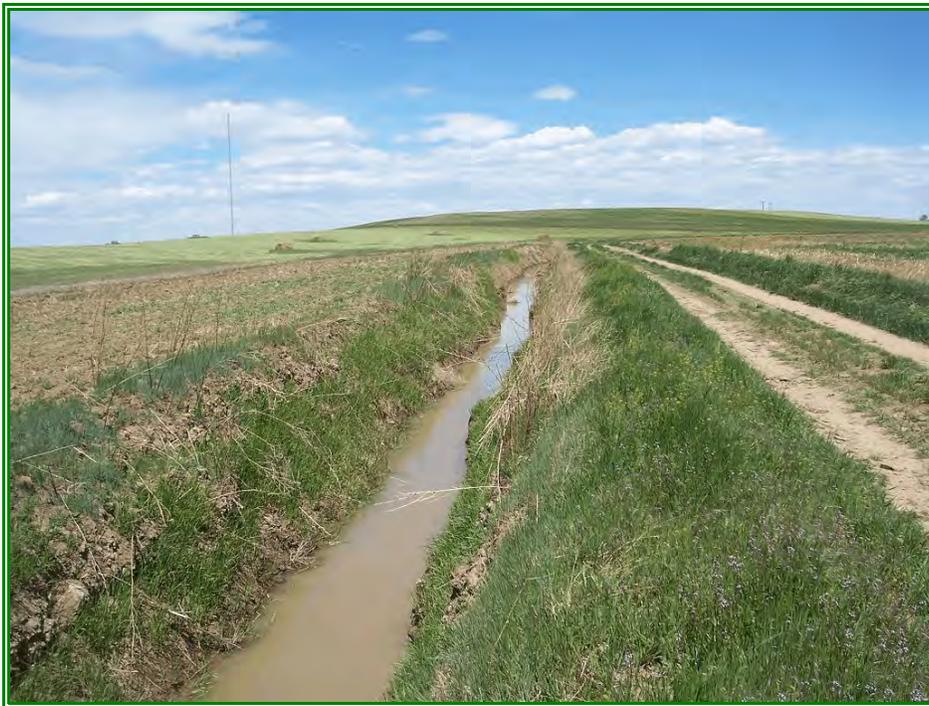
Community Ditch view to northeast

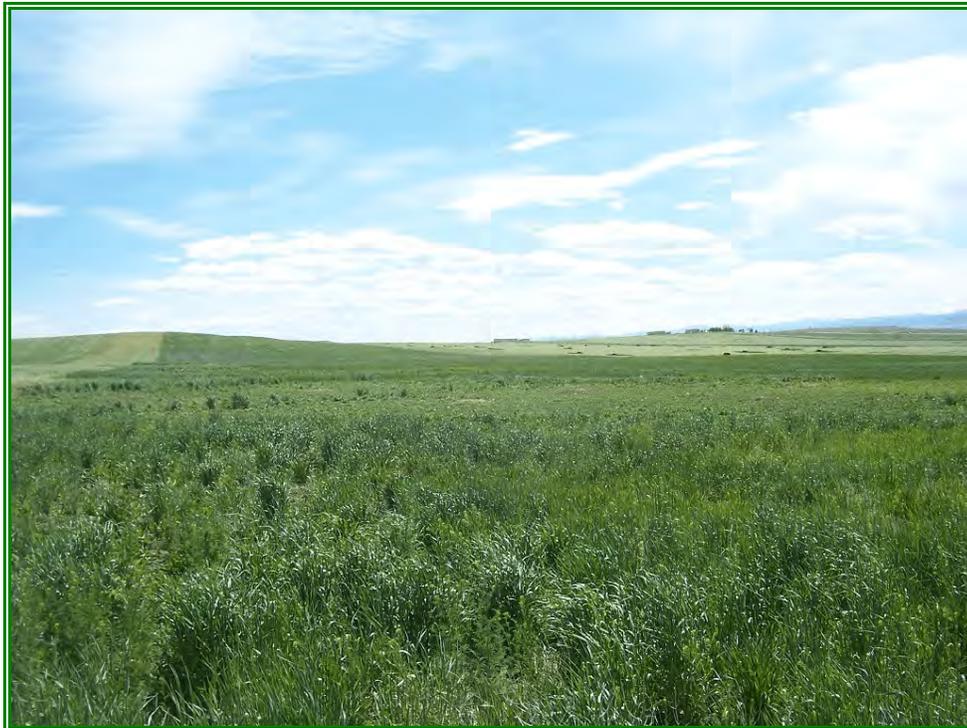
Prairie dog colony along Erie Parkway

This migratory species is most often seen in Colorado during the summer months. During the inspection a large active prairie dog colony was observed on the northern end of the subject property. **Due to the existence of the active prairie dog colony, a burrowing owl survey will be required if construction occurs during nesting season between March 15th and October 31st.**

Due to the presence of the prairie dog colony a burrowing owl and mountain plover survey will be required if construction occurs during nesting season between March 15th and October 31st. The survey procedures should follow the recommendations contained in the Colorado Division of Wildlife (DOW) “Recommended Survey Protocol and Actions to Protect Nesting Burrowing Owls”. The prairie dog colony will need to be “humanely” removed prior to development.

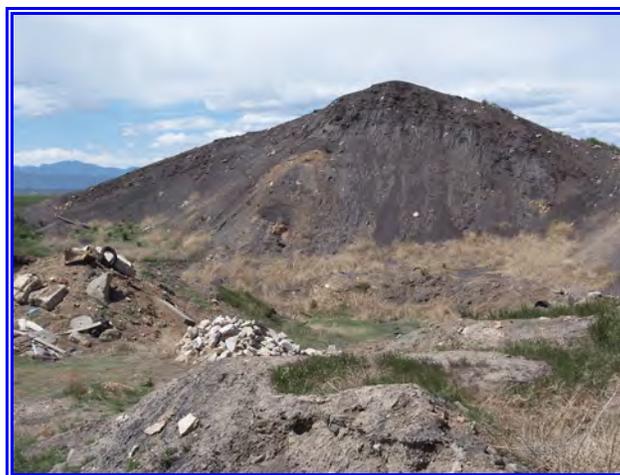
Waste pile Boulder Valley #1

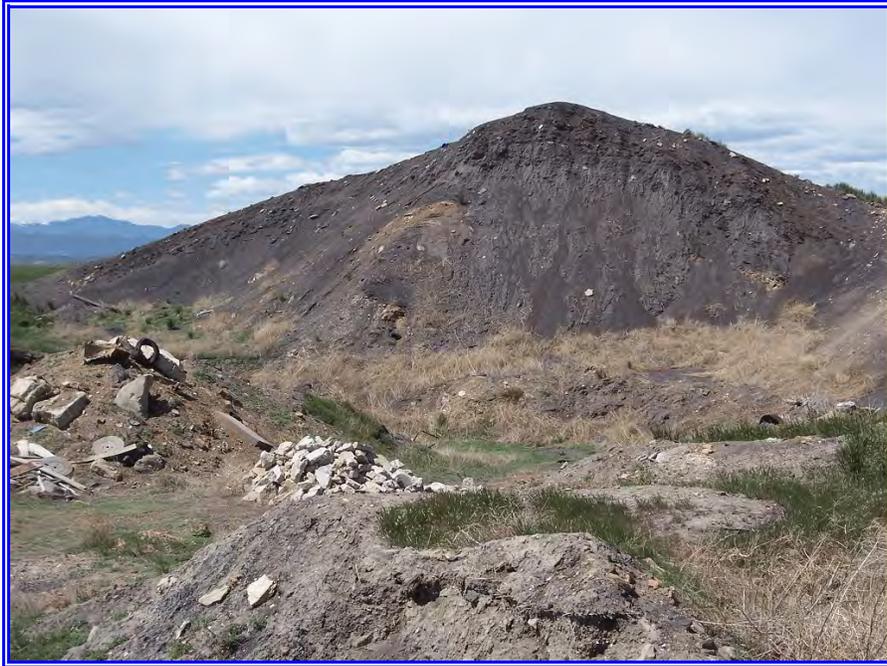
Coal waste from Boulder Valley #1 Mine west of site

Records from the Colorado Division of Mines and the Colorado Geologic Survey show the “Columbine” Mine began operation in 1920 and continued until 1946. Total production from all operations was placed at 7, 216,286 tons. Entry to the mine was gained via a 300 foot deep, two compartment production shaft 3,500 feet to the southwest.

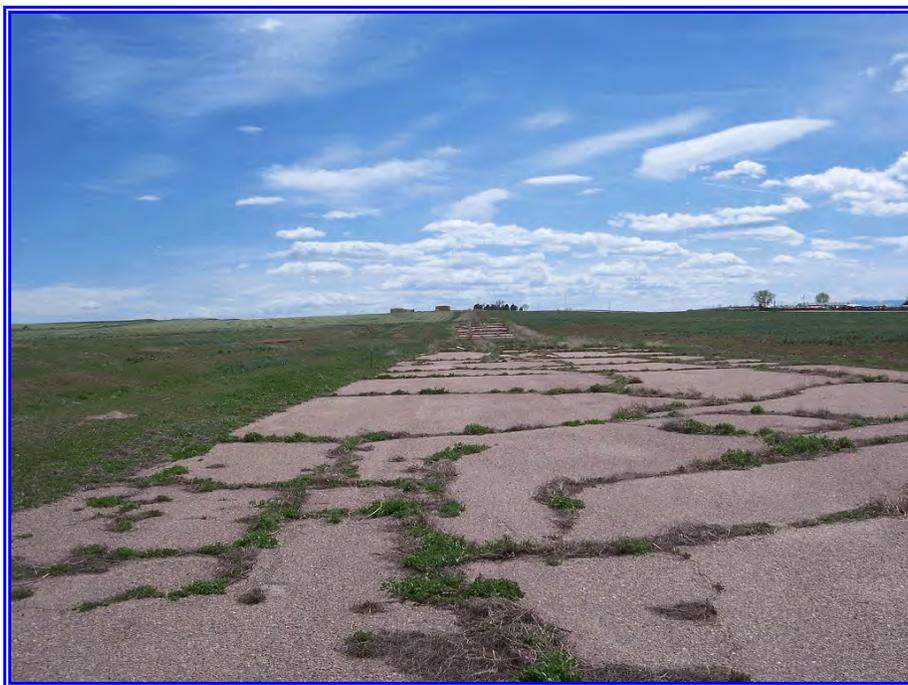
Mountain View drag strip view to southwest, residence shown in center

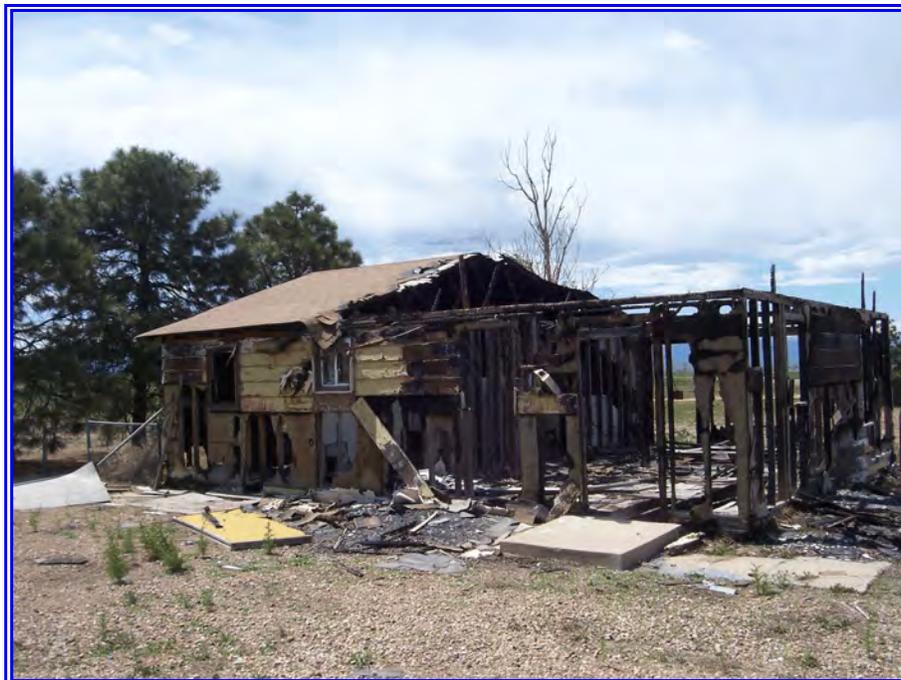
Burn-out residence adjacent to drag strip

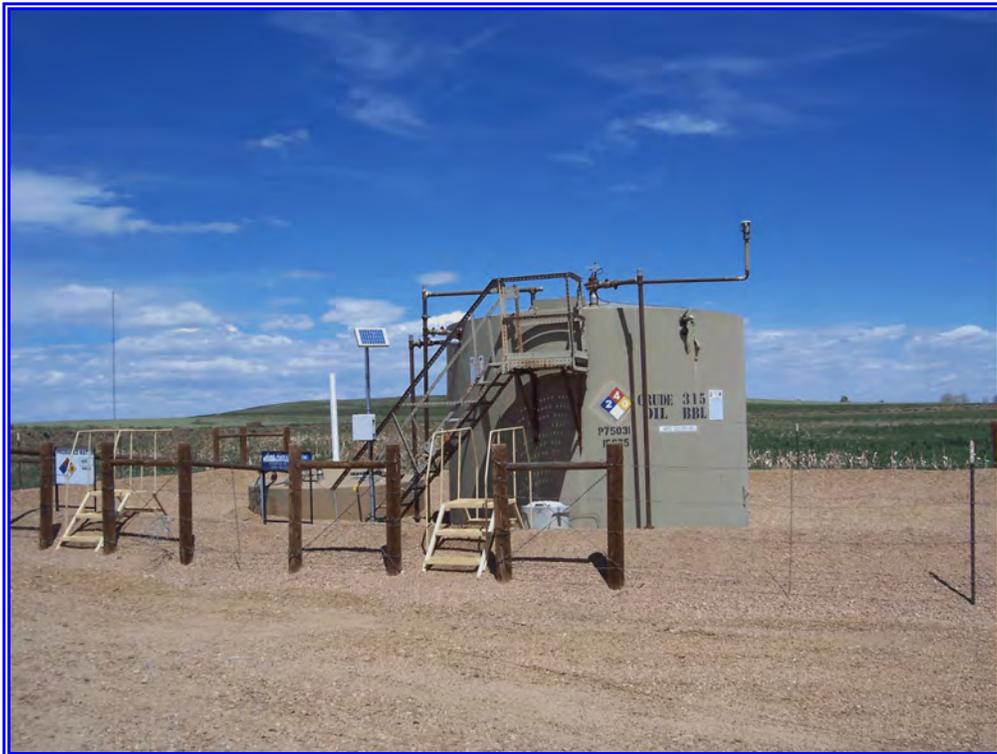
Crude oil storage tank for Champlin 86 Amoco Unit L #1

Facility ID	Facility Name	Operator	Status	Releases or Violations
05-123-12613	Champlin 86 Amoco Unit L#1	Kerr-McGee	Producing	None

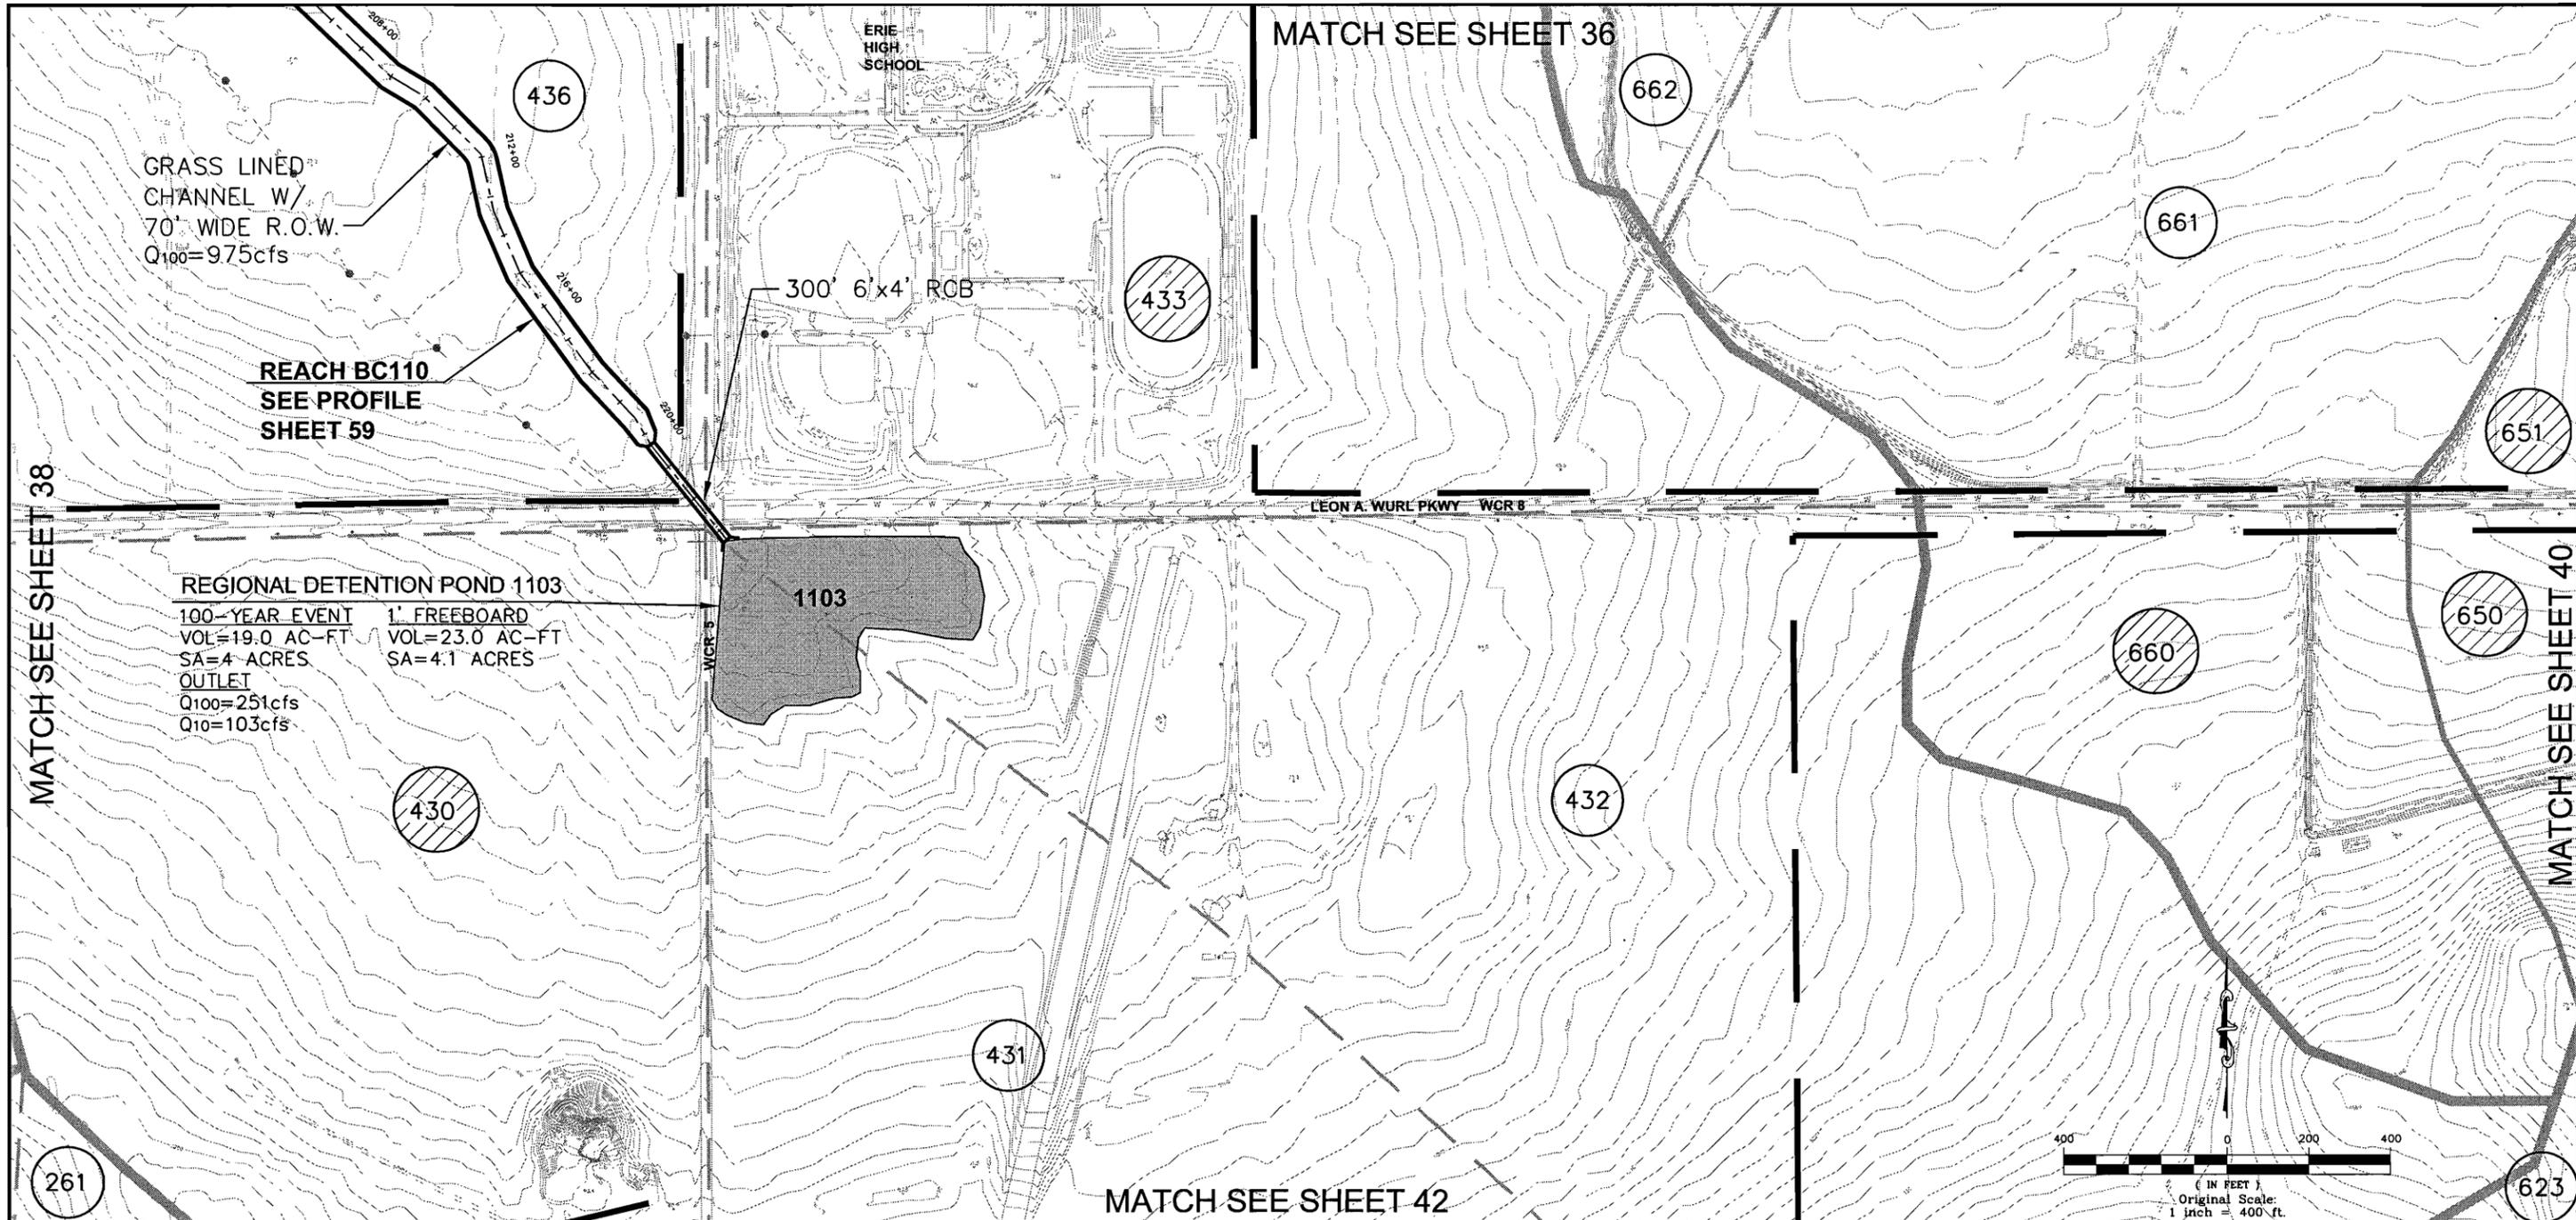
REGIONAL DETENTION POND 1103
 100-YEAR EVENT VOL=19.0 AC-FT
 SA=4 ACRES
 OUTLET Q100=251cfs
 Q10=103cfs
 1' FREEBOARD VOL=23.0 AC-FT
 SA=4.1 ACRES

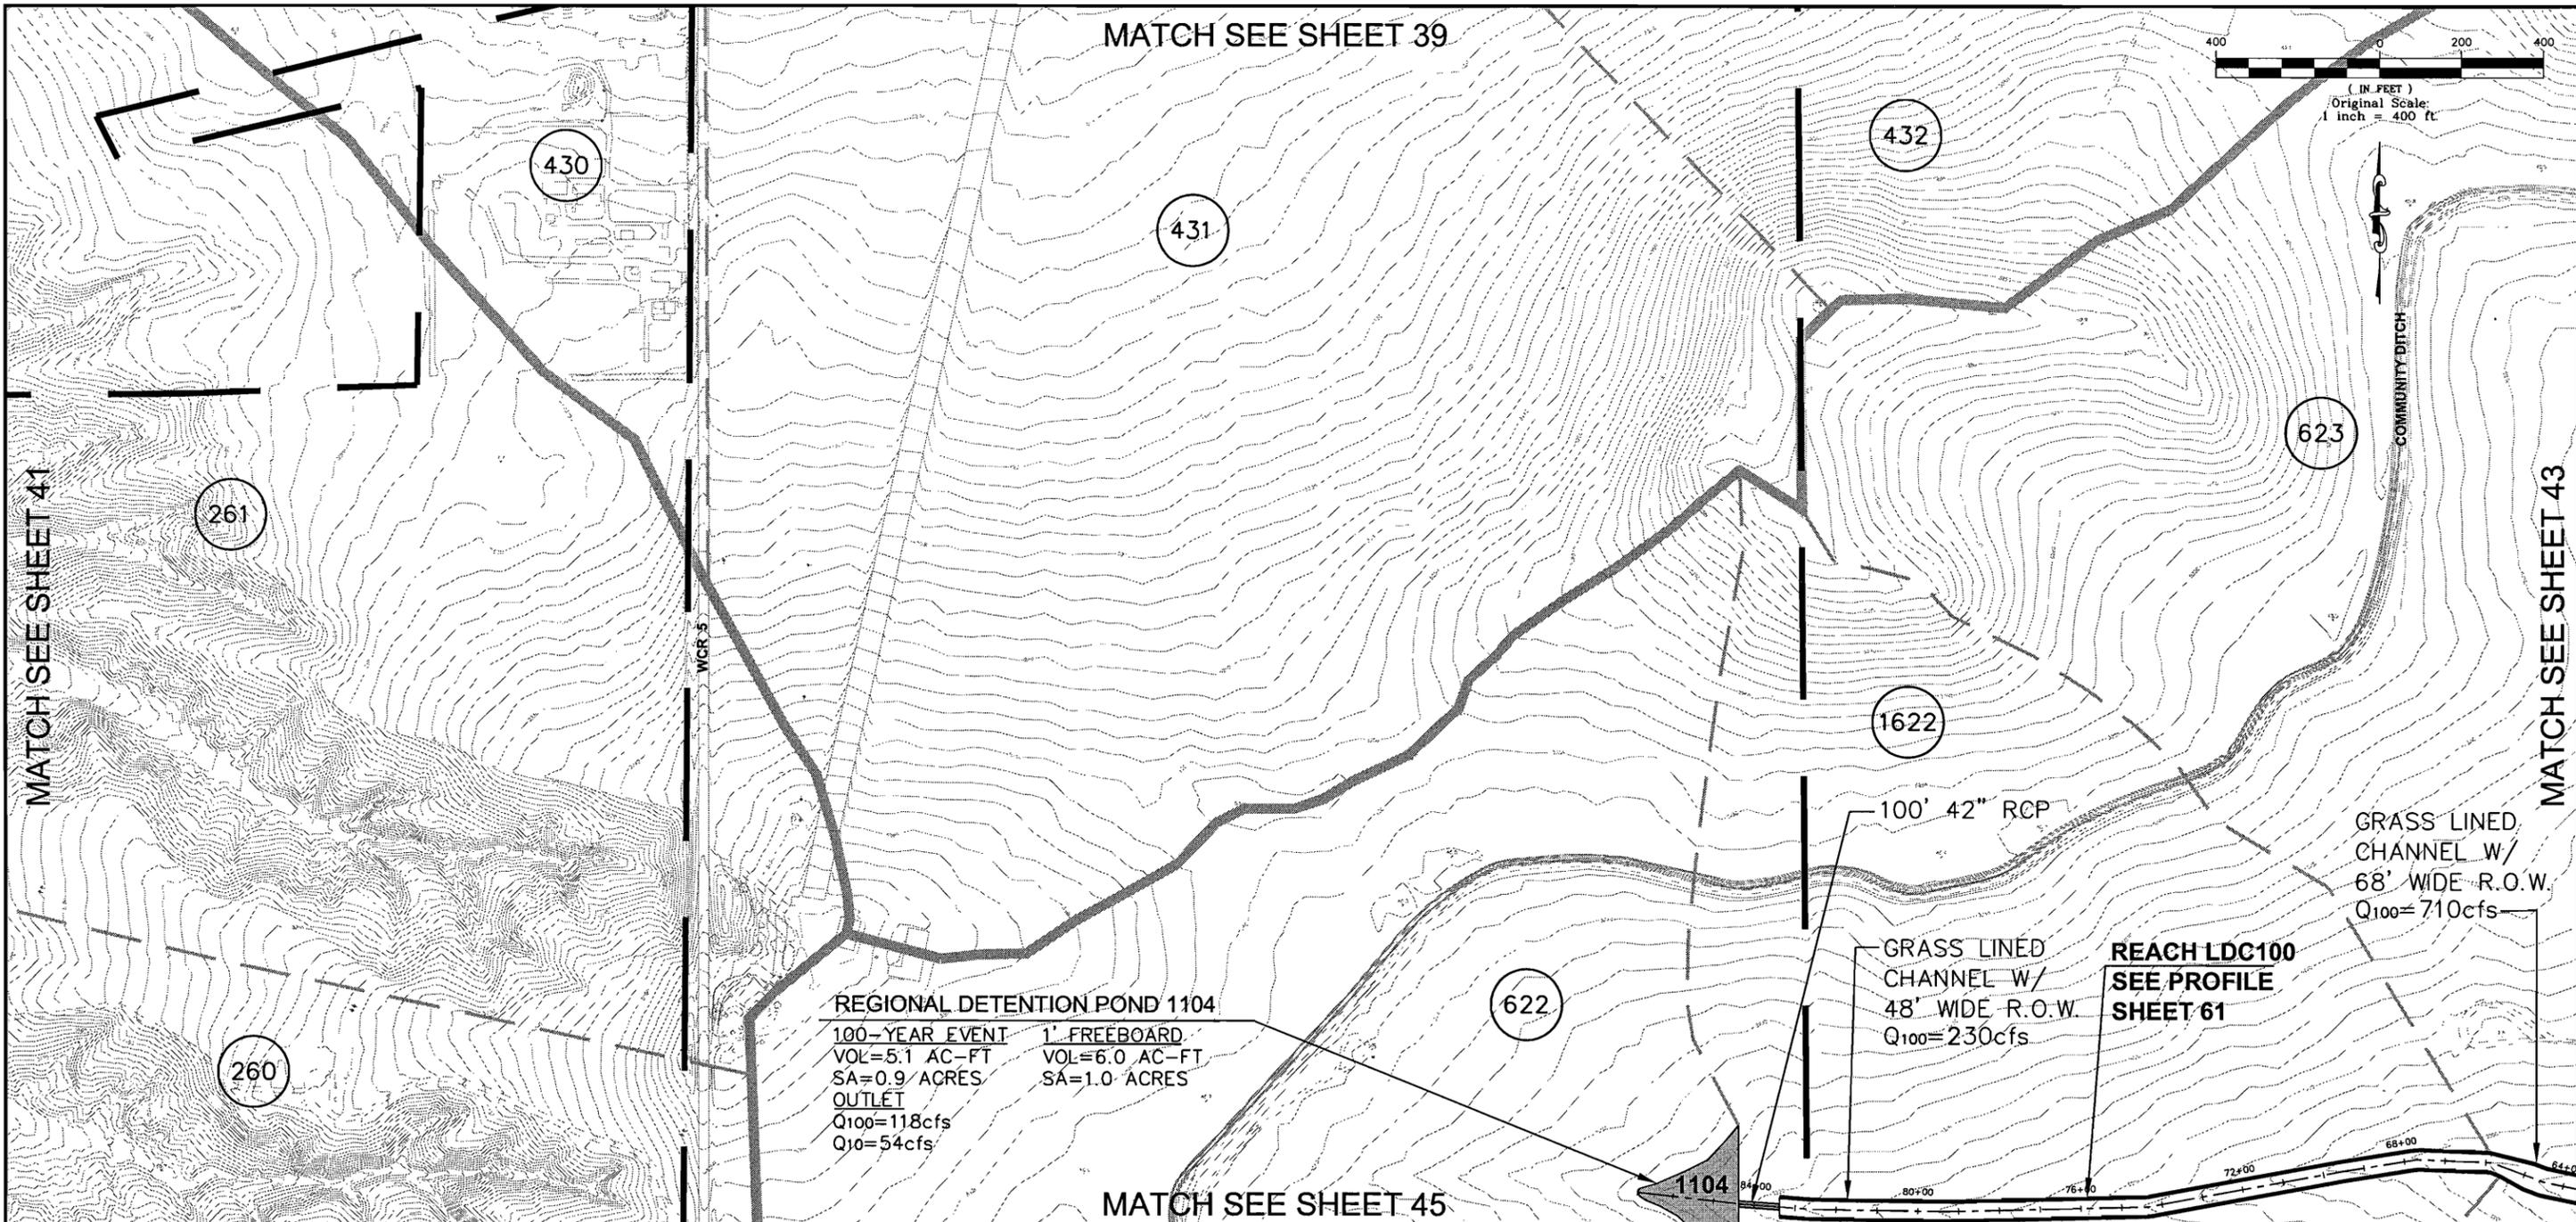
REGIONAL DETENTION POND 1104
 100-YEAR EVENT VOL=5.1 AC-FT
 SA=0.9 ACRES
 OUTLET Q100=118cfs
 Q10=54cfs
 1' FREEBOARD VOL=6.0 AC-FT
 SA=1.0 ACRES

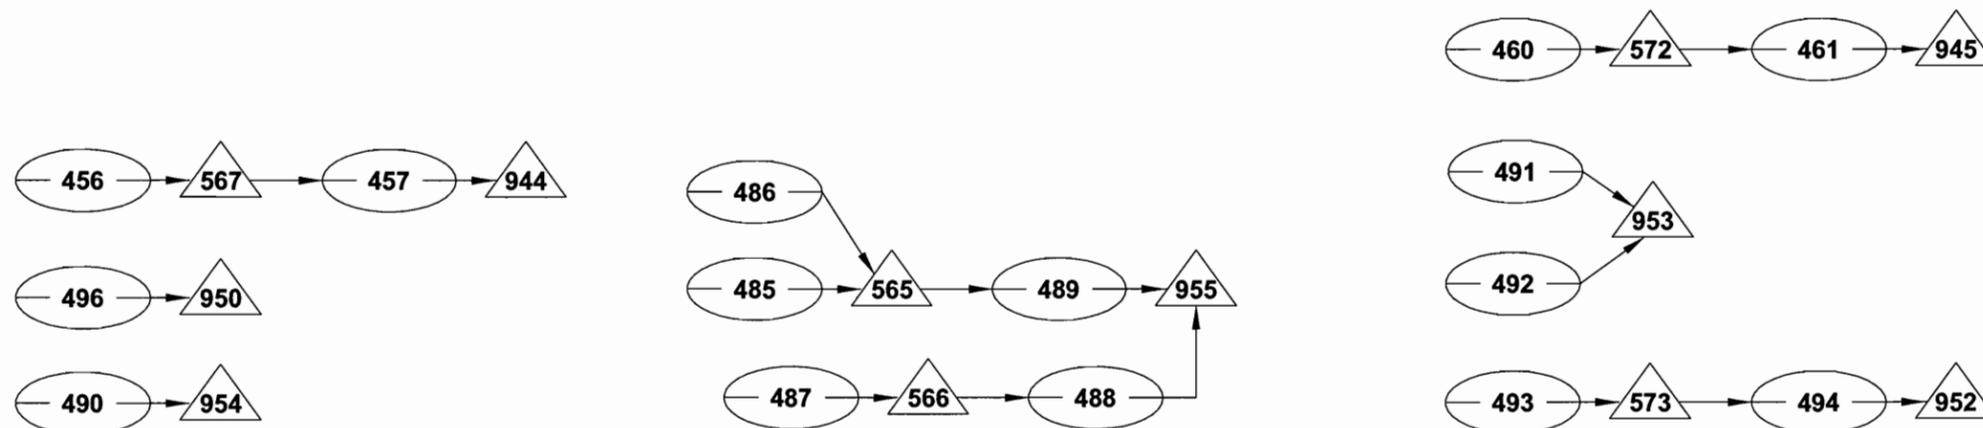
BOULDER CREEK TRIBUTARIES (AREA EAST OF BOULDER CREEK)
