James Enterprises Inc.  
- Archaeologists -  
P.O. Box 1064, Ft. Collins, CO 80522  
(970) 484-3335

**CLASS III CULTURAL RESOURCE SURVEY OF THE PROPOSED  
ANDALUSIA RESIDENTIAL DEVELOPMENT, WELD COUNTY, COLORADO**

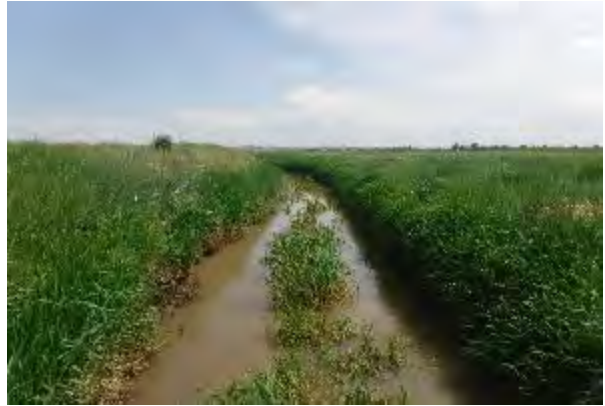
**Photo 8.** View south of Cottonwood Extension Ditch within the survey area. This ditch contained herbaceous vegetation within the ditch bottom and the banks appeared to be regularly burned to remove vegetation which is evident in this photo.

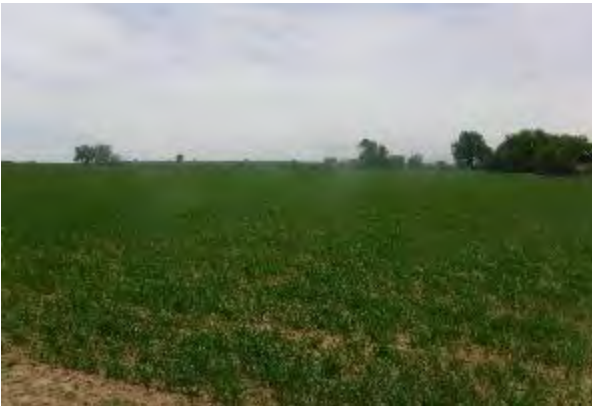
**Photo 9.** View north of Cultivated Cropland vegetation community consisting entirely of planted wheat row crops in the northeast portion of the survey area.
