ASSESSMENT OF IMPACT REPORT

NORTH WESTERLY

This impact report is provided to the Town of Erie, Colorado, as required in the PD Zoning Development Guide. North Westerly is approximately 390 acres located within the Town of Erie, owned by: Southern Land Company.

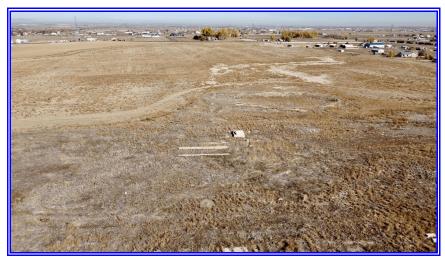
View to north showing 230 kv powerline, Community ditch, and mine debris

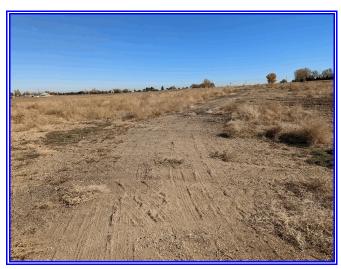
NOAA site

Western Environment reviewed the provided previous Phase I Environmental Site Assessment, Performed by Terracon Consultants, Inc., dated July 1st, 2008. This report (attached) identified a leaking pad mounted transformer located adjacent to the NOAA tower and petroleum production as REC's. No evidence of the transformer or stained soil were observed during this assessment.

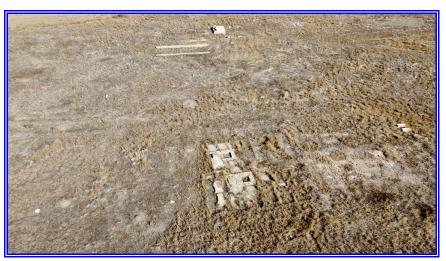
Clayton Mine debris

1) surrounded by a temporary construction barrier, was present in the northwestern portion of the site. At the time of the inspection a "work over" rig was operating within the barrier. Concrete foundations and **debris** from the abandoned Clayton Mine was present in just east of the Community Ditch (Figure 2). Debris included broken concrete, metal, bricks and wire. This area had been left uncultivated due to the amount of trash and **mine waste consisting of coal and clinker (oxidized coal)**. What appeared to be a mine runoff holding pond was observed to the north of the abandoned coal load out rail spur.

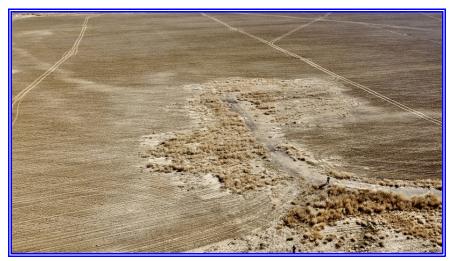
Aerial view of NOAA site

Western Environment inspected the location of the support and equipment building associated with the NOAA tower site. No structures were observed with only crushed rock road base and small (less than 2-3 inches) plastic and ceramic debris, likely electric insulators used to protect the tower from lighting strikes.

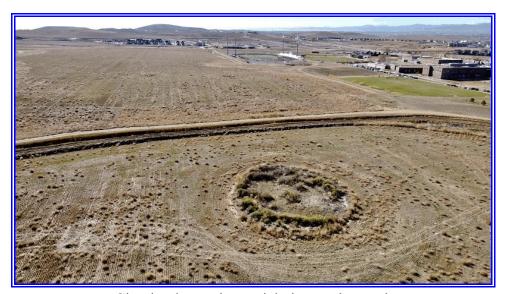
Circular depression aerial view to the south

Directly south of the Clayton Mine site, a large circular depression was observed in aerial views. Upon inspection, this depression was filled with **debris** including automotive parts, tires, bed springs and wood scrap. This material was likely the reason that no cultivation was possible, resulting the circular shape of the feature. Western Environment reviewed the original mine maps of the Clayton Mine to determine if this feature might be mine related. No correlation to any mine structures, shafts or de-watering wells, were made. This feature may be a low area that due to surface runoff or moisture from the adjacent irrigation ditch, could not be farmed.

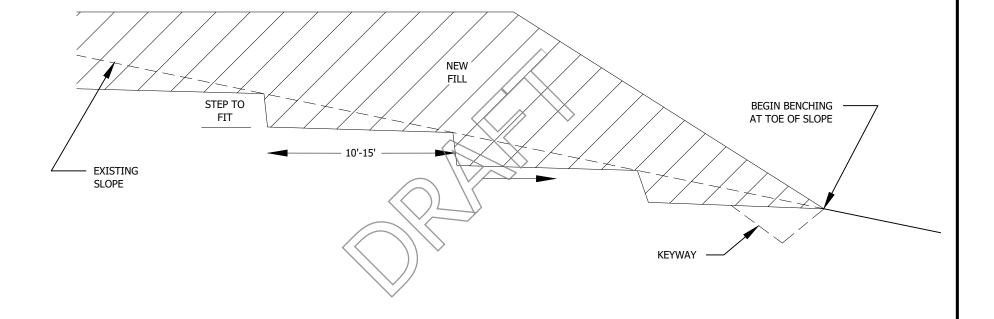
- 1. BENCHING REQUIRED WHEN EXISTING SLOPE IS 5 : 1 (HORIZONTAL : VERTICAL) OR STEEPER
- 2. CONTINUE BENCHING UNTIL NATURAL SLOPE FLATTENS OR DAYLIGHTS
- 3. DRAINS MAY BE REQUIRED IF GROUND WATER IS ENCOUNTERED
- 4. ADDITIONAL EXCAVATION MAY BE REQUIRED BY AGW IF SLOPE INSTABILITY IS NOTED
- 5. A KEYWAY MAY BE REQUIRED BY AGW DEPENDING UPON SLOPE CONFIGURATION
- 6. NOT TO SCALE

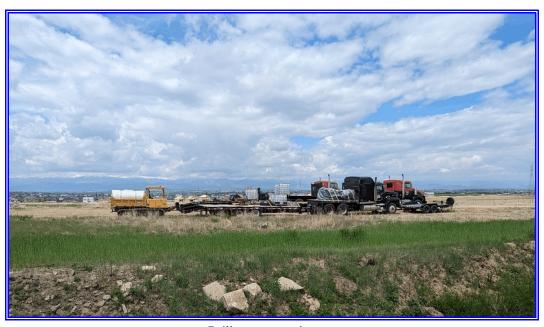
Drill support equipment

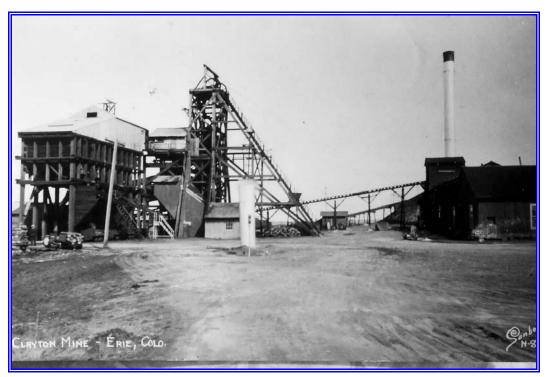
Clayton Mine, Photo provided by the Erie Historical Society

The second mine occurring beneath the west one half of Section16 is the **Clayton Mine** (Figure 3). The Clayton Mine began operation in 1920 and continued to 1942 having a recorded production of 3,333,225 tons. The maximum yearly production of 260,000 tons occurred in 1925. Based upon review of the original maps, the mining method was classified as a modified room and pillar mine using the Pillar Retreat method of mining. Entry to the mine occurred from a 350 foot deep production shaft located on the subject property (Figure 3). An air shaft also approximately 350 feet in depth was located 250 feet north of the main production shaft.

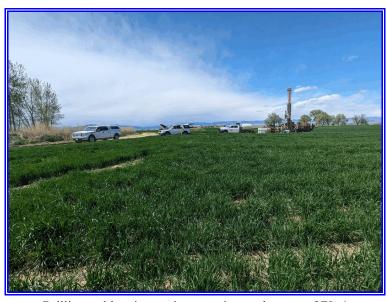
Drilling and logging equipment, view to the west of EL-4

After drilling and logging, each hole required plugging in a manner which would not allow water to enter the workings. On all holes, a simple cement plug was set from 2 to 15 feet or the bottom of the surface casing (after removal) with the remaining footage of the hole being filled with bentonite chips to inhibit fluid penetration. Native soil was then replaced from 2 feet to the surface.

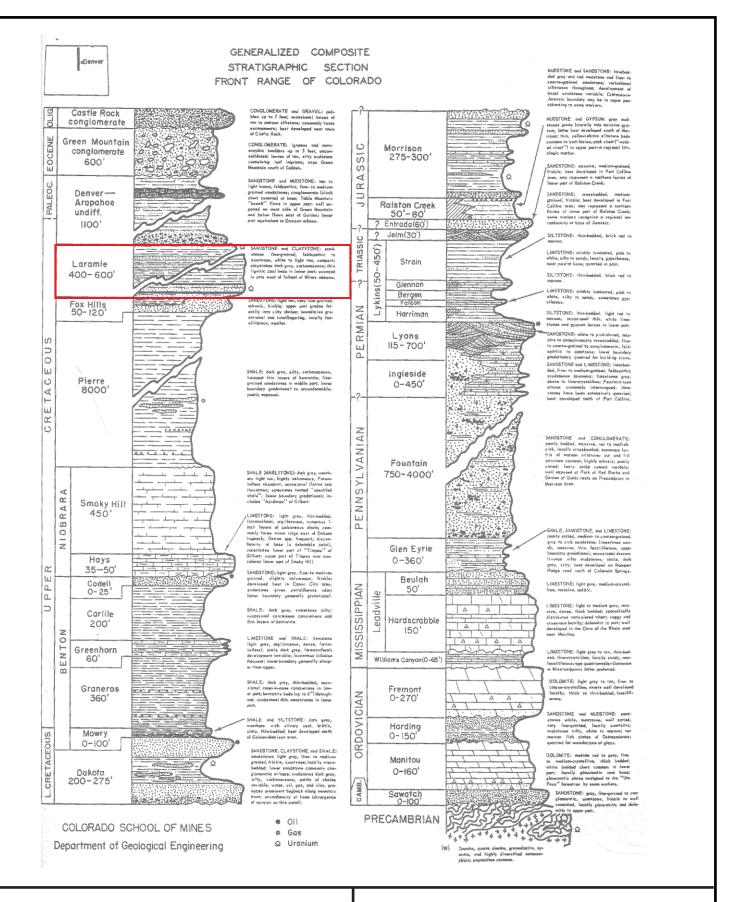
Figure 4- Generalized Stratigraphic Section North Westerly Project Section 16, Township 1 North, Range 68 West Weld County, Colorado

The proposed subdivision lies on the western edge of the Denver-Julesberg Basin against the Front Range Uplift. This basin contains up to 13,000 feet of sediments derived from the ancestral Rockies which laid to the west. Three kinds of faulting occur in this portion of the basin. A basement-controlled late Cretaceous Laramide faulting is the most prevalent and is the result of deformation associated with uplift. The second has been described by Davis and Weimer (1976) as growth-faulting as a result of differential loading of the deltaic sequence at the time of deposition. The third type, recently identified, is low angle reverse faults.

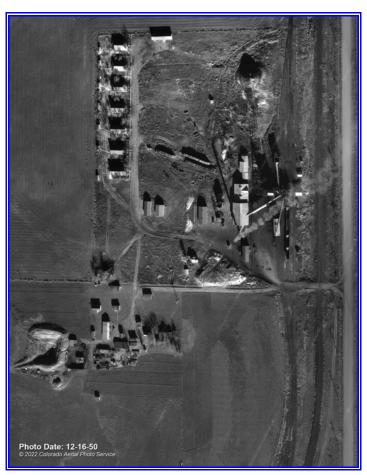
1950 aerial photo Morrison Mine

Two abandoned coal mines occur beneath the North Westerly Parcel. The mine present in a portion of the northeast corner of the project is referred to as the **Morrison Mine** (Figure 3). Records on file with the Colorado Division of Mines (attached) show that production began in 1930 and the operation was officially closed on December 20th 1966 after producing 2,169,664 tons. Entry to the Morrison Mine was gained via a 160 foot deep shaft located approximately 2,500 feet northeast of the subject property in Section 9. Maximum production for the Morrison Mine was 132,000 tons in 1945. At the time the mine closed, it was owned by the Clayton Coal Company.

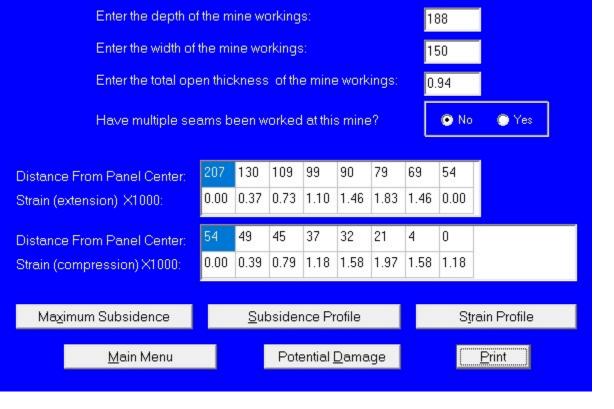
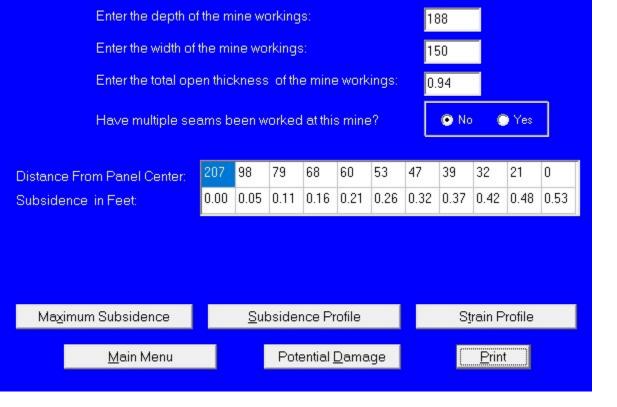
Relationship of Damage to Length of Structure and Horizontal Ground
