Schofield Farm -
Barn Rehabilitation

2203 N 111th Street
Erie, Colorado 80516

ROOF PLAN

A-120

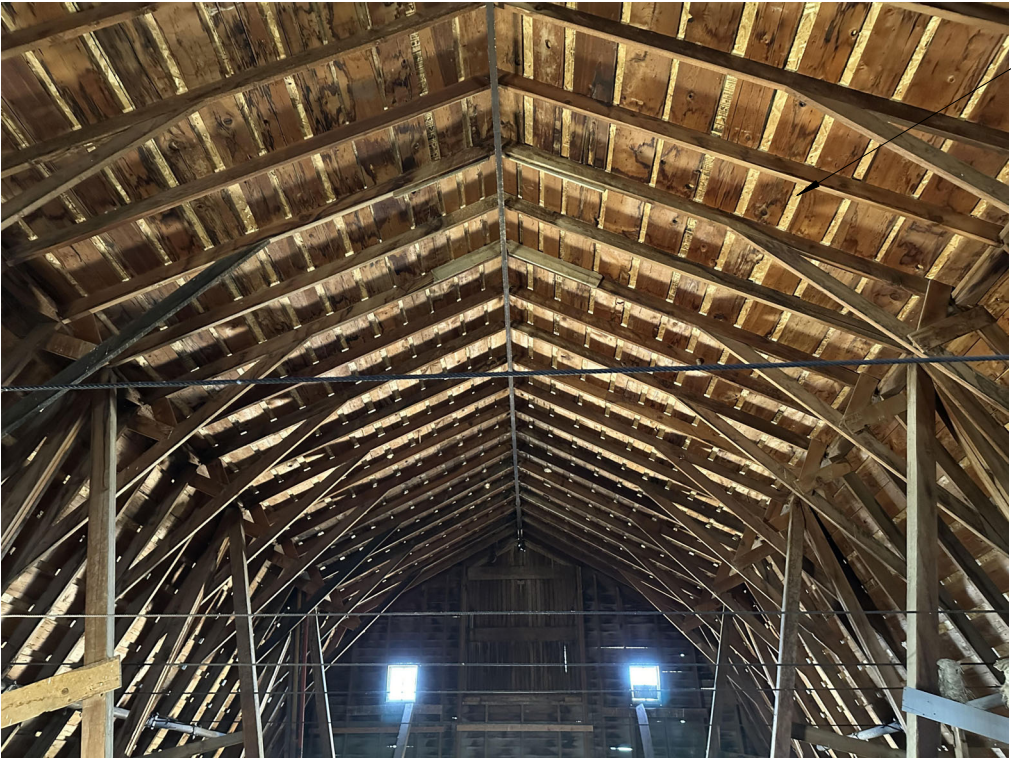
3 INTERIOR VIEW OF ROOF FRAMING
1/4" = 1'-0"

EXISTING ROOF FRAMING AND HISTORIC SHEATHING TO REMAIN AT INTERIOR OF SECOND FLOOR. NOTE THAT INSULATION IS PROPOSED TO EXTERIOR OF SHEATHING TO RETAIN THE CHARACTER OF THE SECOND FLOOR SPACE IN THE BARN.

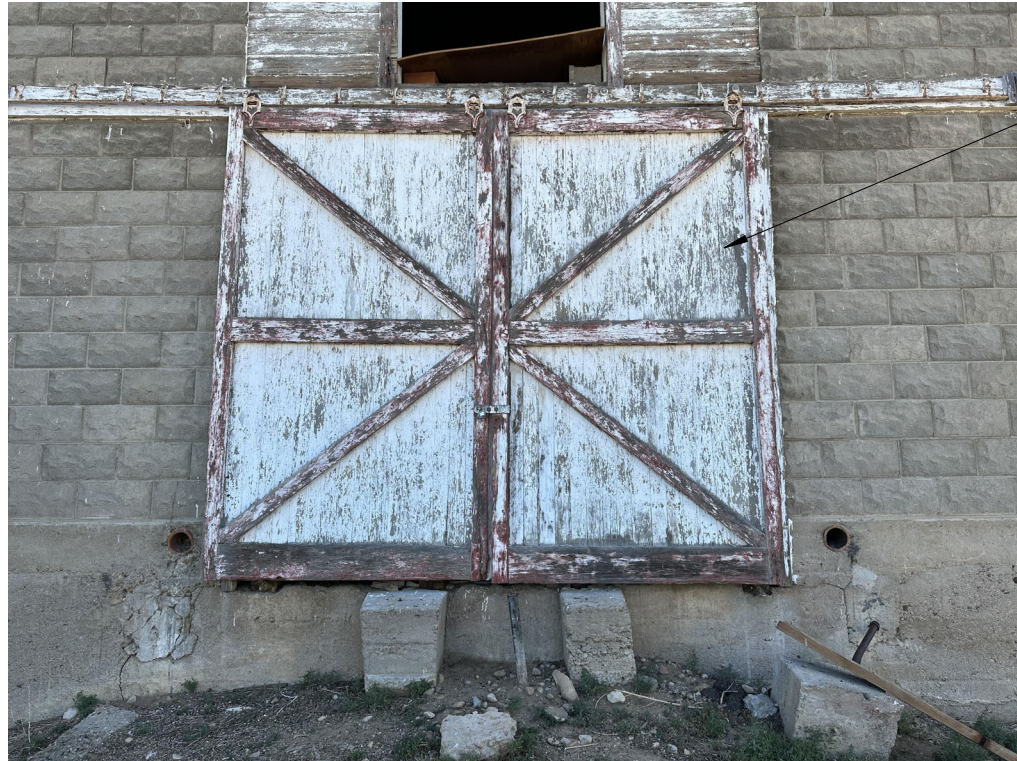
2 TYPICAL SLIDING DOORS
1/4" = 1'-0"

REHABILITATE TWO (2) LEAF SLIDING DOORS AT EAST AND WEST ELEVATIONS SUCH THAT DOORS ARE FULLY OPERABLE ALONG EXTERIOR SLIDING TRACK

UPON COMPLETION OF WOOD REHABILITATION, PREP, PRIME, AND PAINT INTERIOR AND EXTERIOR DOOR, FRAME, AND TRIM COMPONENTS
