## Utility Conformance Letter

RE: Utility Conformance Letter - Erie Police Station, 1000 Telleen Avenue, Erie, CO 80516

The Erie Police Department Expansion project involves increasing the footprint of the existing Town of Erie Police Department building by adding an approximately 17,229 SF two story addition for a total of 48,349 SF to accommodate the need for a growing department to serve the increasing population within the Town of Erie, Colorado. The proposed 48,349 square foot building is located on an approximately 5.56 acre parcel at 1000 Telleen Avenue, Erie, Colorado 80516 situated in the SE ¼ of the SE ¼ of Section 13, Township 1N, Range 69W of the 6<sup>th</sup> Principal Meridian zoned Community Mixed-Use (CMU).

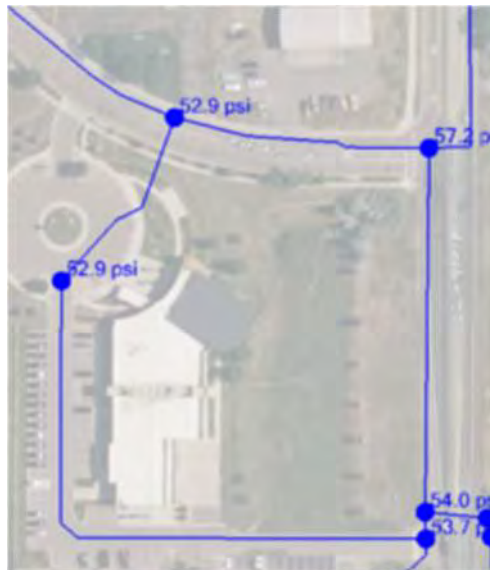
**Figure 1 – Town of Erie Water Model Excerpt**

The proposed Erie Police Department Expansion is located in Town of Erie potable water pressure zone 2 and Professional Engineering Consultants (PEC) was provided with the following excerpt (**Figure 1**) from the Town of Erie's water distribution model that illustrates residual pressures at select nodes & under the maximum daily demand.

In addition to this information provided by the Town the project team collected site specific Hydrant testing data which has been included in Exhibit B following this letter. Hydrant flow testing was performed at two existing hydrants located on site. Hydrant one on the northwest corner of the building and hydrant two on the southeast corner of the building. Residual and static pressures measured at existing hydrants closely match the residual pressure at select nodes adjacent to the site sent over in the Town of Erie Water Model Excerpt.

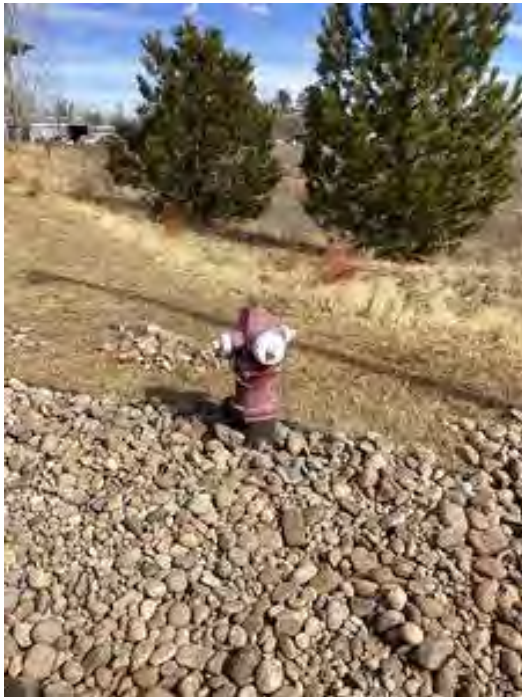
2 Hydrant - Is the hydrant properly painted and is the paint in good condition?

*Paint is faded due to sun*

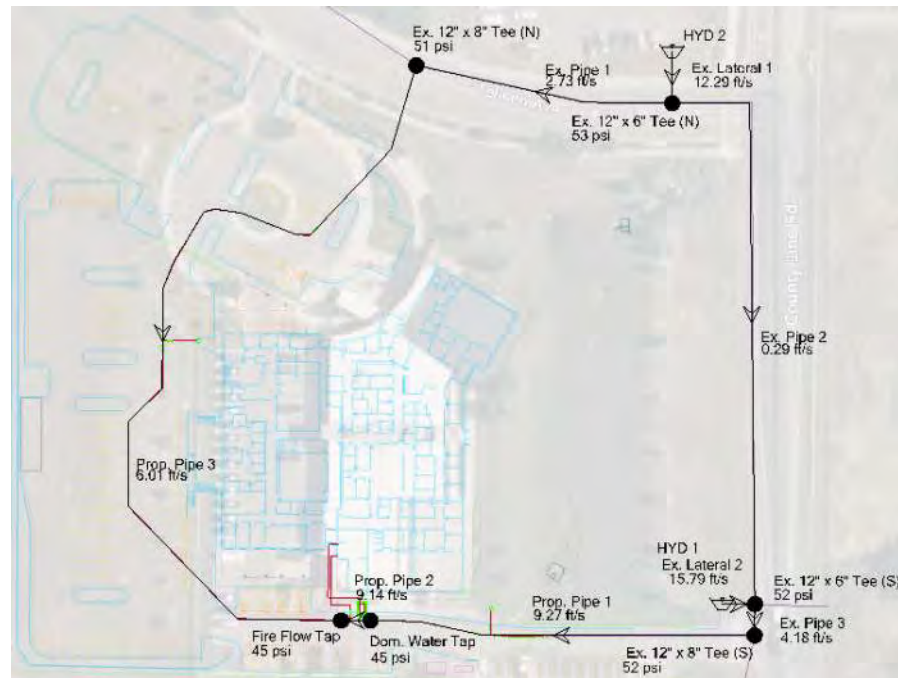
### Third Scenario - Fire Flow Demand

Peak fire flow demand of 2,375 gpm reflected at Fire Flow Tap node. All other nodes remain at base flow condition of 20 gpm
