Town of Erie Police Department Expansion

Utility Conformance Letter

RE: Utility Conformance Letter - Erie Police Station, 1000 Telleen Avenue, Erie, CO 80516

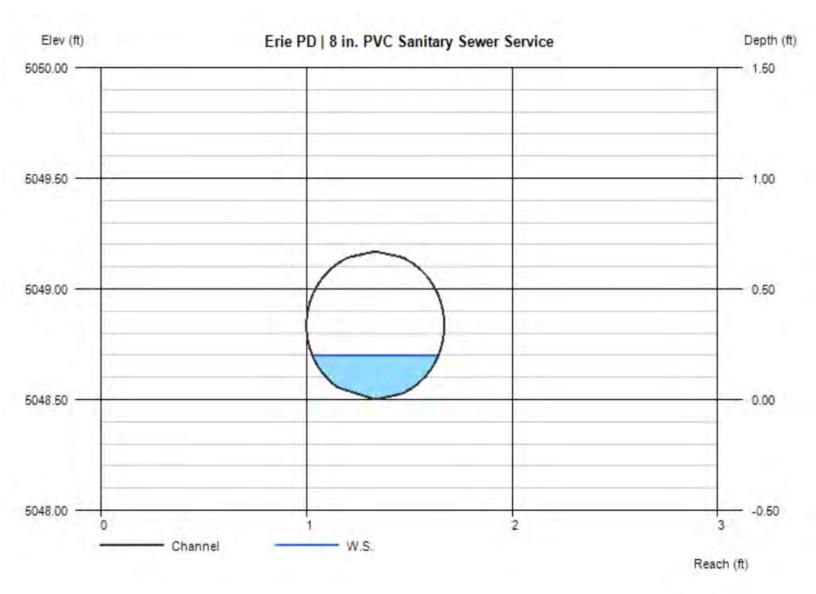
Channel Report

| Circular | | Highlighted | |
|---|---|---|---|
| Known Q (cfs) | = 0.25 | | |

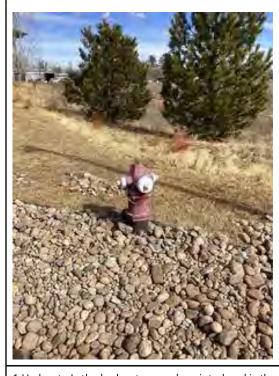
1 Hydrant - Is the hydrant properly painted and is the paint in good condition?

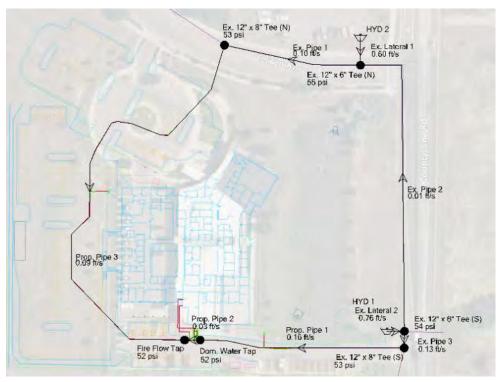
Base Scenario - Hydrant Calibration

20 GPM Demand at all nodes shown

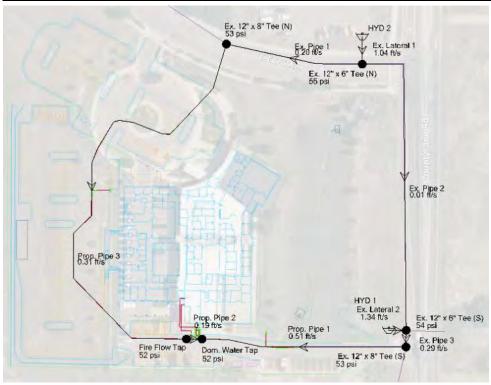
Second Scenario - Peak Domestic Demand

110 GPM at domestic water tap node, 20 gpm at all other nodes

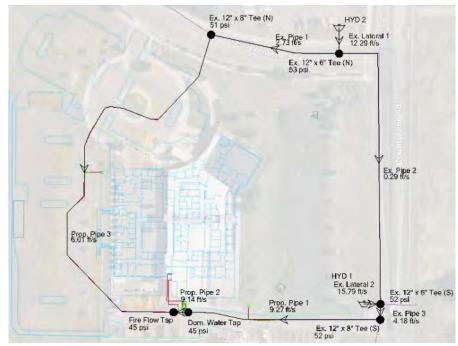
Third Scenario - Fire Flow Demand

Peak fire flow demand of 2,375 gpm reflected at Fire Flow Tap node. All other nodes remain at base flow condition of 20 gpm

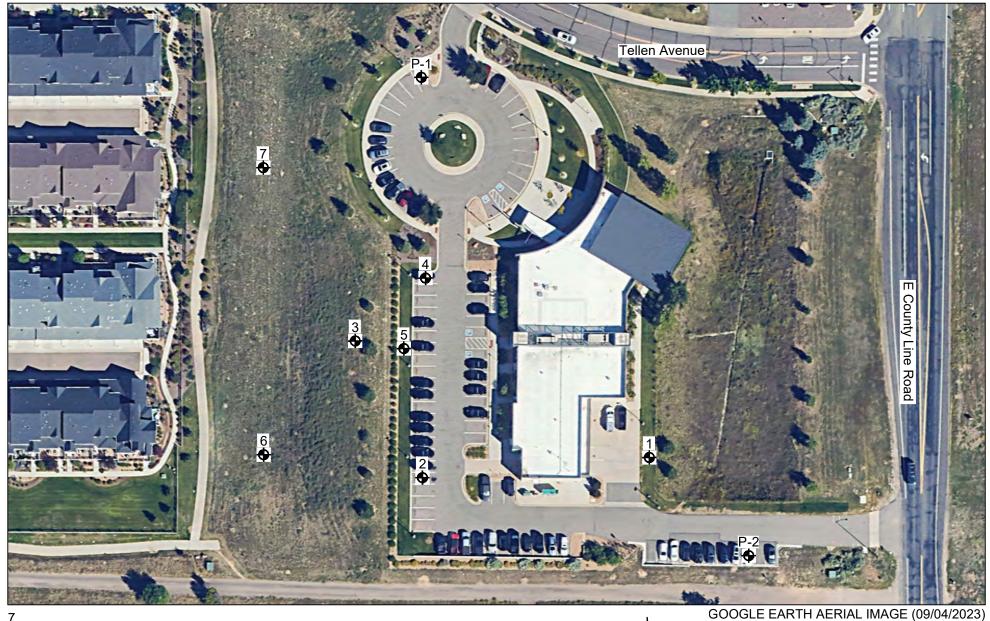
Indicates test hole numbers and approximate locations.

The subsurface exploration for the project was conducted on January 27th and February 4th, 2025. A total of nine (9) test holes were drilled with a truck-mounted and a buggy-mounted, continuous flight power auger rig to evaluate the subsurface conditions as well as to retrieve soil samples for laboratory testing and analysis. Seven (7) foundation test holes were drilled near the proposed location for the new building to depths of approximately 30 to 36 feet below existing grades. Two (2) test holes were drilled for the proposed parking areas and drive lanes to depths of approximately 5 to 10 feet below existing grades. A representative of GROUND directed the subsurface exploration, logged the test holes in the field, and prepared the soil and bedrock samples for transport to our laboratory.

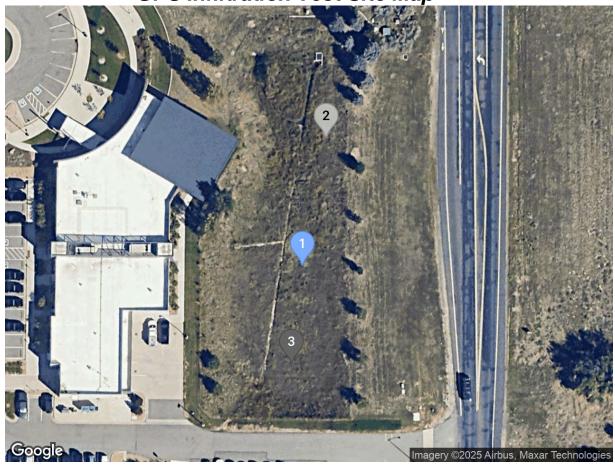
GPS Infiltration Test Site Map

K_{sat} best-fit site average: 45 mm/hr or 1.78 in/hr
