## Utility Conformance Letter

RE: Utility Conformance Letter - Erie Police Station, 1000 Telleen Avenue, Erie, CO 80516

**Geotechnical Subsurface Exploration Program  
Erie Police Station Addition  
Erie, Colorado**

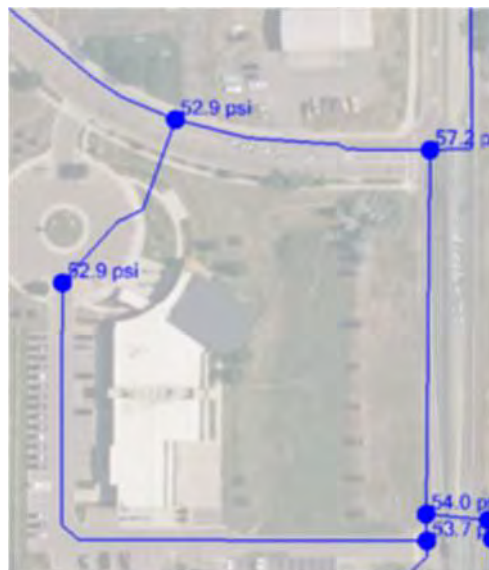
**Figure 1 – Town of Erie Water Model Excerpt**

The proposed Erie Police Department Expansion is located in Town of Erie potable water pressure zone 2 and Professional Engineering Consultants (PEC) was provided with the following excerpt (**Figure 1**) from the Town of Erie's water distribution model that illustrates residual pressures at select nodes & under the maximum daily demand.

In addition to this information provided by the Town the project team collected site specific Hydrant testing data which has been included in Exhibit B following this letter. Hydrant flow testing was performed at two existing hydrants located on site. Hydrant one on the northwest corner of the building and hydrant two on the southeast corner of the building. Residual and static pressures measured at existing hydrants closely match the residual pressure at select nodes adjacent to the site sent over in the Town of Erie Water Model Excerpt.

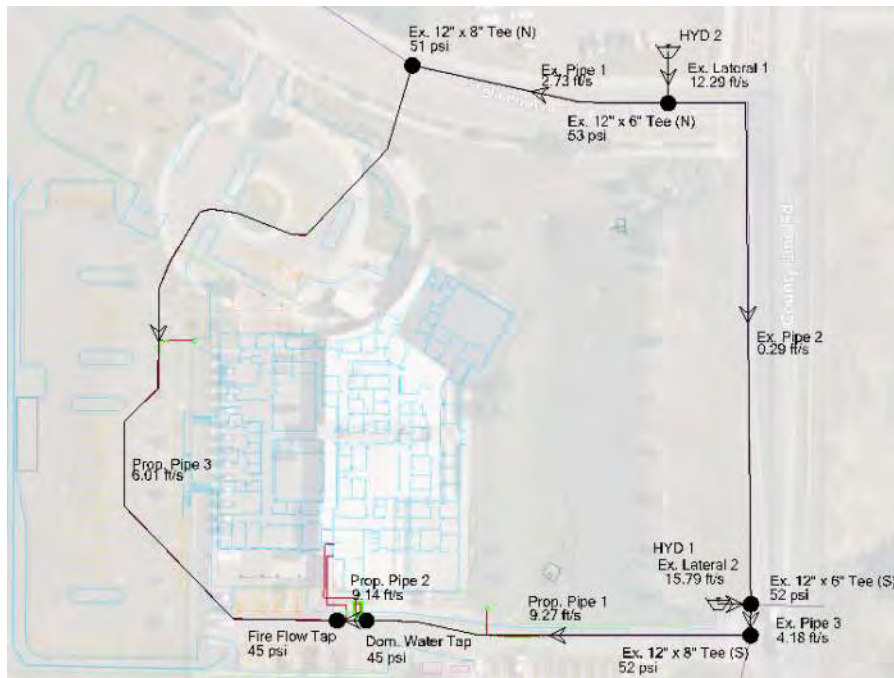
### Third Scenario - Fire Flow Demand

Peak fire flow demand of 2,375 gpm reflected at Fire Flow Tap node. All other nodes remain at base flow condition of 20 gpm
