Schofield Farm Original  
Barn & Brooder House  
Rehabilitation

FLOOR PLAN

A-101

EXTERIOR ELEVATIONS

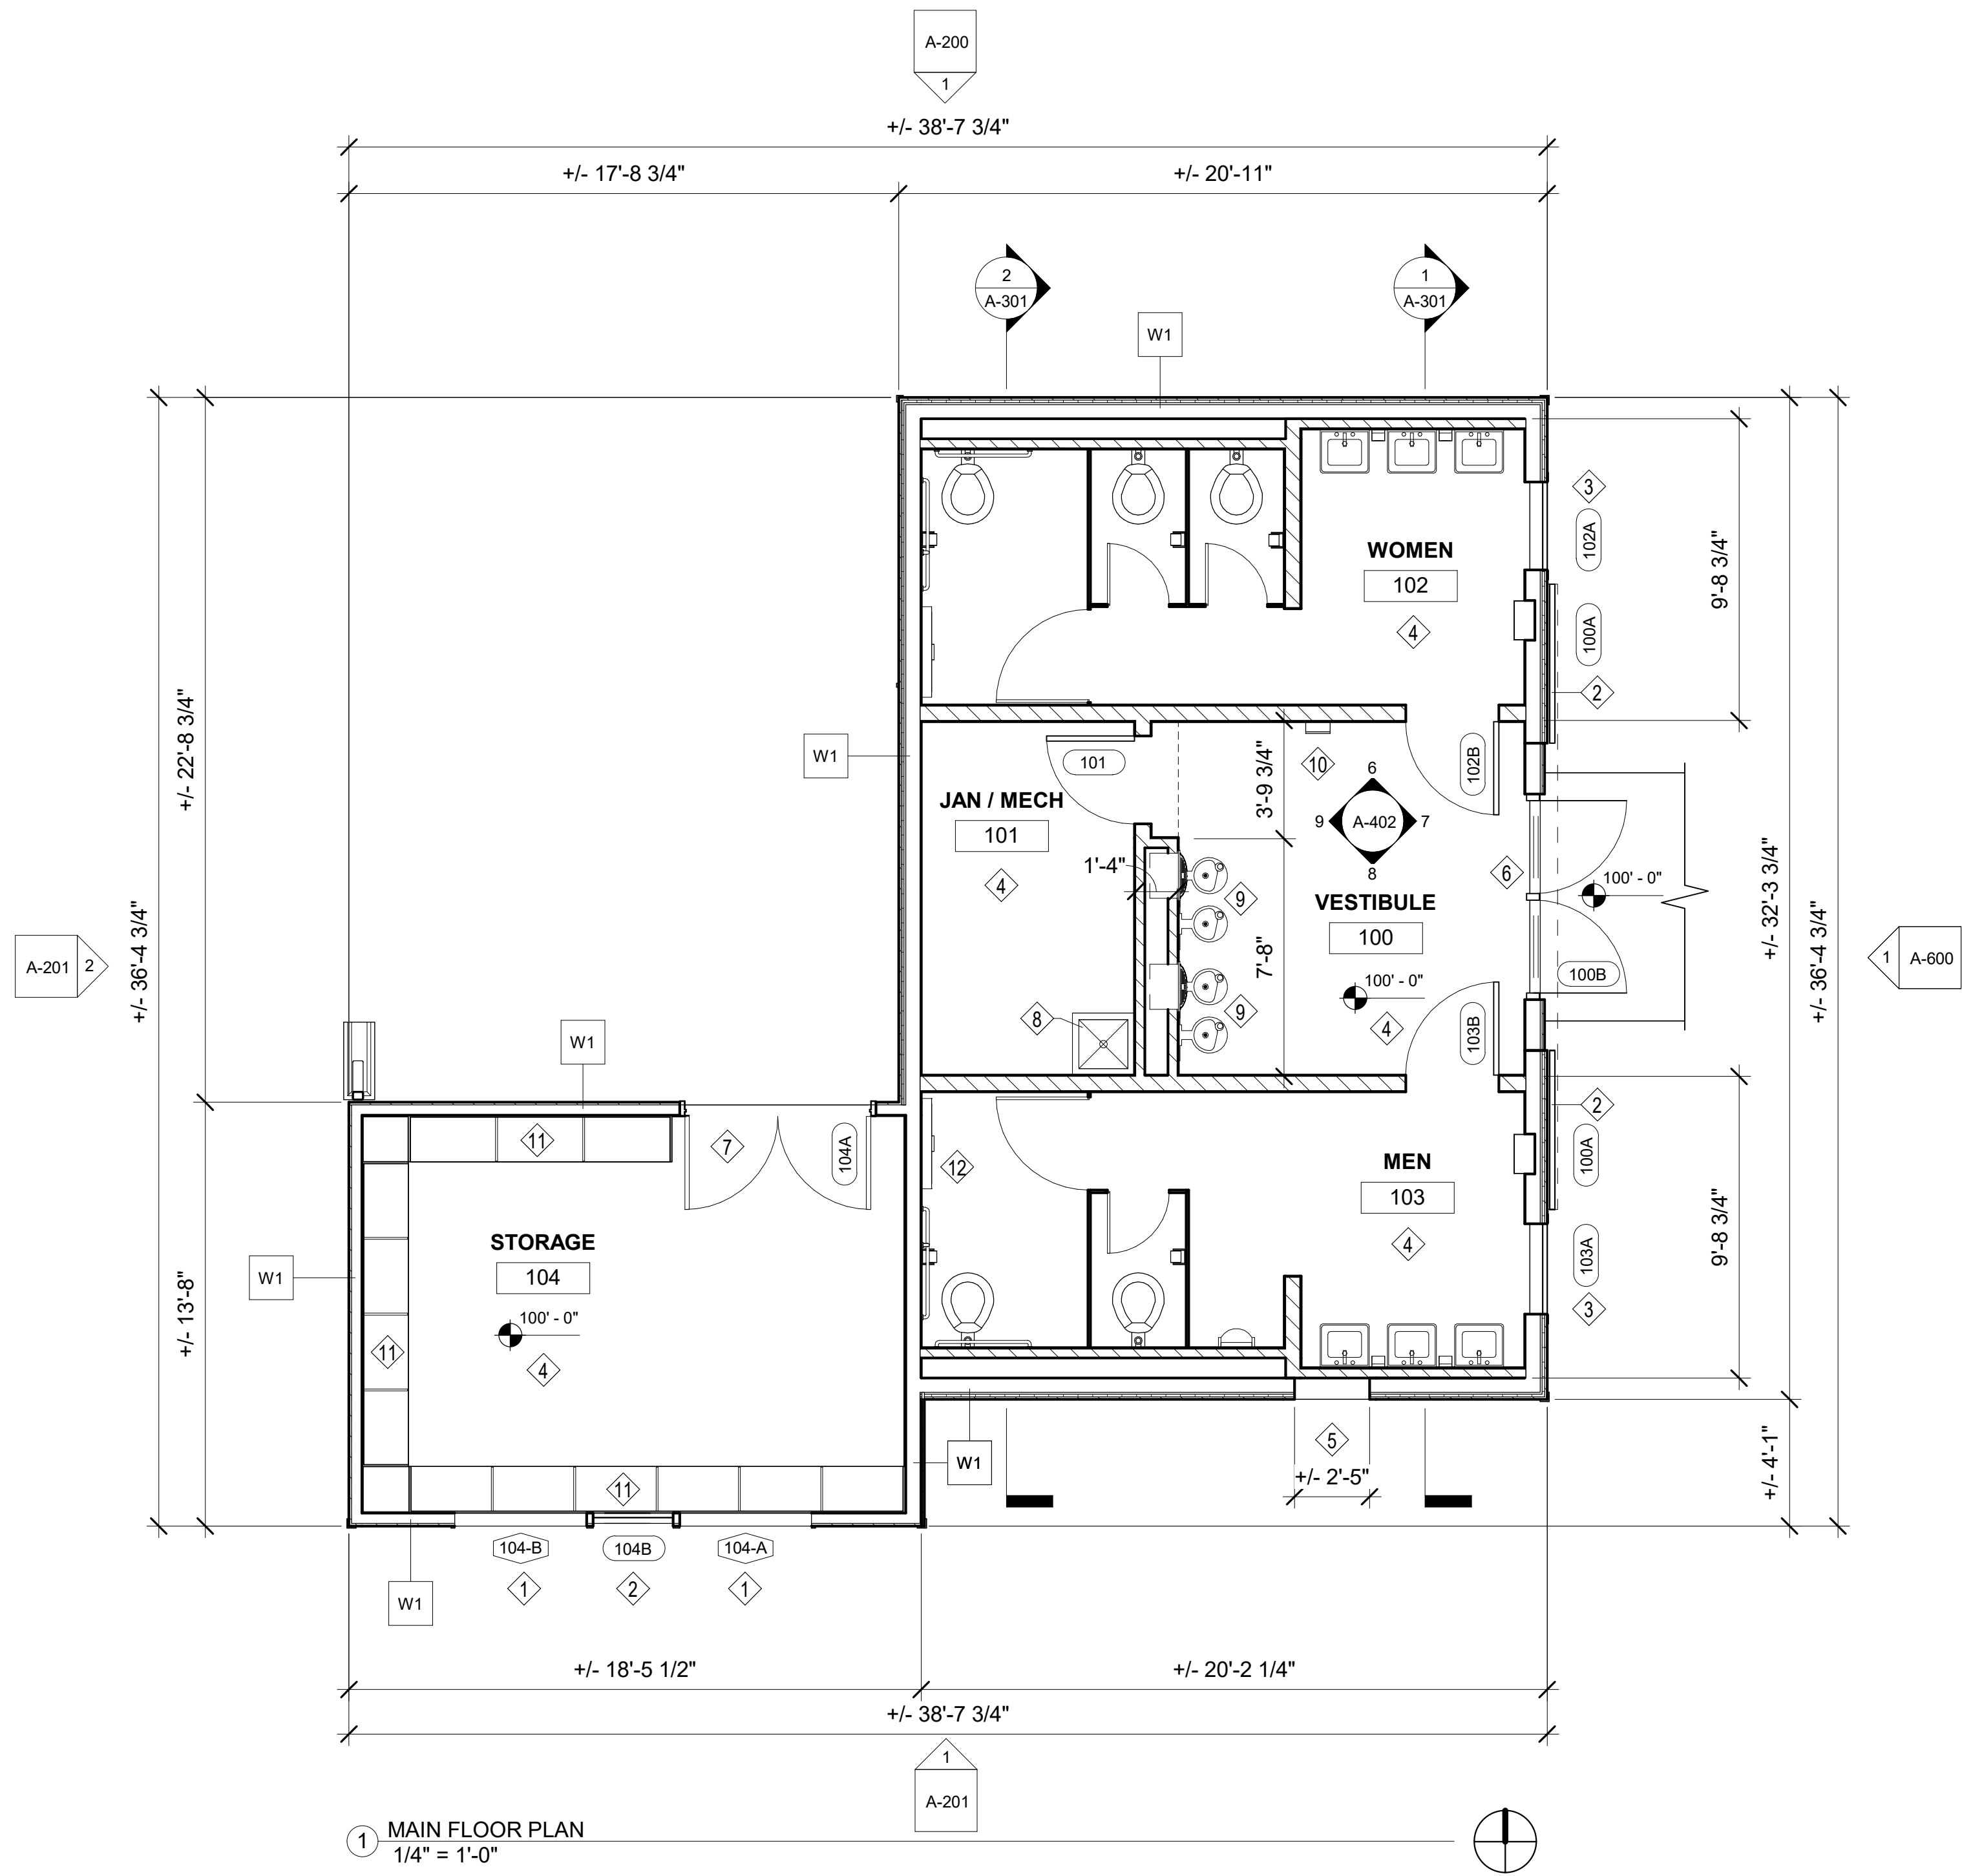
1. REHABILITATE WOOD WINDOW. REPLACE GLAZING WITH PLYWOOD.
2. REHABILITATE WOOD DOOR.
3. INFILL EXISTING DOOR OPENING. REINSTALL ORIGINAL HISTORIC DOOR TO EXTERIOR OF OPENING IN FIXED POSITION.
4. NEW CONCRETE SLAB RE: STRUCTURAL.
5. NEW INSET PAINTED WOOD PANEL AT EXISTING OPENING. PREP, PRIME, AND PAINT TO MATCH SIDING.
6. NEW HOLLOW METAL DOORS PREHUNG IN METAL FRAME. CENTER ASTRIGAL TO BE REMOVABLE. EACH DOOR TO HAVE VISION LITE. ALL GLAZING TO BE TEMPERED.
7. NEW DOORS, FRAME, AND HARDWARE.
8. NEW MOP SINK AND FLOOR DRAIN, RE: PLUMBING.
9. NEW HI-LOW DRINKING FOUNTAIN WITH BOTTLE FILLER, RE: PLUMBING.
10. NEW FIRE EXTINGUISHER CABINET.
11. INSTALL SALVAGED SHELVING UNITS FROM ORIGINAL BARN.
12. NEW DIAPER CHANGING STATION. COORDINATION WITH OWNER FOR LOCATIONS

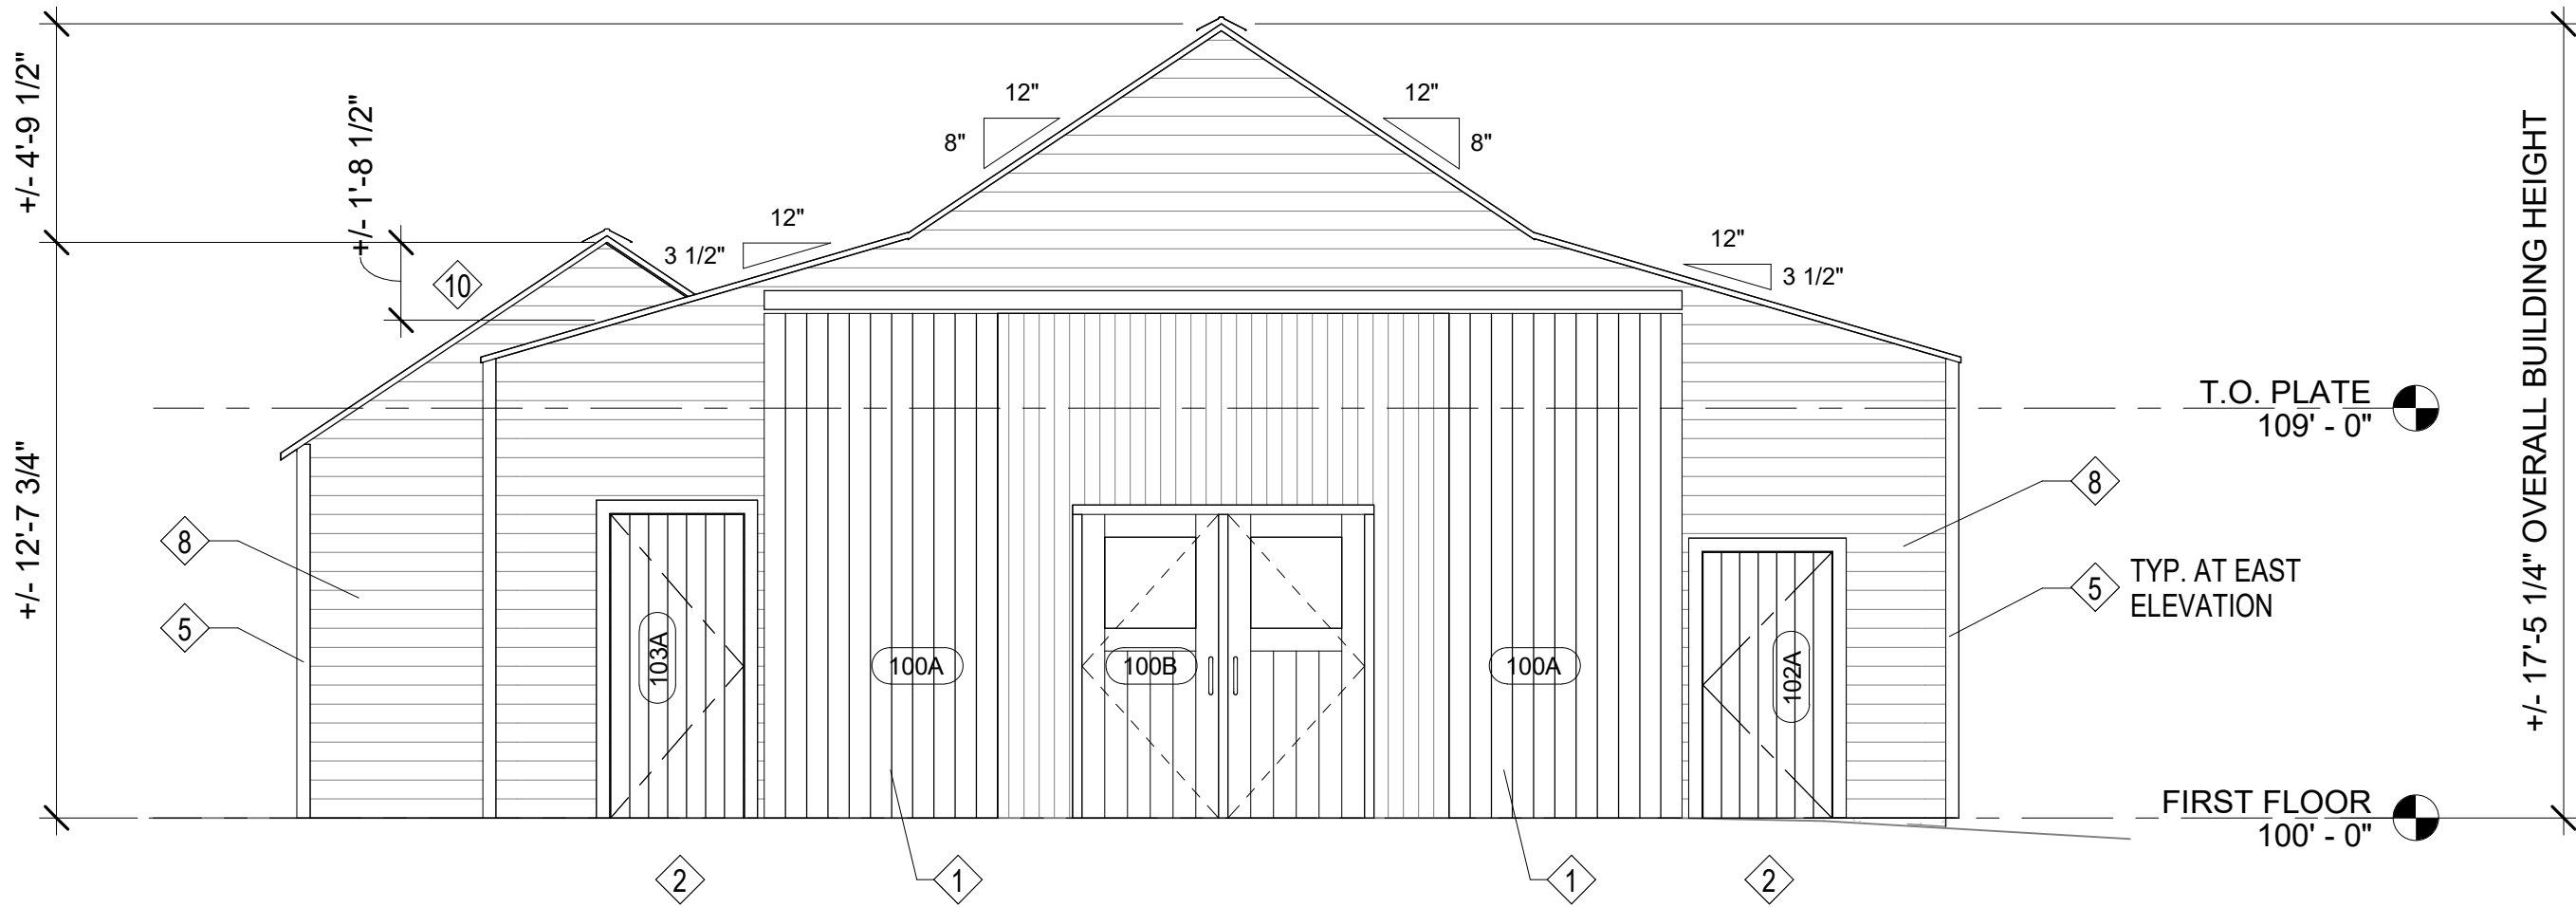
2 EAST EXTERIOR ELEVATION  
1/4" = 1'-0"

1. REHABILITATE SLIDING WOOD DOORS, FRAME, TRACK, AND HARDWARE.
2. REHABILITATE WOOD DOOR. INSTALL AS FIXED PANEL IN ORIGINAL OPENING.
3. REHABILITATE WOOD WINDOW. INSTALL PAINTED WOOD PANEL INSTEAD OF GLASS.
4. REPLACE WOOD SIDING & TRIM TO MATCH ORIGINAL MATERIALS. RE: PHOTO ON THIS SHEET.

5. PREPARE, PRIME, AND PAINT EXTERIOR WOOD TRIM AND SIDING.
6. INSTALL GUTTER. GUTTER PROFILE AND COLOR TO BE SELECTED AND APPROVED BY OWNER AND ARCHITECT.
7. INSTALL DOWNSPOUT AND SPLASHBLOCK. DOWNSPOUT PROFILE AND COLOR TO BE SELECTED AND APPROVED BY OWNER, AND ARCHITECT.
8. REINSTALL SALVAGED WOOD SIDING AND TRIM. ASSUME SALVAGED MATERIALS WILL BE ADEQUATE TO FINISH APPROXIMATELY 50% AT EXTERIOR. ASSUME REMAINING SIDING MATERIAL AND TRIM WILL BE NEW MATERIALS TO MATCH THE ORIGINAL HISTORIC MATERIALS. COORDINATE WITH OWNER AND ARCHITECT FOR LOCATIONS WHERE ORIGINAL MATERIALS ARE TO BE USED.
9. WOOD INFILL PANEL AT EXISTING OPENING.
10. EXISTING ROOF OFFSET TO BE REPLICATED ON NEW BUILDINGS, VERIFY IN FIELD PRIOR TO REMOVAL OF ALL ROOFING MATERIALS.

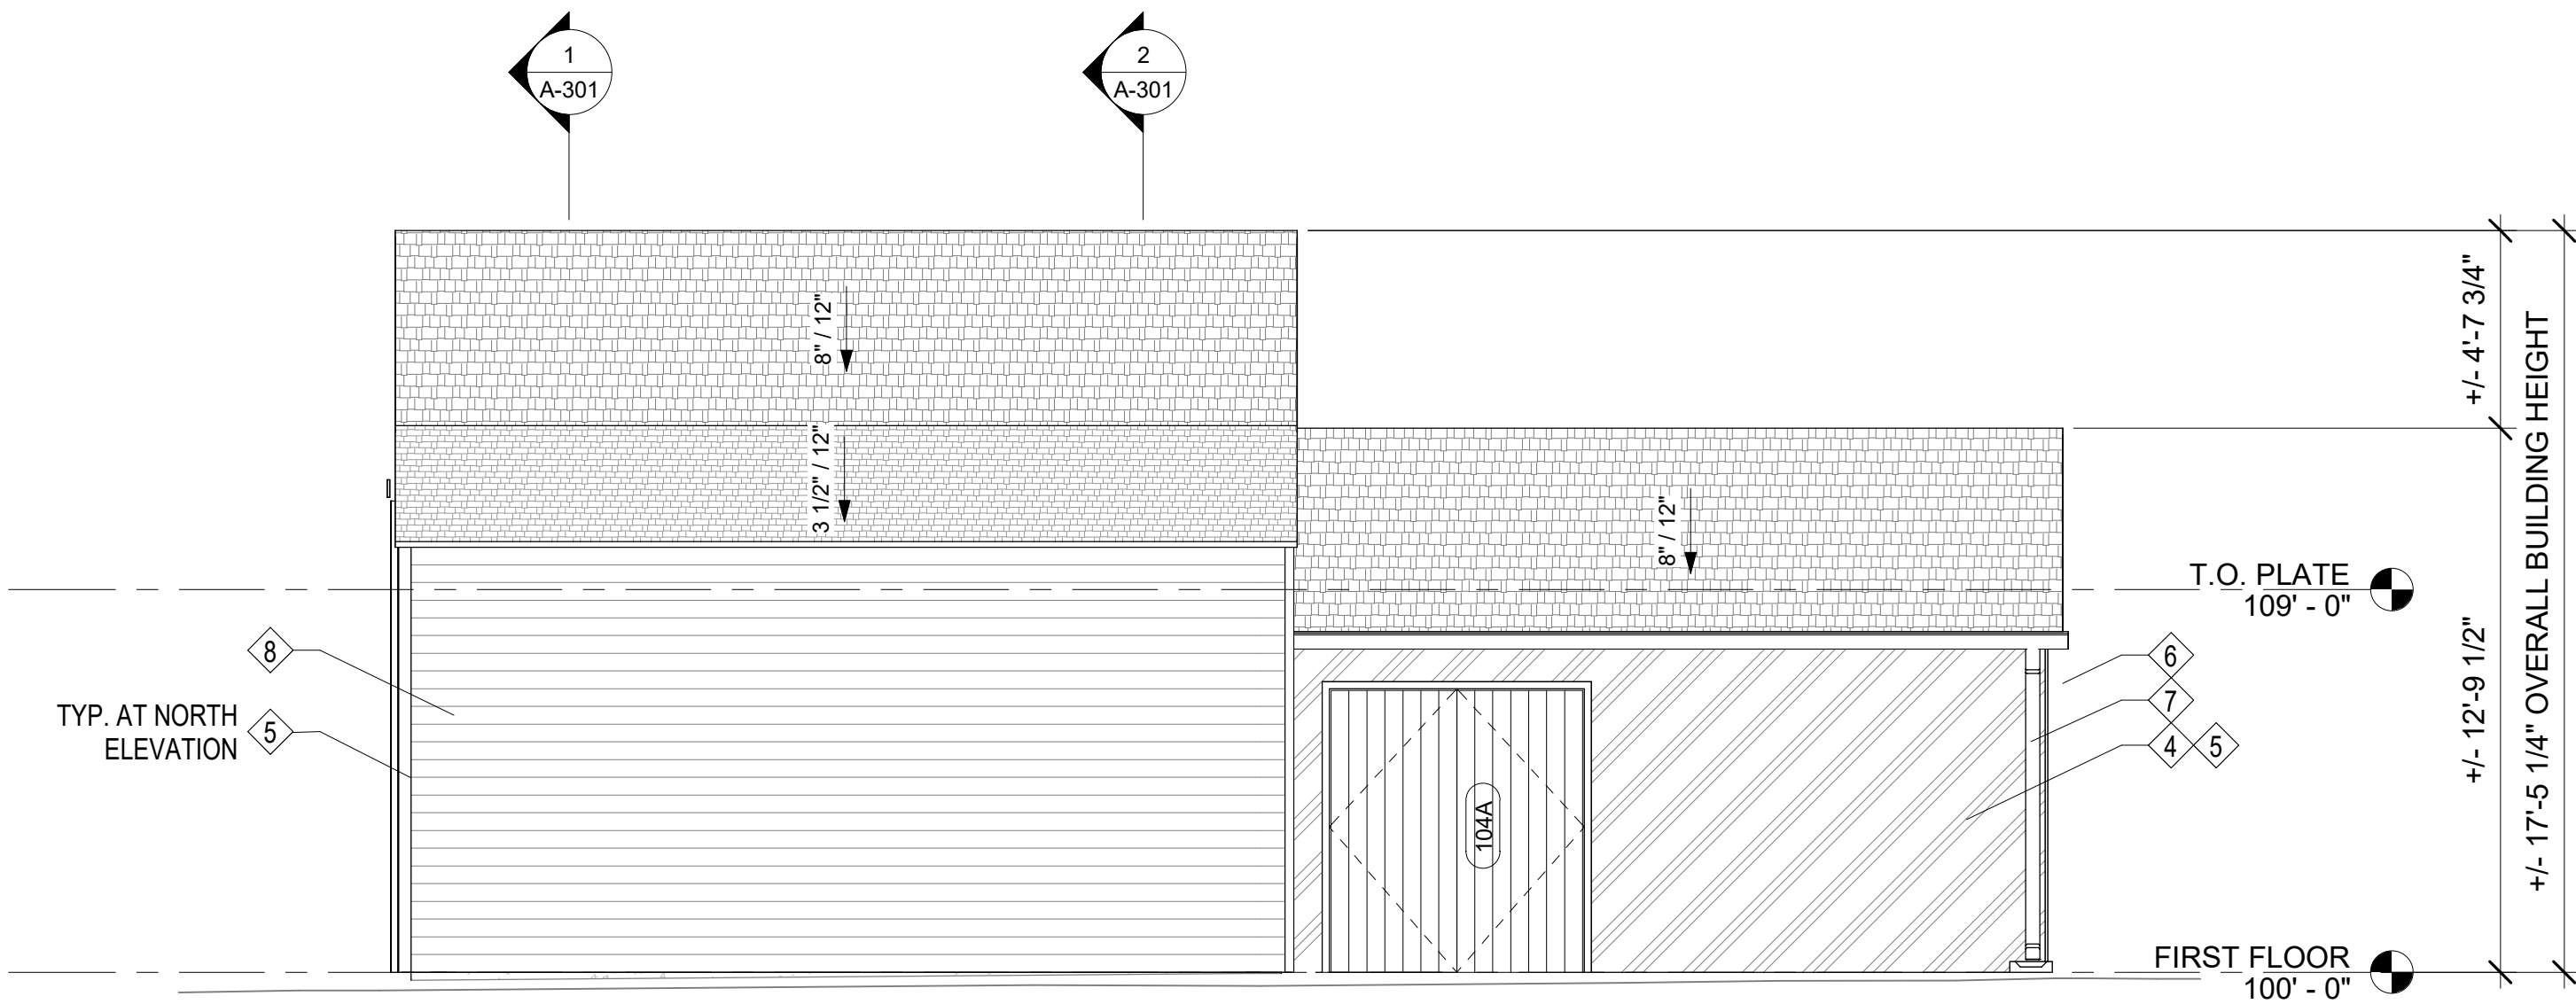
1 NORTH EXTERIOR ELEVATION  
1/4" = 1'-0"

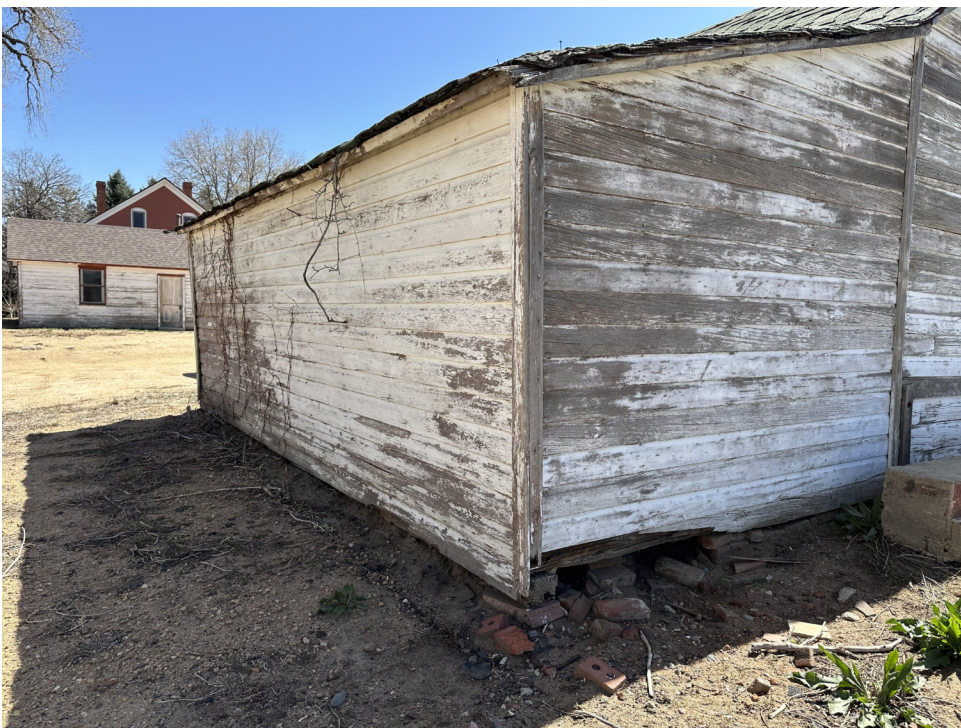
EXISTING BARN SIDING PHOTO

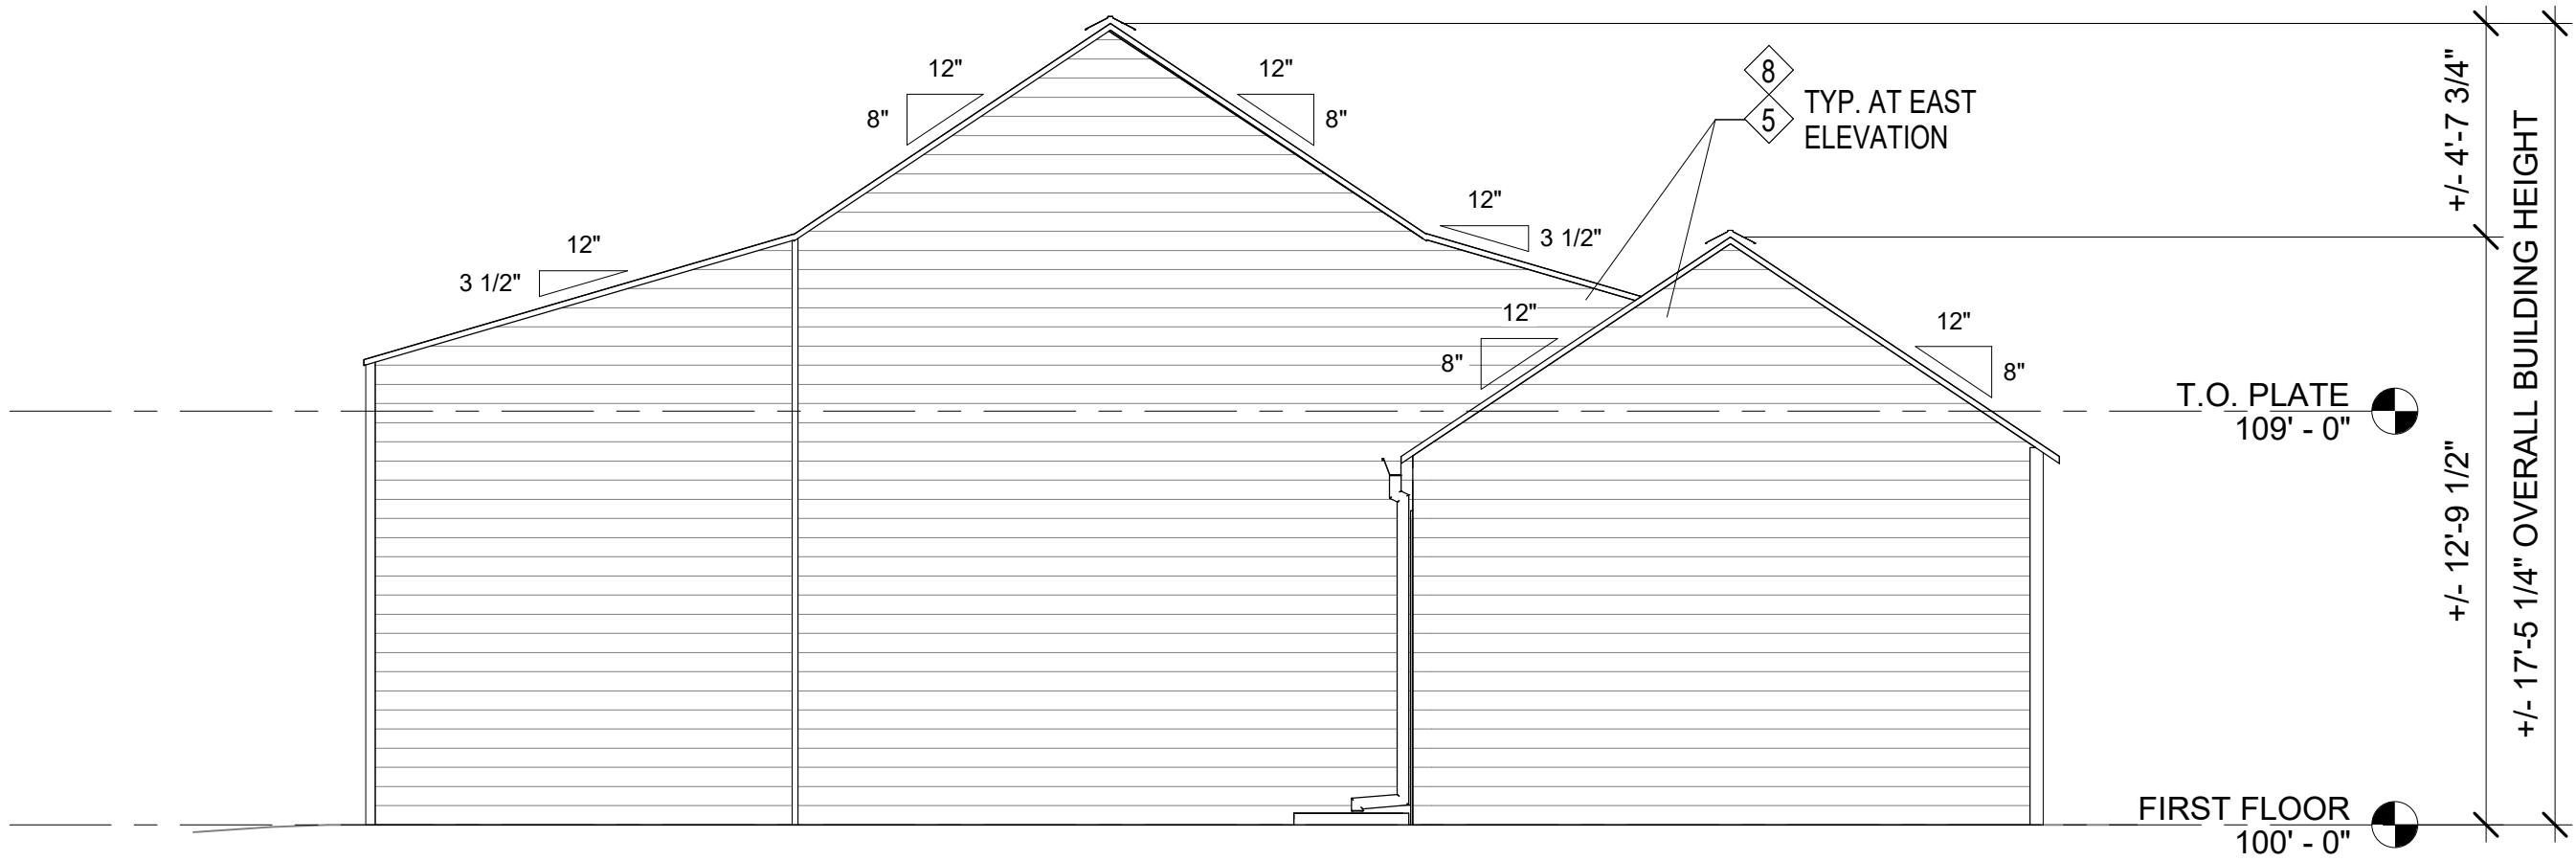
2 WEST EXTERIOR ELEVATION  
1/4" = 1'-0"

- REPLACE WOOD SIDING & TRIM TO MATCH ORIGINAL MATERIALS. RE: PHOTO ON THIS SHEET.
- EXTENT INDICATED WITH:
- PREPARE, PRIME, AND PAINT EXTERIOR WOOD TRIM AND SIDING.

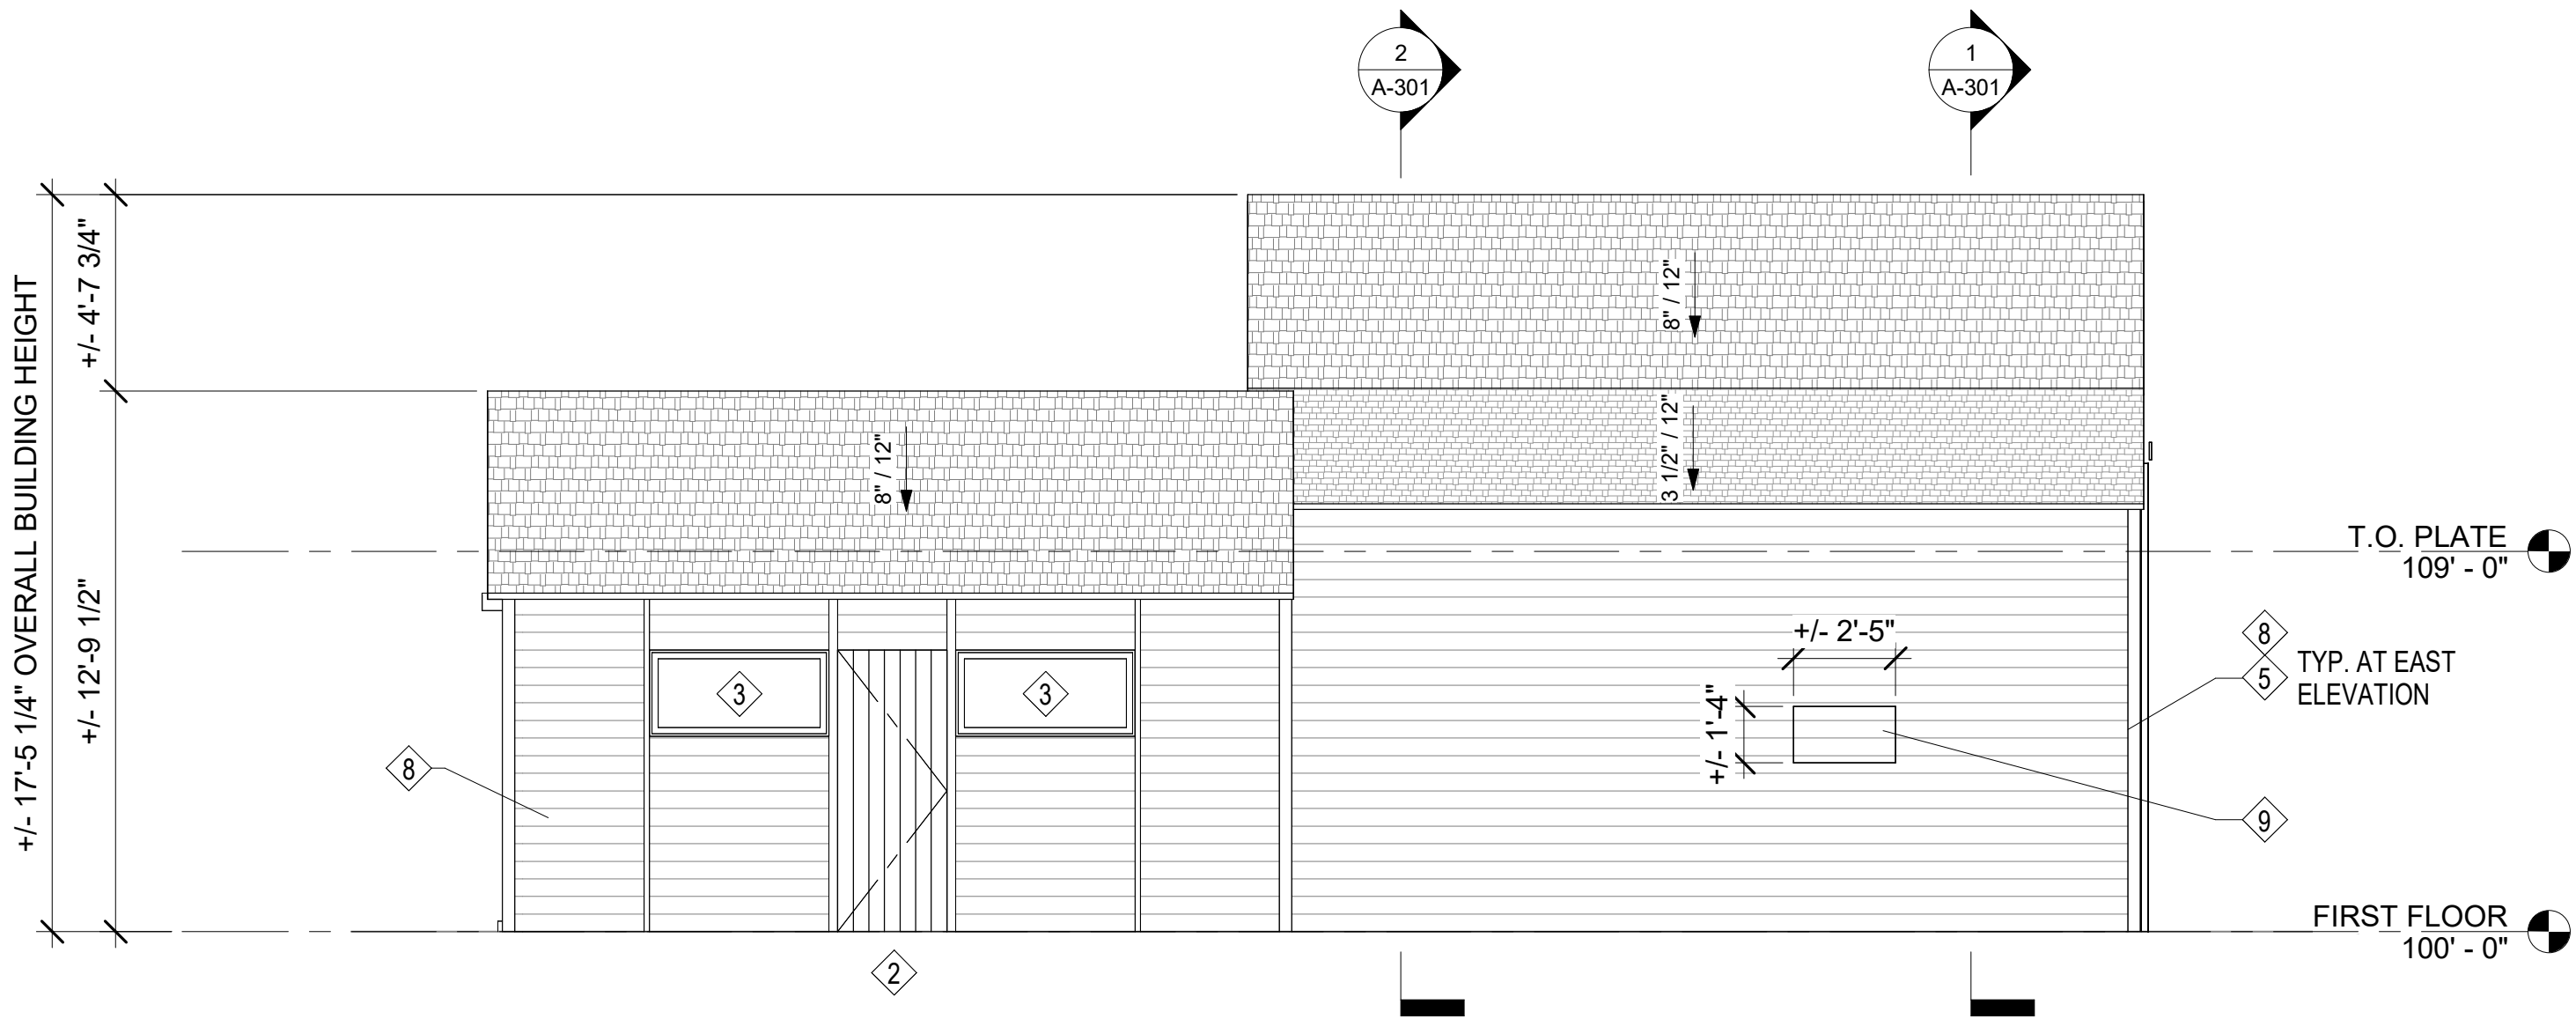
1 SOUTH EXTERIOR ELEVATION  
1/4" = 1'-0"
