# Erie Town Center Conditions Survey

Town of Erie Urban Renewal Authority

December 4, 2024

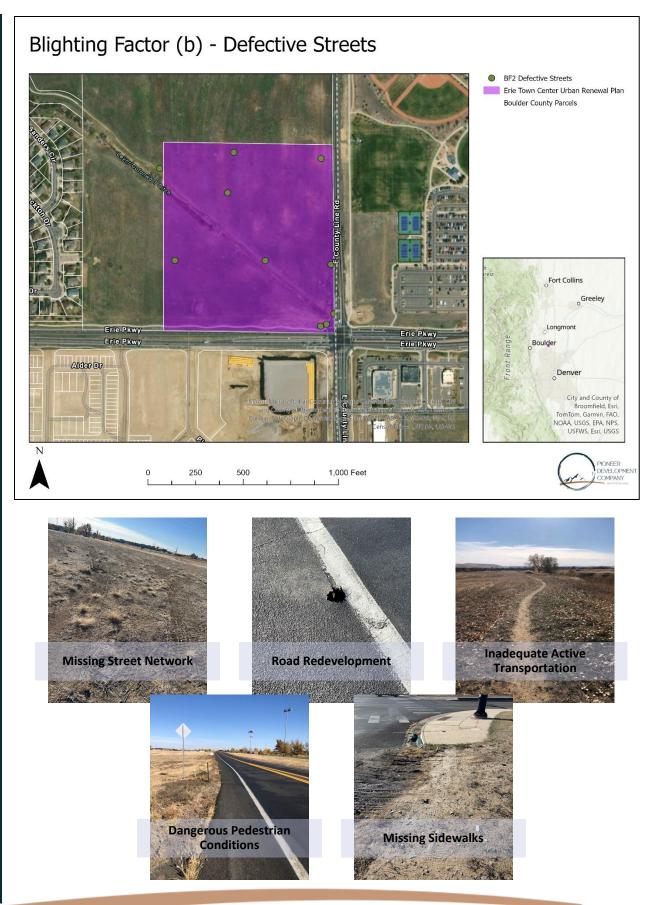
When viewed through this lens, the survey area exhibits conditions that warrant the inclusion of this blighting factor. There are no internal streets or parking lots within the site. In fact, the property lacks ingress and egress points. There is an existing multi-modal, concrete bike path lining Erie Parkway, creating a barrier to adding right-in, right-out options. A new traffic light is likely to be required along Erie Parkway if access is to be gained from the site onto that arterial. The irrigation ditch may also complicate internal circulation and may require bridges or culverts to facilitate a road network through the parcel's interior. These road network improvements represent extraordinary costs highlighting the types of development challenges subsumed by this blighting factor.

The southern boundary of the property, adjacent to Erie Parkway, features active transportation facilities. However, at the parcel's southeast corner, these facilities terminate. The Plan area's eastern border will require new active transportation infrastructure to mitigate pedestrian traffic hazards along East County Line Road. There are also a series of informal trails within the site that should be upgraded or redeveloped once construction begins.

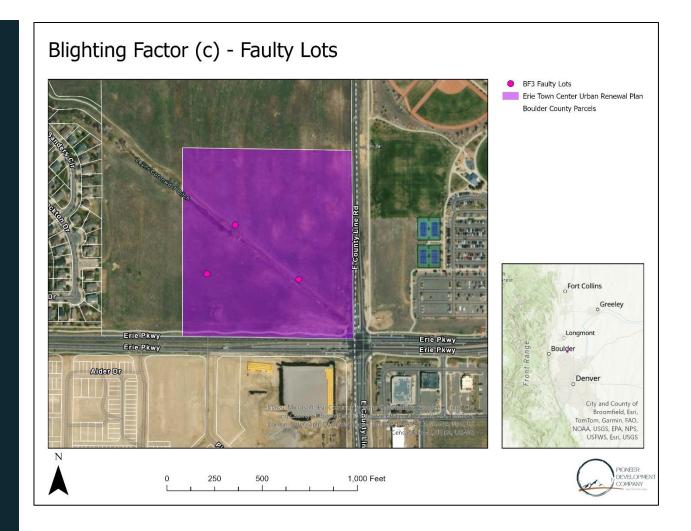
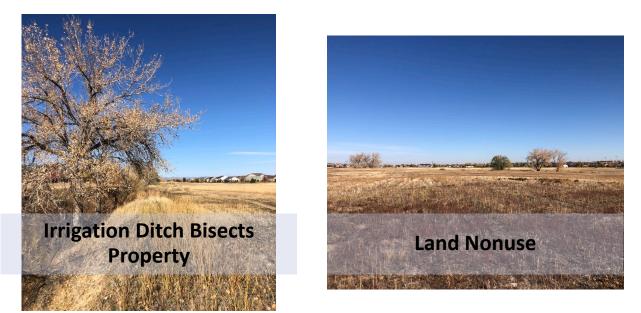
More specifically, the parcel is impacted by undermining shafts and an irrigation ditch. The undermining shafts and coal subsidence hazards lining Erie Parkway limit new construction to the parcels northwest corner unless significant mitigation occurs. The Leyner Cottonwood irrigation ditch further constrains this parcel by transecting the property. The irrigation is large and would require significant engineering and construction to be undergrounded. This will also require negotiations with the Ditch Company, which controls the easement across the property. The current lot configuration yields unproductive conditions, as evidenced by the land's non-use.

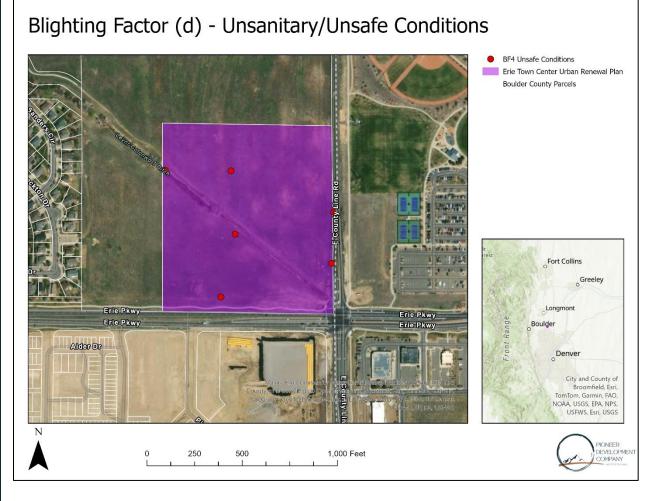
The most notable unsafe condition identified within the Plan area is the historic undermining. Lithos Engineering completed a Coal Mine Subsidence Study on this property in 2022, which found severe hazards associated with these historic extraction processes. The Plan area is located within the Boulder-Weld Coal Field, and was part of the now abandoned Garfield No. 1 Mine, and the Lister, Garfield No. 2, and Marfel/Pinnacle Mines. The Mines present unique risks to future development, and significant geotechnical challenges. The Lithos study found that nearly 30% of the site falls within severe to high subsidence hazards, and that there exist three abandoned shafts within the Plan boundary. There may also exist "dangerous gases" within the now abandoned mine network. The Lithos study recommended additional subsidence analysis throughout the Plan area, and specifically recommended that no development occurs within 100 feet of the located mine shafts. These findings highlight a unique, hazardous conditions that meets this blighting factor's threshold for inclusion.

While the coal mine subsidence hazards represents the primary concern facing future development, the Plan area's eastern boundary also exhibited dangerous pedestrian traffic conditions. The property adjacent to East County Line Road lacks sidewalks or bike lanes. These facilities abruptly end at the East County Line Road and Erie Parkway intersection. These missing active transportation facilities represent another unsafe condition within the Plan area.

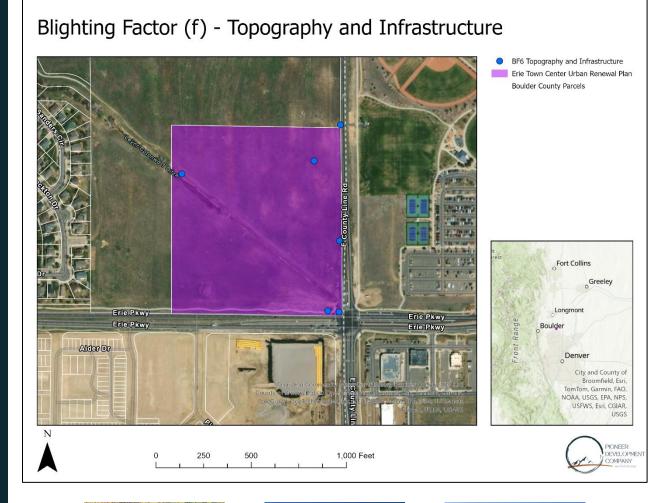
The site visit found an overall lack of infrastructure throughout the survey area that made it inadequate to facilitate new development as-is. The survey area lacked internal road networks, stormwater drainage facilities, central water and sewer services, and street lighting. The irrigation ditch cannot provide stormwater drainage, meaning that future development will need to carefully engineer runoff to new stormwater facilities. The Business zoning designation would mandate the provision of public infrastructure extended throughout the Plan area. Its absence represents a challenge to sound development and justifies the inclusion of this factor.

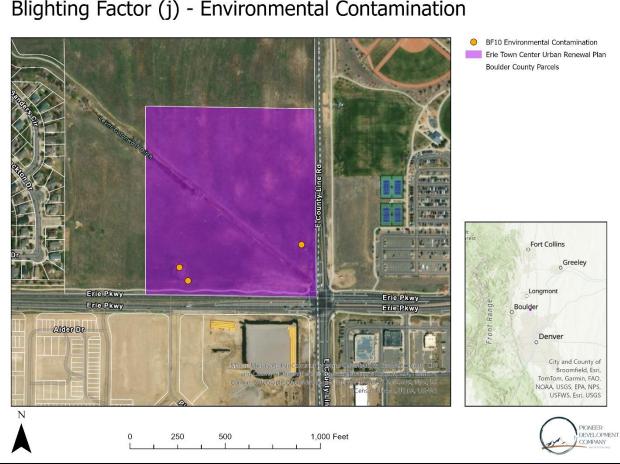
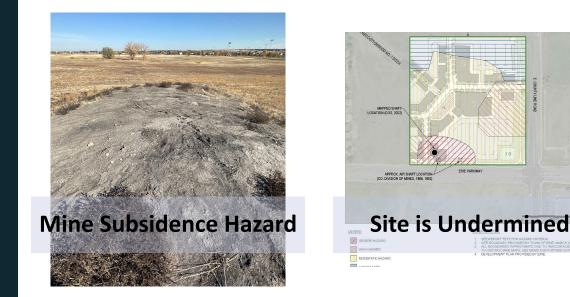
As explained in Factor 4 (d), this site exhibits environmentally hazardous conditions. The 2022 Lithos Engineering report found historic undermining present throughout the Plan area. According to that study, 70% of the site is undermined by the abandoned Garfield No. 1 Coal Mine, and ~30% of the site falls within severe to high subsidence hazards. The site is also impacted by secondary mines including the Lister Mine, Garfield No. 2, and Marfel/Pinnacle Mines. These mines were operated during the late 1800's, and have been abandoned for nearly a century. The study found evidence of three shafts within the Plan boundary, and undermining between 50 and 100 feet below the surface.

These historic uses present a severe environmental and geotechnical hazard. Future development must contend with these subsidence hazards, and potentially mitigate these issues. The Lithos report estimated that subsidence mitigation could cost as much as \$400,000 per acre. The presence of this unique environmental hazard, and its exorbitant cost, are conditions that support this blighting factor inclusion.

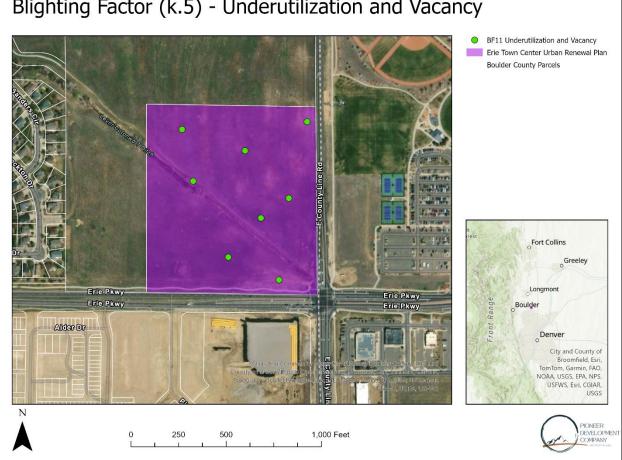
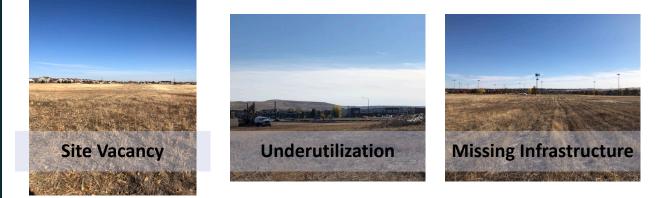
The survey area's underutilization and vacancy warranted the inclusion of blighting factor 11, as it specifically is triggered when vacancy is abundant within a Plan area. It is important, however, to evaluate site vacancy in the context of its surroundings. Obviously, vacant land could be utilized productively as agricultural land. In that example, the land should not be characterized as underutilized. However, when vacant land is also being positioned for redevelopment, its current condition can be described as underutilized. This property exemplifies underutilization when compared to its surroundings. The neighboring parcels have already undergone dense or intense residential and commercial development. The development pressure within Erie is fever-pitched, and yet this site has remained vacant. It is currently owned by the Town, being studied by the Town's economic development department for redevelopment and zoned as Business (B).

This context reveals that the parcel is underutilized relative its location, community planning initiatives and market forces. This underutilization is evidence for blighting factor eleven (11), and represents an additional condition for Urban Renewal treatment. The level of vacancy and underutilization is direct evidence for the inclusion of this blighting factor.

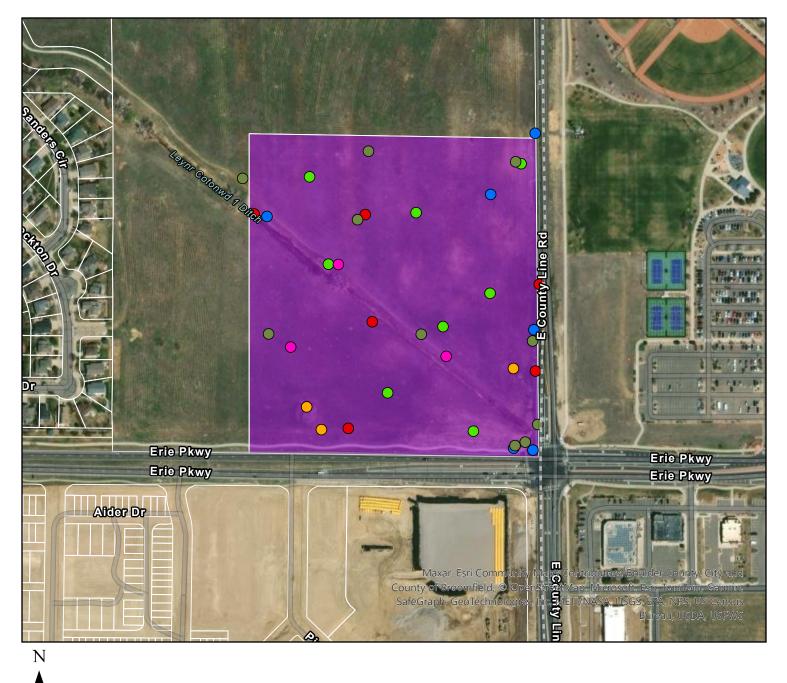
## Conditions Survey Area - Blighting Factors Map

- BF2 Defective Streets
- BF3 Faulty Lots
- BF4 Unsafe Conditions
- BF6 Topography and Infrastructure
- **BF10** Environmental Contamination
- BF11 Underutilization and Vacancy
  Erie Town Center Urban Renewal Plan
  Boulder County Parcels
