## **SPRING HILL**

### **MASTER UTILITY REPORT**

Submitted To:  
Town of Erie, Colorado

DECEMBER, 2021

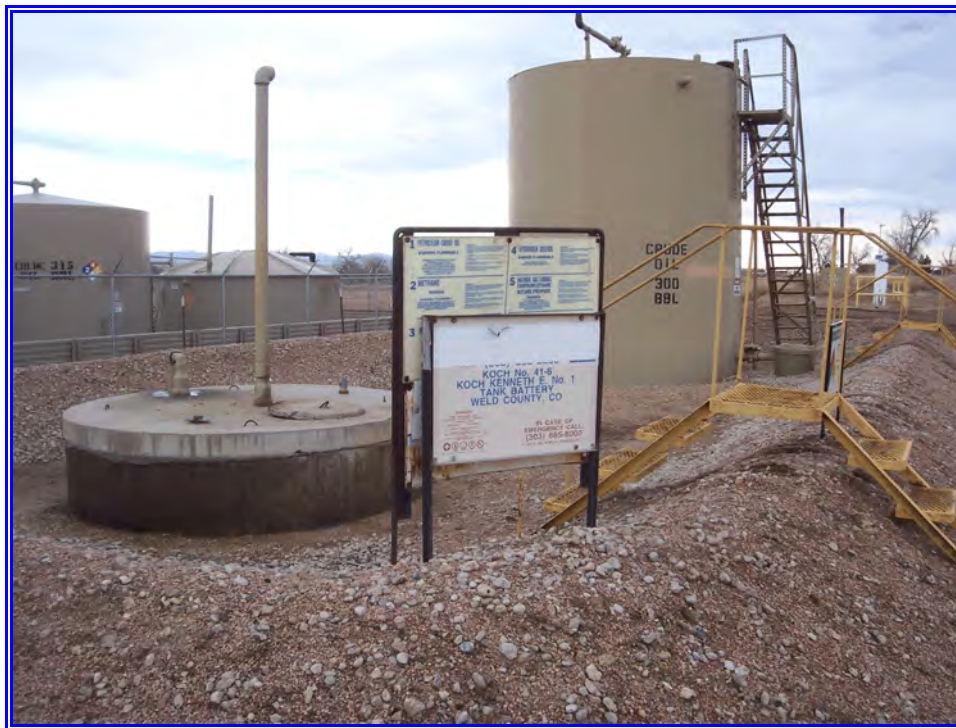
At the time of inspection, the northeastern area of the northern parcel contained irrigated crops, however the remainder of the of the northern parcel was used for grazing or fallow. Twelve oil/gas wells were observed throughout the northern parcel, including an older oil well labeled Koch 41-6, located in the northeast area of the site just east of the Boulder and Weld Ditch. No petroleum staining was observed associated with these facility.

One of the 28 petroleum production facilities on the project

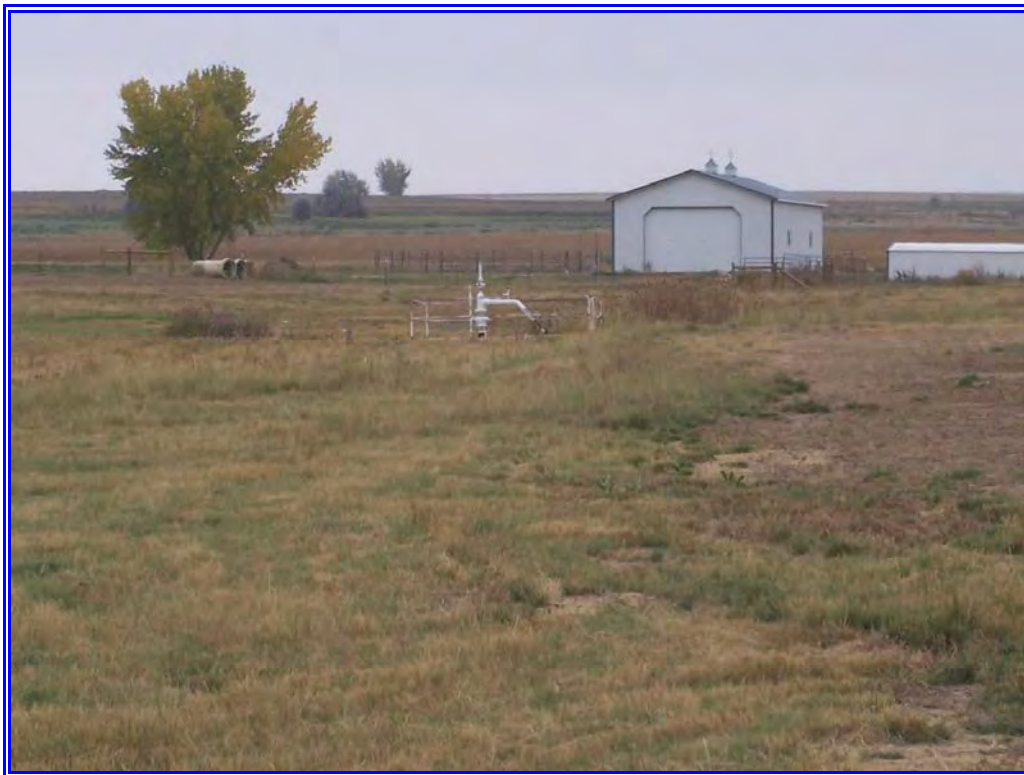
A large currently leased equipment building was observed in the northwest corner of the property. Various agricultural equipment and heavy machinery surrounded the building. No soil staining was observed around the structure. Two cattle sheds made from underground storage tanks were observed on the property. A large cattail marsh is present in the center portion of the northern tract. Off site inspection of the residences adjoining the property indicated that they contained homes and varying numbers of buildings. The old Koch Dairy farm borders the project site to the east, and contains many sheds and abandoned vehicles parked on the property. Additionally, the residence to the northeast contained an above ground storage tank.

Leased equipment shed northwest portion of site

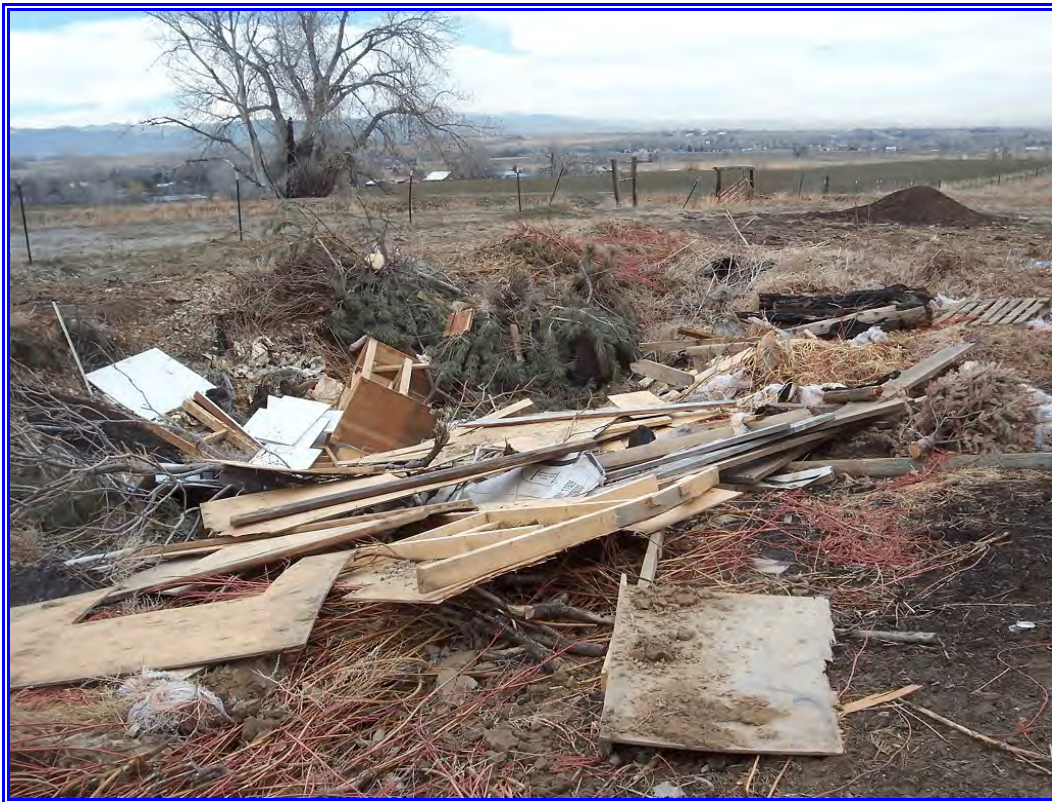
At the time of the inspection, the southern parcel of the subject site was also in agricultural use. Areas to the east contained irrigated crops including alfalfa hay with the western area used for grazing. Hay bales, and farm equipment were observed in the center of the property. Sixteen oil/gas wells were located throughout the southern parcel. No significant soil staining was observed adjacent to the wells. A trash burn pit for was observed on the southwest end of the property. This pit contained lumber, bailing twine tree limbs, household trash and deer and cow carcasses.

Burn pit, view to northwest
